I-RL-3010.19-1320-970-TNA-001

TITLE: IHM Report – Part I

## Inventory of Hazardous Materials Manual Part I

Ship / Vessel name	PETROBRAS XIX
Flag	Panama
Distinctive No. / Letters	3FHI5
Port of Registry	PANAMA
Type of vessel	Floating storage unit
Gross Tonnage	22589
IMO Number	8753720
Name of Shipbuilder	
Name of Shipowner	BRASPETRO OIL SERVICES CO.
Date of delivery	31/12/1982
IHM Inventory Number	RJN0/2024/8753720/ssf
Revision Number	4.0

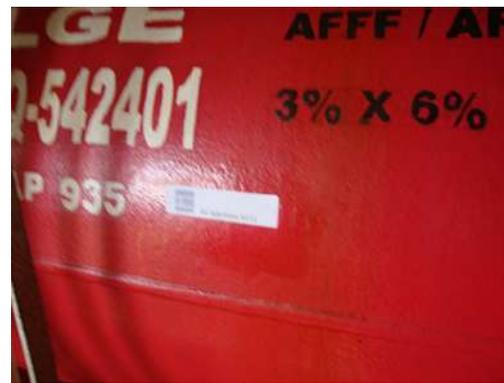
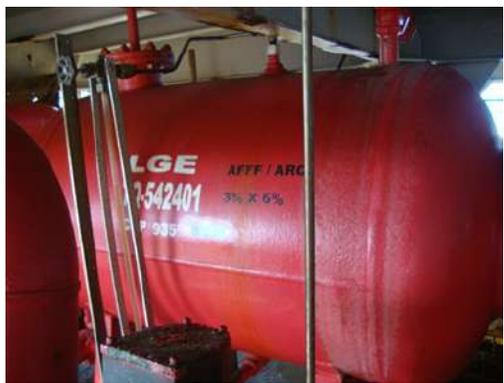
Location / Zone / Deck	Expected Hazardous Materials	Check procedure	Sample No.	Sample result	Quantity	Recommended Action
Helideck Miscellaneous	PFOS	Visual	A111	Contained	0.935 m3	No immediate action required
Fire protection/fighting system-Extinguishing agent-Foam tank (Tk 542401) / Fr.45 - PS

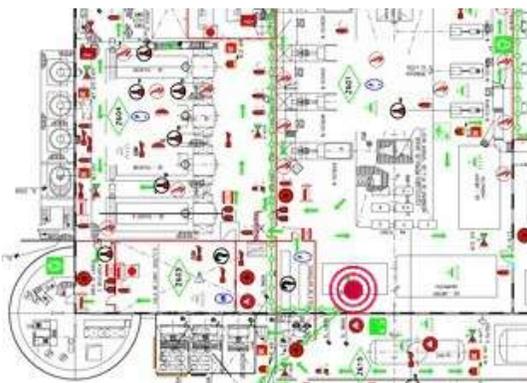
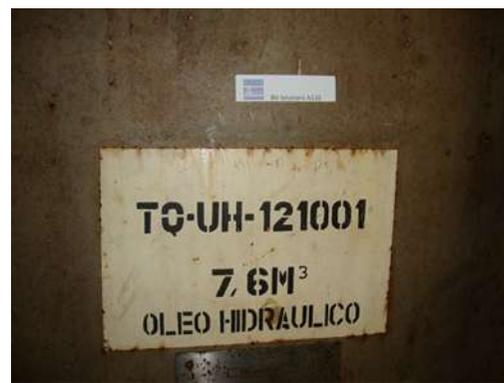
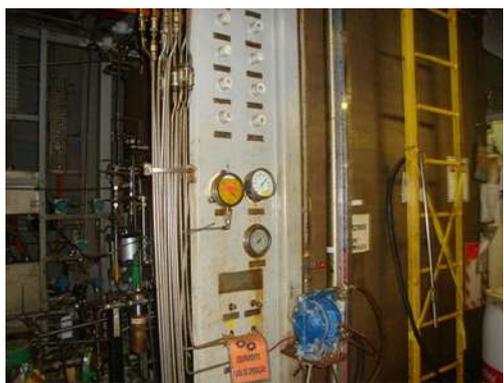
Lower Deck Cargo Area	PFOS	Visual	A110	Contained	7.6 m3	No immediate action required
Miscellaneous-Hydraulic oil-Hydraulic Oil Tank (Tk UH-121001) / Transfer pump room / Fr. 11 - PS

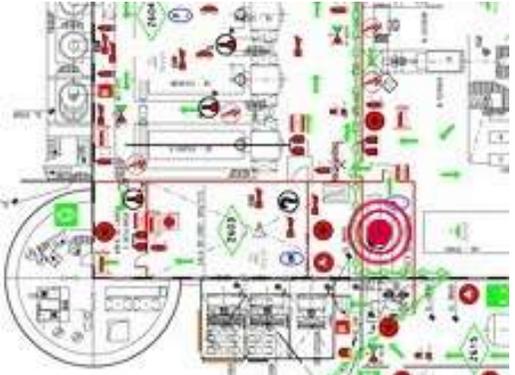
Location / Zone / Deck	Expected Hazardous Materials	Check procedure	Sample No.	Sample result	Quantity	Recommended Action
Lower Deck Cargo Area	Lead	Visual	A109	Contained	300 PCS	No immediate action required
Battery-Battery plates-Battery / Exportation pump room / Fr. 10 - PS

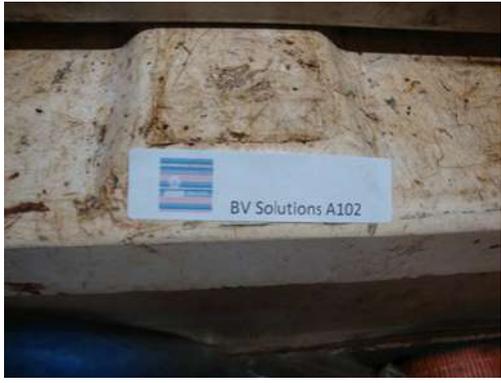
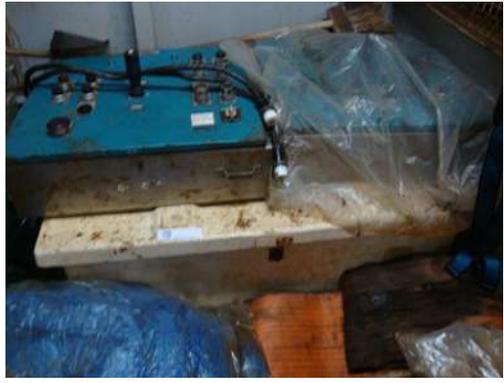
Location / Zone / Deck	Expected Hazardous Materials	Check procedure	Sample No.	Sample result	Quantity	Recommended Action
Main Deck Main Deck	Lead	Visual	A102	Contained	4 PCS	No immediate action required
Battery-Battery plates-Diesel Fire Pump MB-UB-542001B / Fr. 44 - STB

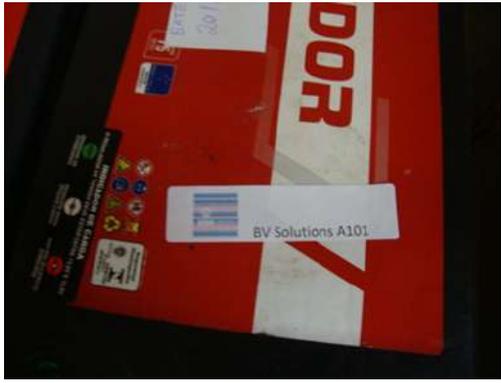
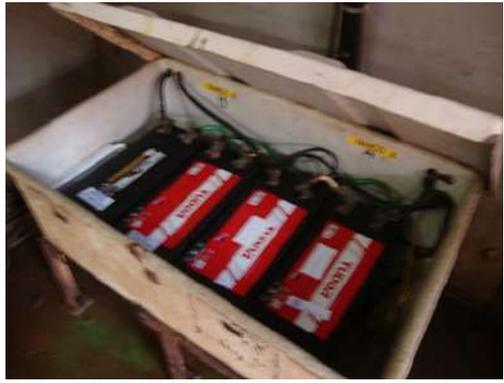
Main Deck Main Deck	Lead	Visual	A101	Contained	4 PCS	No immediate action required
Battery-Battery plates-Diesel Fire Pump MB-UB-542001A / Fr. 44 - PS

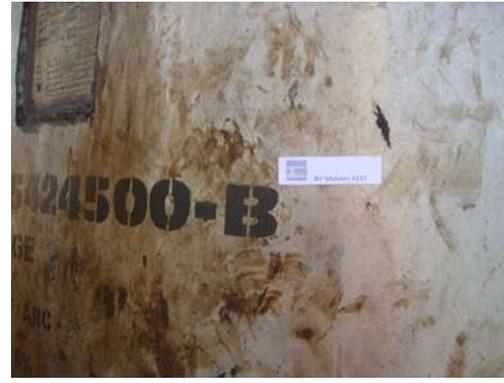
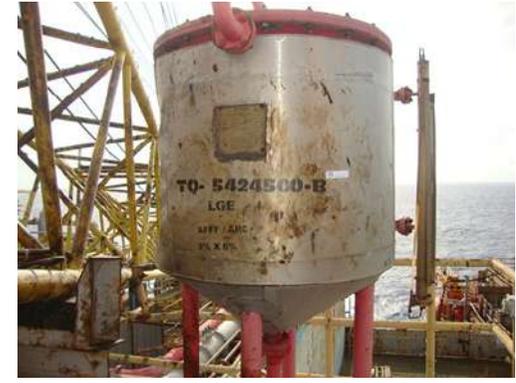
Location / Zone / Deck	Expected Hazardous Materials	Check procedure	Sample No.	Sample result	Quantity	Recommended Action
Upper Deck Cargo Area	PFOS	Visual	A112	Contained	0.75 m3	No immediate action required
Fire protection/fighting system-Extinguishing agent-Foam tank (Tk 5424500B) / Fr. 35 - PS

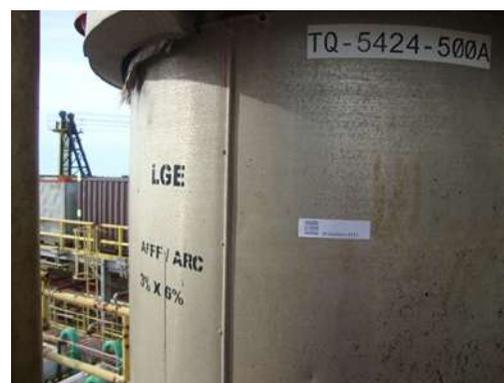
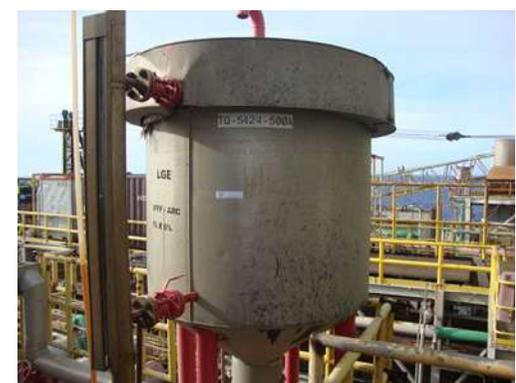
Upper Deck Cargo Area	PFOS	Visual	A113	Contained	0.75 m3	No immediate action required
Fire protection/fighting system-Extinguishing agent-Foam tank (Tk 542500A) / Fr. 18 - PS

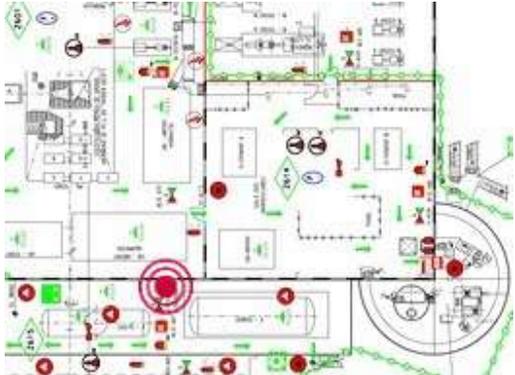
Location / Zone / Deck	Expected Hazardous Materials	Check procedure	Sample No.	Sample result	Quantity	Risk Level Assessment	Remarks				
Lower Deck Cargo Area	Asbestos	Sampling	A51	Not Contained							
Lagging material and insulation-Lagging material-External area / Piping insulation (attached Tk V541203) / Fr. 8 - STB

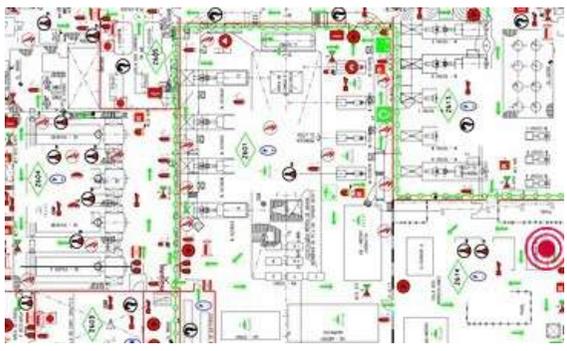
Lower Deck Engine Room	Asbestos	Sampling	A67	Not Contained			
Miscellaneous-Insulation-Hydrocyclone CI 5336501B insulation / Hydrocyclone room / Fr. 14 - STB

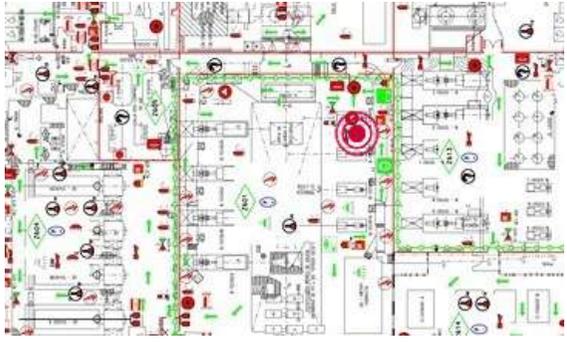
Location / Zone / Deck	Expected Hazardous Materials	Check procedure	Sample No.	Sample result	Quantity	Risk Level Assessment	Remarks
Lower Deck Engine Room	Asbestos	Sampling	A64	Not Contained			
Piping - Miscellaneous-Insulation-Piping insulation close to pump \B122301D\ / Exportation pumps room / Fr. 23 - STB

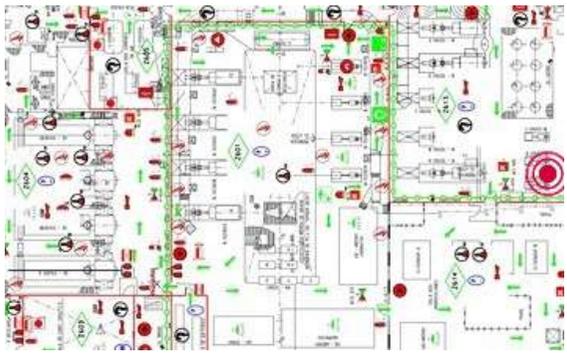
Lower Deck Engine Room	Asbestos	Sampling	A65	Not Contained			
Piping - Miscellaneous-Lagging material-Piping insulation - Pump MB 5125001-B / Injection water pumps room / Fr. 19 - STB

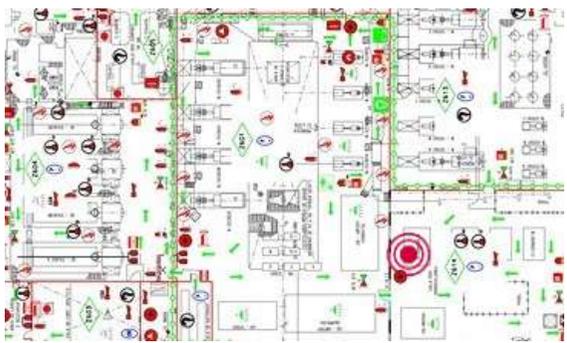
Lower Deck Engine Room	Asbestos	Sampling	A68	Not Contained			
Piping - Miscellaneous-Insulation-Piping insulation attached to hydrocyclone CI 533601A / Hydrocyclone room / Fr. 14 - STB

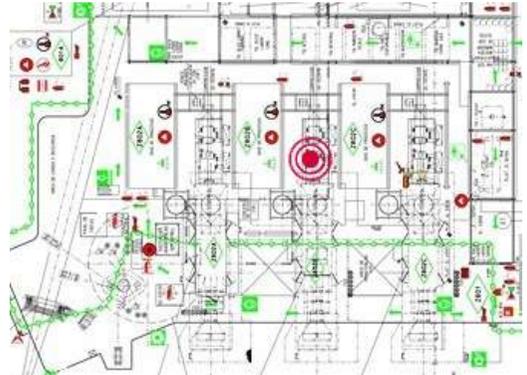
Main Deck Cargo Area	Asbestos	Sampling	A32	Not Contained			
Piping - Miscellaneous-Insulation-External area / Piping insulation / Fr. 14 - PS

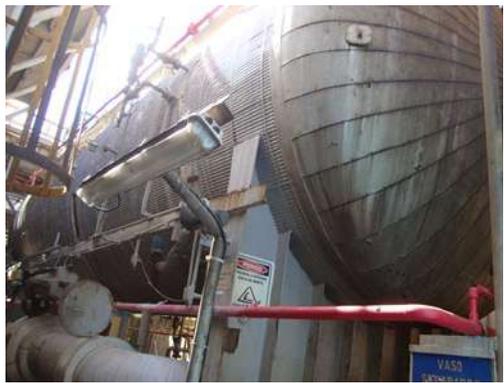
Main Deck Cargo Area	Asbestos	Sampling	A15	Not Contained			
Miscellaneous-Insulation-External area / Separator tank SG 122303 insulation / Fr. 25 STB

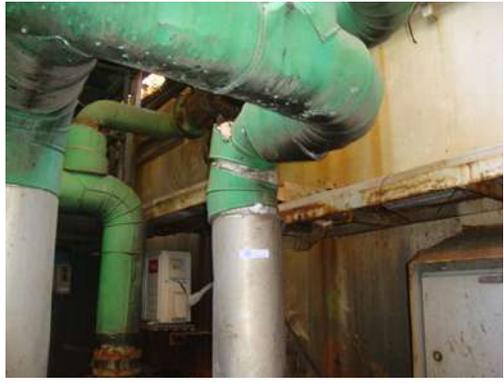
Location / Zone / Deck	Expected Hazardous Materials	Check procedure	Sample No.	Sample result	Quantity	Risk Level Assessment	Remarks
Main Deck Cargo Area	Asbestos	Sampling	A14	Not Contained			
Piping - Miscellaneous-Insulation-External area / Piping insulation / Fr. 37 - CL

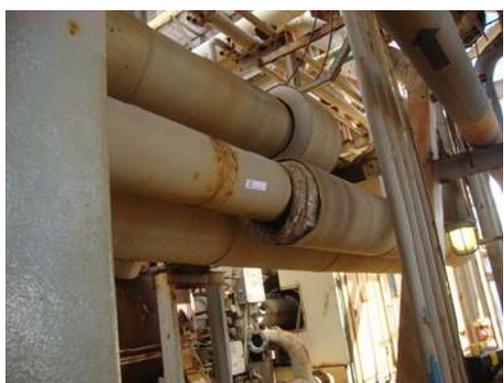
Main Deck Cargo Area	Asbestos	Sampling	A34	Not Contained			
Piping - Miscellaneous-Insulation-External area / Piping insulation / Fr. 15 - PS

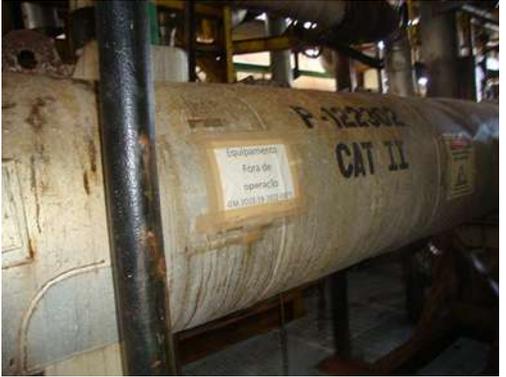
Main Deck Cargo Area	Asbestos	Sampling	A25	Not Contained			
Miscellaneous-Insulation-External area / Tank P122302A insulation / Fr. 14 - STB

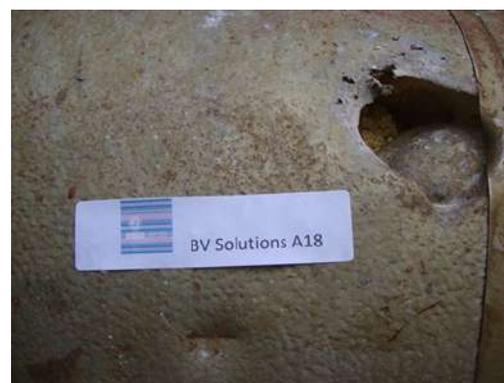
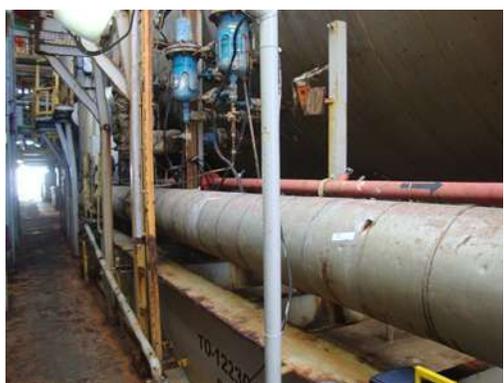
Location / Zone / Deck	Expected Hazardous Materials	Check procedure	Sample No.	Sample result	Quantity	Risk Level Assessment	Remarks
Main Deck Cargo Area	Asbestos	Sampling	A18	Not Contained			
Piping - Miscellaneous-Insulation-External area / Piping insulation (attached Tk 122301B) / Fr. 22 - STB

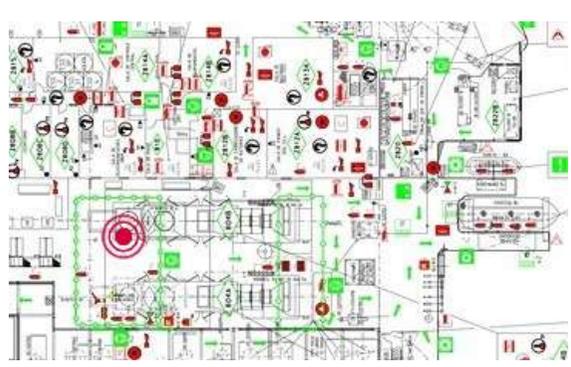
Main Deck Cargo Area	Asbestos	Sampling	A13	Not Contained			
Cargo space-Insulation-External area / Piping insulation / Fr. 35 - STB

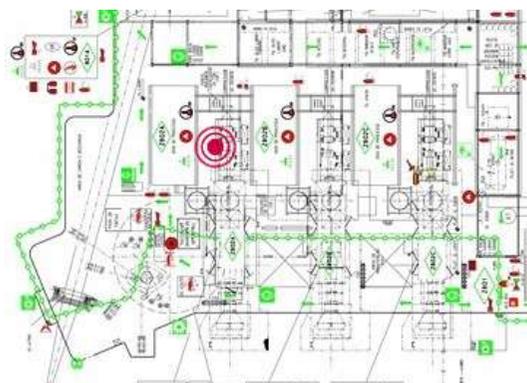
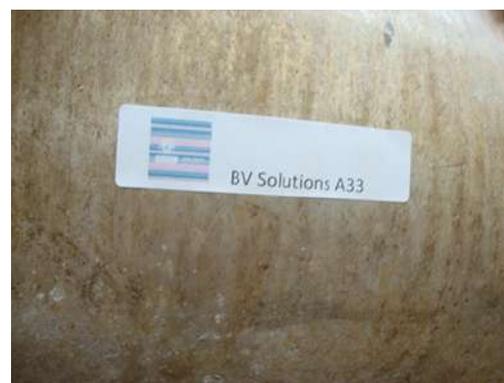
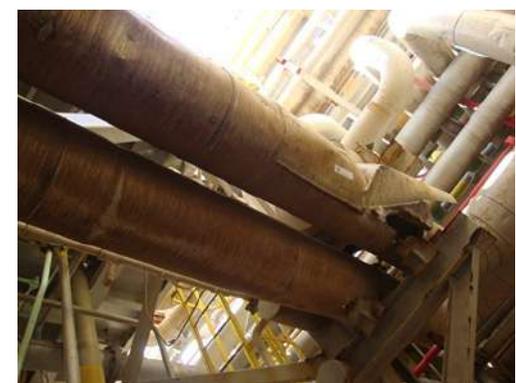
Location / Zone / Deck	Expected Hazardous Materials	Check procedure	Sample No.	Sample result	Quantity	Risk Level Assessment	Remarks
Main Deck Cargo Area	Asbestos	Sampling	A33	Not Contained			
Piping - Miscellaneous-Insulation-External area / Piping insulation / Fr. 15 - PS

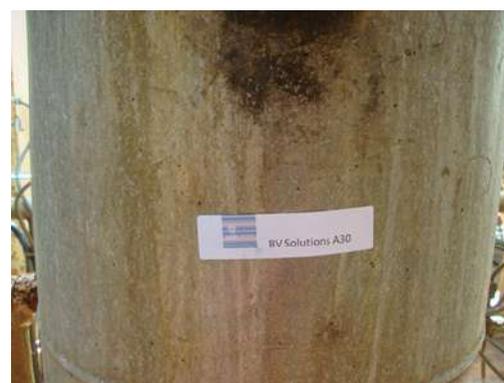
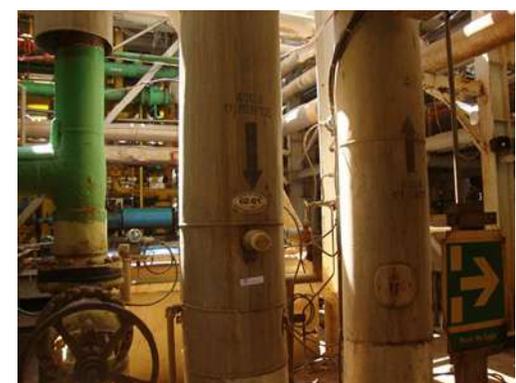
Main Deck Cargo Area	Asbestos	Sampling	A30	Not Contained			
Cargo space-Insulation-External area / Piping insulation / Fr. 18 - STB

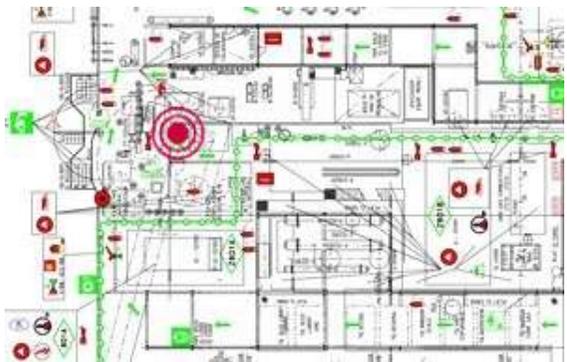
Location / Zone / Deck	Expected Hazardous Materials	Check procedure	Sample No.	Sample result	Quantity	Risk Level Assessment	Remarks
Main Deck Cargo Area	Asbestos	Sampling	A39	Not Contained			
Miscellaneous-Insulation-External area / TK V-UC-122302 (Booster) insulation / Fr. 28 - PS

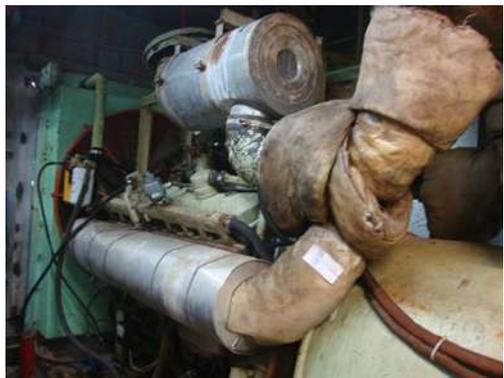
Main Deck Main Deck	Asbestos	Sampling	A05	Not Contained			
Lagging material - exhaust pipe-Lagging material-Exhaust gas - Emergency generator - DGE 514002 / Fr. 42 - STB

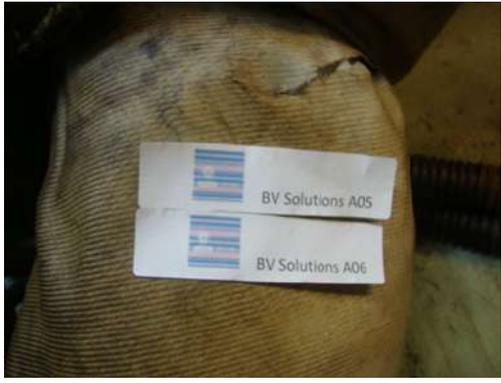
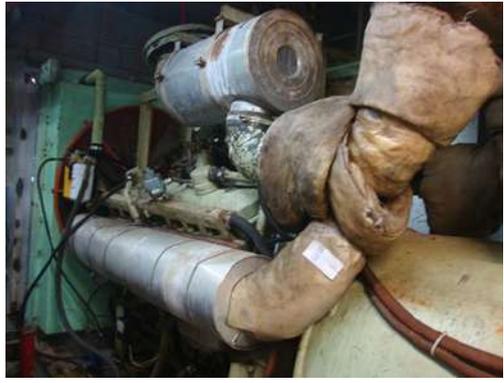
Location / Zone / Deck	Expected Hazardous Materials	Check procedure	Sample No.	Sample result	Quantity	Risk Level Assessment	Remarks
Main Deck Main Deck	Asbestos	Sampling	A06	Not Contained			
Exhaust gas system-Insulation-Exhaust gas - Emergency generator - DGE 514002 / Fr. 42 - STB

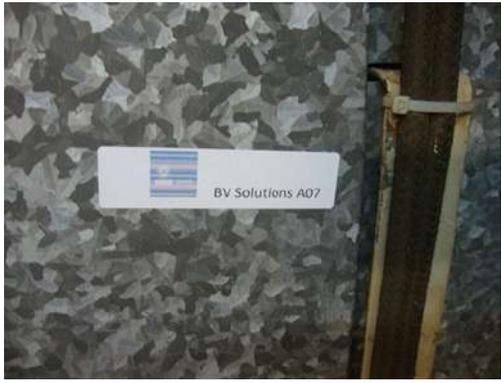
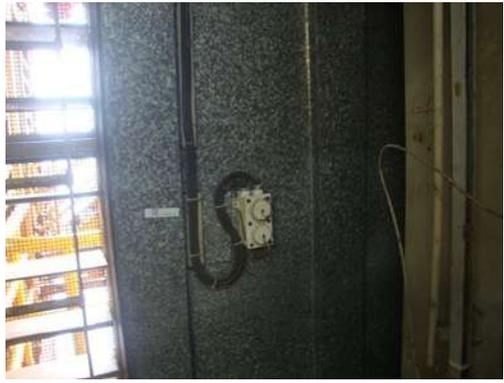
Main Deck Main Deck	Asbestos	Sampling	A07	Not Contained			
Bulkhead plating-Insulation-Bulkhead insulation / Emergency generator room / Fr. 42 - STB

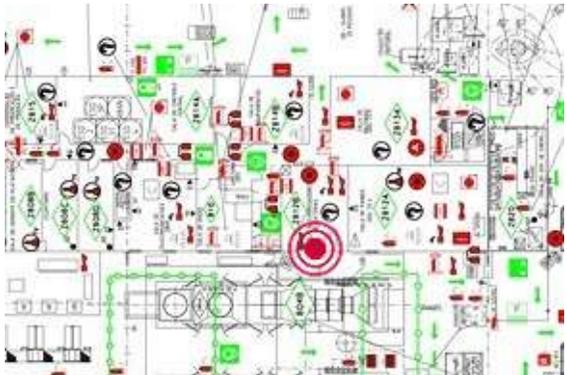
Location / Zone / Deck	Expected Hazardous Materials	Check procedure	Sample No.	Sample result	Quantity	Risk Level Assessment	Remarks
Main Deck Main Deck	Asbestos	Sampling	A08	Not Contained			
Bulkhead plating-Insulation-Bulkhead insulation / Battery charger room / Fr. 41 - STB

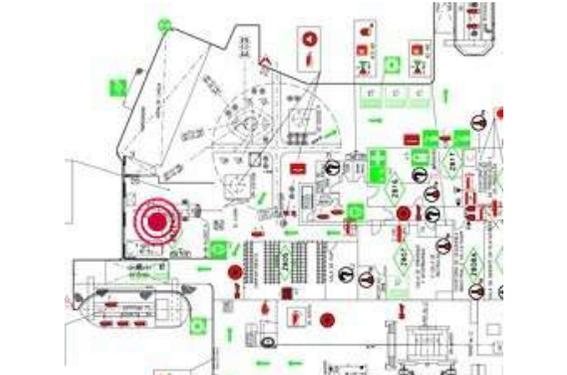
Main Deck Main Deck	Asbestos	Sampling	A03	Not Contained			
Diesel Engine-Insulation-External area / Diesel Fire Pump PS - MB-UB 542001A / Fr.43 - PS

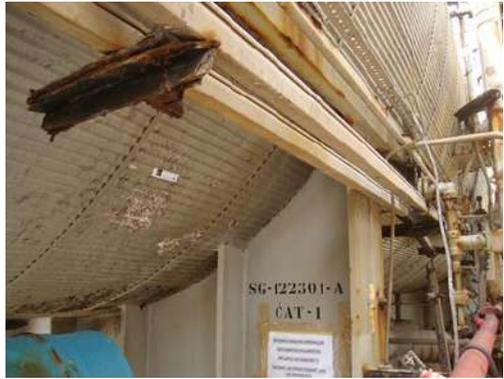
Location / Zone / Deck	Expected Hazardous Materials	Check procedure	Sample No.	Sample result	Quantity	Risk Level Assessment	Remarks
Upper Deck Cargo Area	Asbestos	Sampling	A43	Not Contained			
Miscellaneous-Insulation-External area / Tk SG123301-A insulation / Fr. 12 - STB

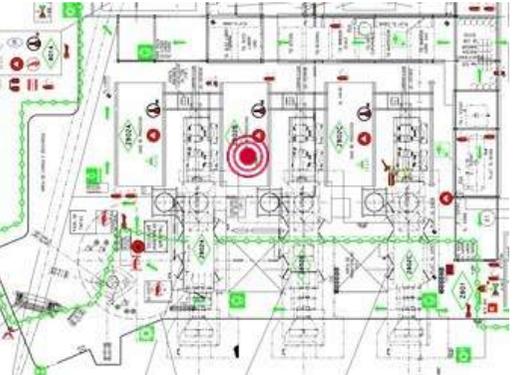
Upper Deck Cargo Area	Asbestos	Sampling	A47	Not Contained			
Piping - Miscellaneous-Insulation-External area / Piping insulation (attached discharge Turbo Compressor \C) / Fr. 15 - PS

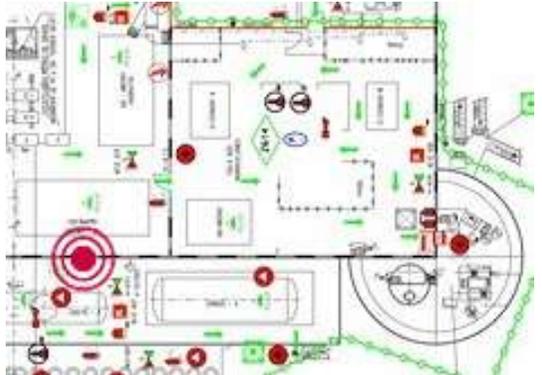
Location / Zone / Deck	Expected Hazardous Materials	Check procedure	Sample No.	Sample result	Quantity	Remarks					
Lower Deck Cargo Area	HBCDD	Sampling	A53	Not Contained							
Bulkhead plating-Concrete-Passive protection transverse beam / Fr. 9 - STB

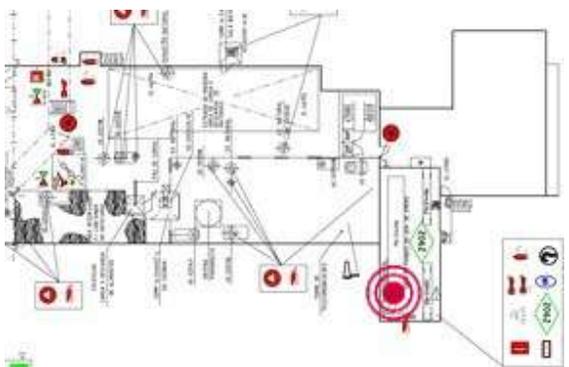
Location / Zone / Deck	Expected Hazardous Materials	Check procedure	Sample No.	Sample result	Quantity	Remarks
Upper Deck Superstructure	PCB	Visual	A106	Not Contained		
Transformer-Insulating oil-Electrical transformer - TF514503 / Essential Panel room / Fr. 37 - STB

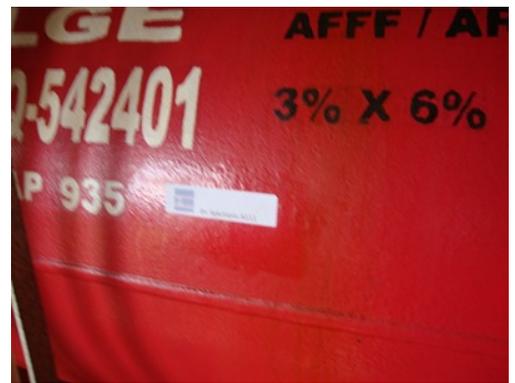
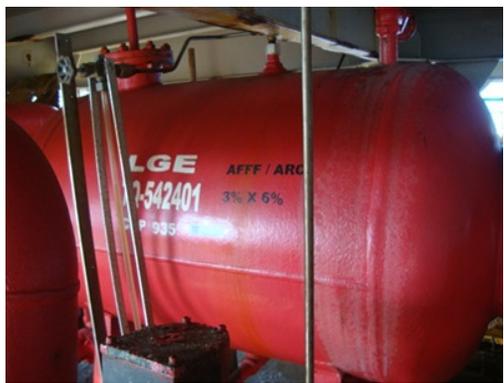
Location / Zone / Deck	Expected Hazardous Materials	Check procedure	Sample No.	Sample result	Quantity	Recommended Action
Helideck Miscellaneous	PFOS	Visual	A111	Contained	0.935 m3	No immediate action required
Fire protection/fighting system-Extinguishing agent-Foam tank (Tk 542401) / Fr.45 - PS

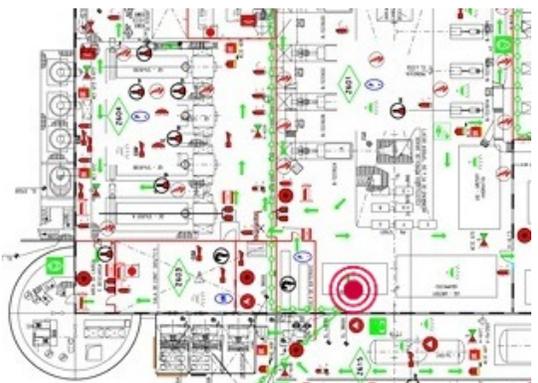
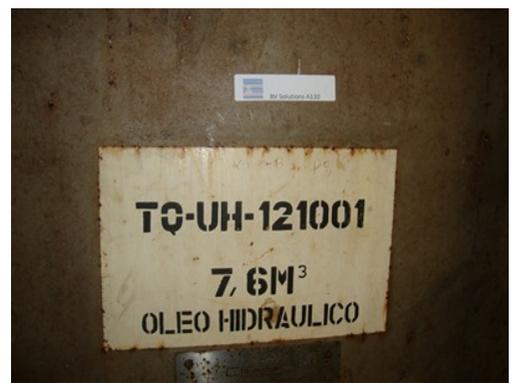
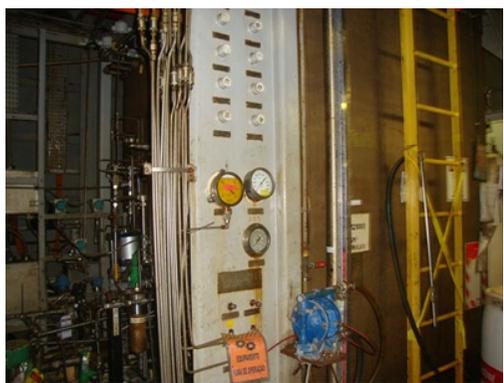
Lower Deck Cargo Area	PFOS	Visual	A110	Contained	7.6 m3	No immediate action required
Miscellaneous-Hydraulic oil-Hydraulic Oil Tank (Tk UH-121001) / Transfer pump room / Fr. 11 - PS

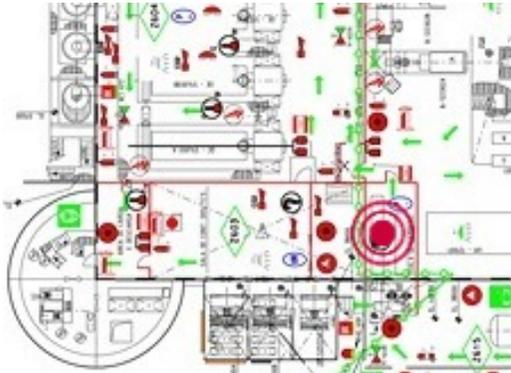
Location / Zone / Deck	Expected Hazardous Materials	Check procedure	Sample No.	Sample result	Quantity	Recommended Action
Lower Deck Cargo Area	Lead	Visual	A109	Contained	300 PCS	No immediate action required
Battery-Battery plates-Battery / Exportation pump room / Fr. 10 - PS

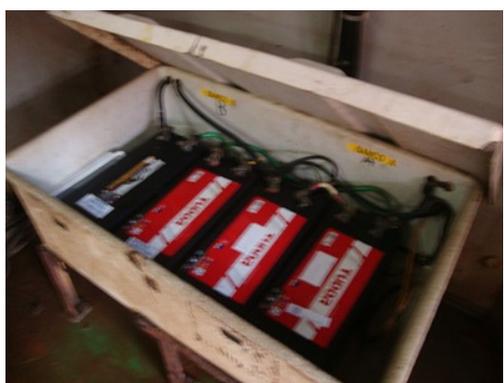
Main Deck Main Deck	Lead	Visual	A101	Contained	4 PCS	No immediate action required
Battery-Battery plates-Diesel Fire Pump MB-UB-542001A / Fr. 44 - PS
