**BUREAU
VERITAS**

Inventory of Hazardous Materials Manual Part I

Ship / Vessel	PETROBRAS 26
name	PANAMA
Particulars of the ship	
Ship / Vessel name	Flag
Flag	
Distinctive No. / Letters	HP8997
Distinctive No. / Letters	
Port of Registry	PANAMA
Port of Registry	Port of Registry
Type of vessel	Type of vessel Offshore submersible unit
Gross Tonnage	Gross Tonnage 20313
IMO Number	IMO Number 8764169
Name of Shipbuilder	Name of Shipbuilder Vyborg
Shipyard	
Name of Shipowner	Petrobras Netherlands B.V.
Date of delivery	Name of Shipowner 31/10/1997
IHM Inventory Number	RJN0/2023/8764169/Xw5
Revision Number	Date of delivery 5.0
IHM Inventory Number	
Revision Number

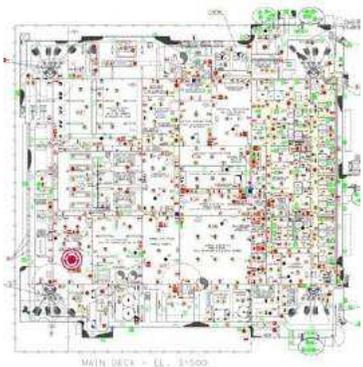
Area / Zone / Deck	Expected Hazardous Materials	Check procedure	Sample No.	Sample result	Quantity	Recommended Action
Deck EI.31500 Deck	PFOS	Visual	A108	PCHM	PCHM - Quantity to be determined	
Control Room / Control Systems-Hydraulic oil- Control Panel Room / Frame 117 STB

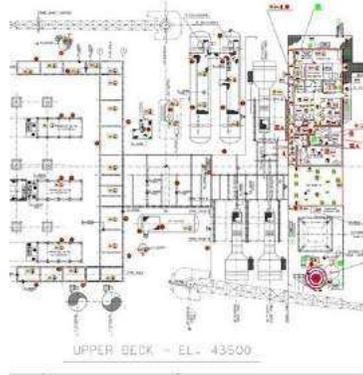
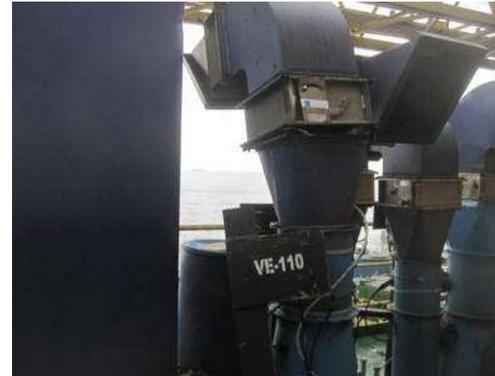
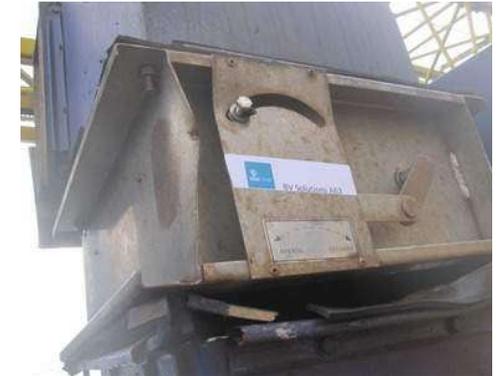
ion duct -Rubber applications-Ventilation VE
ame 26 STB

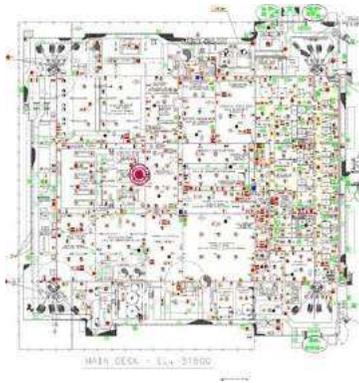
Location / Zone / Deck	Expected Hazardous Materials	Check procedure	Sample No.	Sample result	Quantity	Risk Level Assessment	Remarks
Deck EI.31500 Identification	Asbestos	Sampling	A43	Not Contained			
Miscellaneous-Insulation-Exportation Pump (TQ 122301B 01A) / Frame 84 PS

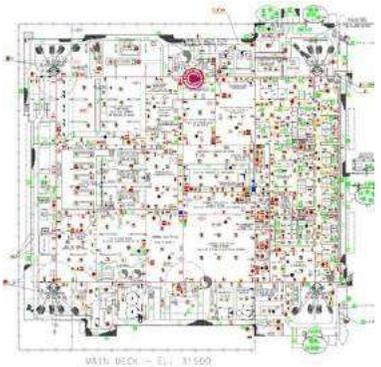
Location / Zone / Deck	Expected Hazardous Materials	Check procedure	Sample No.	Sample result	Quantity	Risk Level Assessment	Remarks
Deck El.31500 Location	Asbestos	Sampling	A40	Not Contained			
Location - Ceiling-Lagging material-Electrical Deck / Frame 34 PS

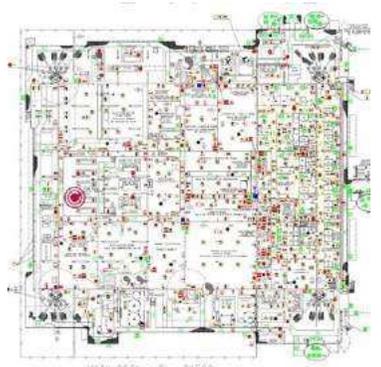
Deck El.31500 Location	Asbestos	Sampling	A44	Not Contained			
Miscellaneous-Insulation-Exportation Pump (122301 J1D) / Frame 111 PS

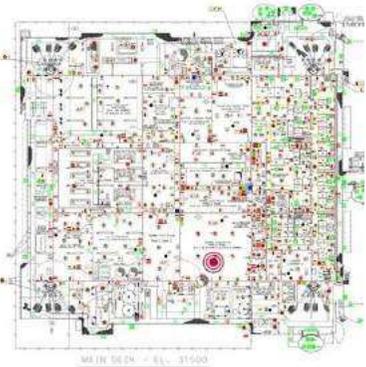
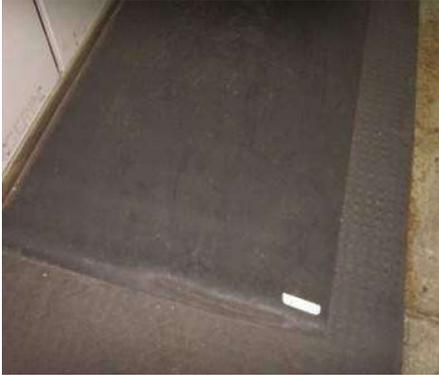
Location / Zone / Deck	Expected Hazardous Materials	Check procedure	Sample No.	Sample result	Quantity	Risk Level Assessment	Remarks
Deck El.31500 Location	Asbestos	Sampling	A35	Not Contained			
Overlapping-Rubber applications-Normal Electrical Room / Frame 52 STB

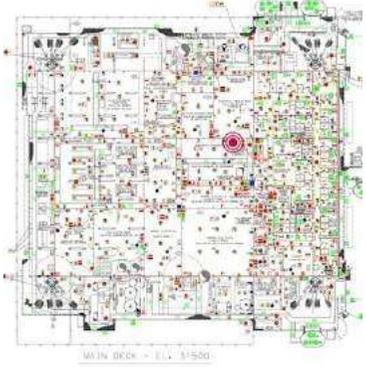
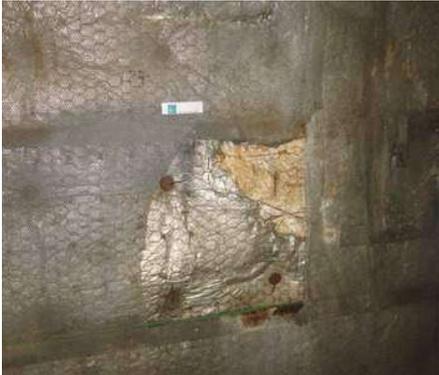
Deck El.31500 Location	Asbestos	Sampling	A38	Not Contained			
Location - Wall-Insulation-Bulkhead insulation / Machinery Generator Room / Frame 38 PS

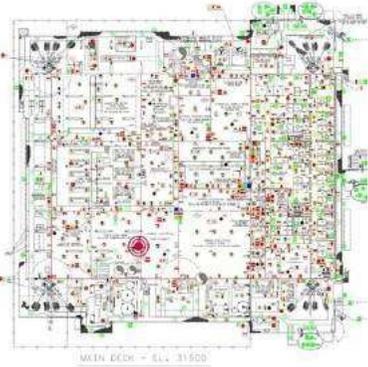
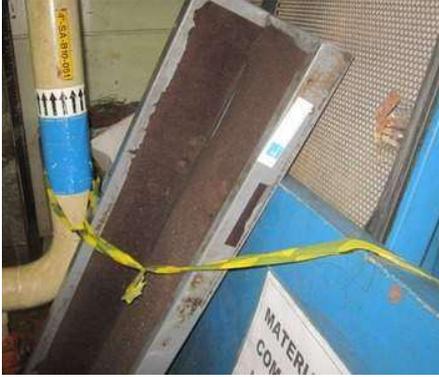
Location / Zone / Deck	Expected Hazardous Materials	Check procedure	Sample No.	Sample result	Quantity	Risk Level Assessment	Remarks
Deck El.31500 Location	Asbestos	Sampling	A42	Not Contained			
Compressor-Insulation-Air Compressor filter / Air Room / Frame 85 STB

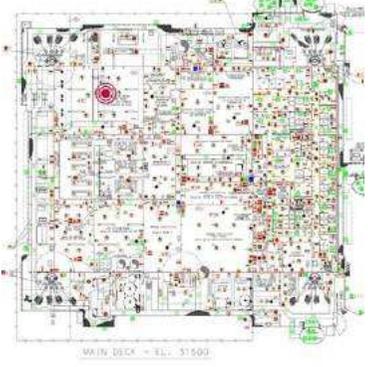
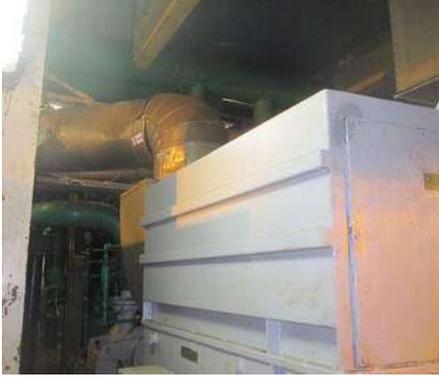
Deck El.31500 Location	Asbestos	Sampling	A47	Not Contained			
Lagging material and insulation-Lagging Injection Water Pump (B125101B) / Frame 94

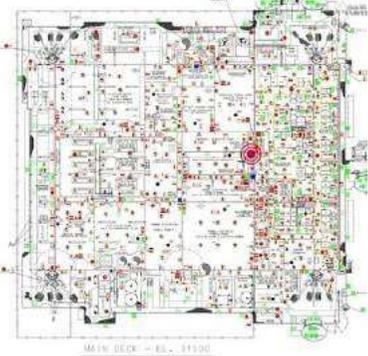
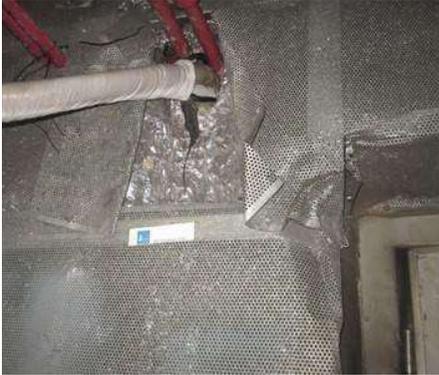
Location / Zone / Deck	Expected Hazardous Materials	Check procedure	Sample No.	Sample result	Quantity	Risk Level Assessment	Remarks
Deck El.31500 Insulation	Asbestos	Sampling	A37	Not Contained			
Insulation - Wall-Insulation-Bulkhead insulation / Machinery Generator Room / Frame 42 PS

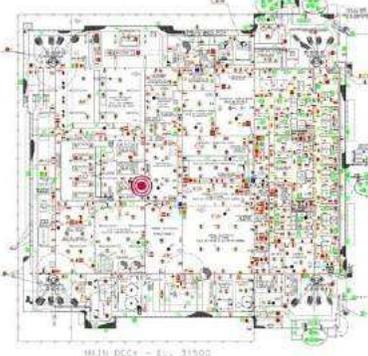
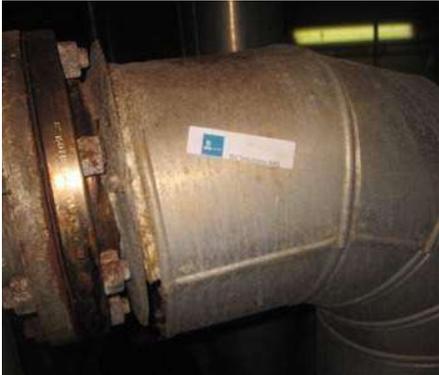
Deck El.31500 Insulation	Asbestos	Sampling	A45	Not Contained			
Miscellaneous-Insulation-Exportation Pump (TQ UC 122301C 01A) / Frame 84 PS

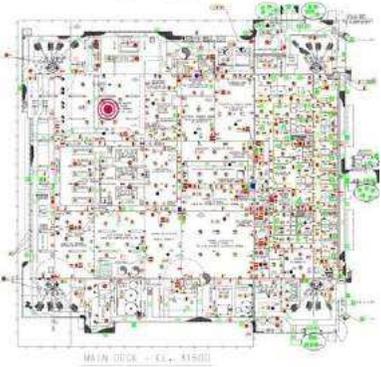
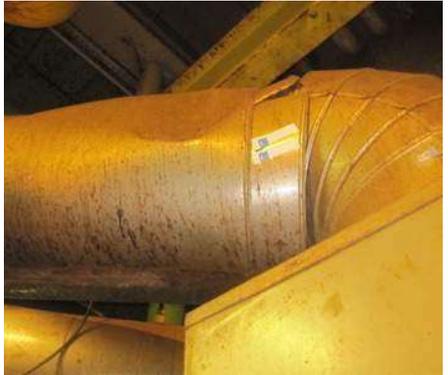
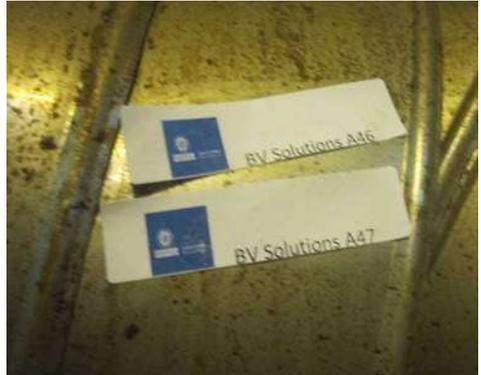
Location / Zone / Deck	Expected Hazardous Materials	Check procedure	Sample No.	Sample result	Quantity	Risk Level Assessment	Remarks
Deck El.31500 Location	Asbestos	Sampling	A46	Not Contained			
Miscellaneous-Insulation-Injection Water Pump (01B)

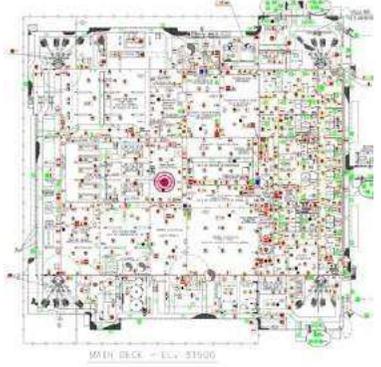
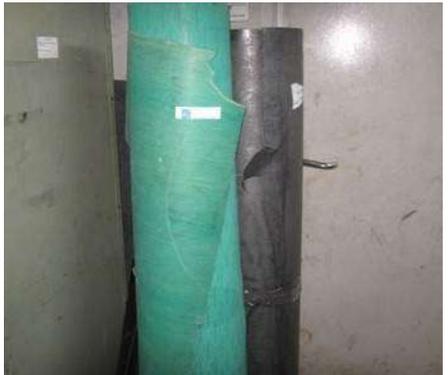
Deck El.31500 Location	Asbestos	Sampling	A41	Not Contained			
As-Gaskets-Warehouse 1 / Frame 72 STB

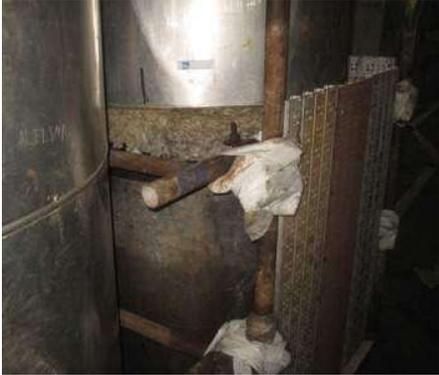
Location / Zone / Deck	Expected Hazardous Materials	Check procedure	Sample No.	Sample result	Quantity	Risk Level Assessment	Remarks
Deck EI.31500 Insulation	Asbestos	Sampling	A36	Not Contained			
Discharge gas system-Insulation-DGE discharge gas Emergency Generator Room / Fram 58 PS

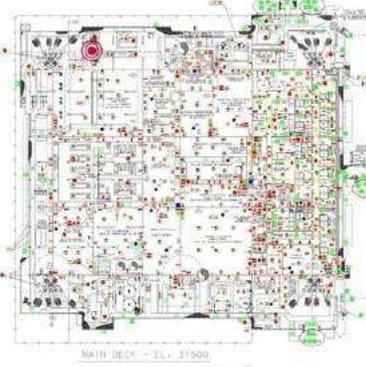
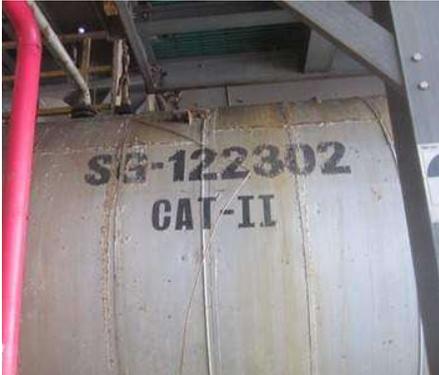
Deck EI.31500 Deck	Asbestos	Sampling	A71	Not Contained			
Insulation material and insulation-Insulation-Test for SG122302 / Frame 102 PS

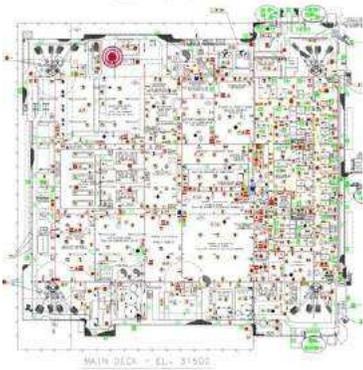
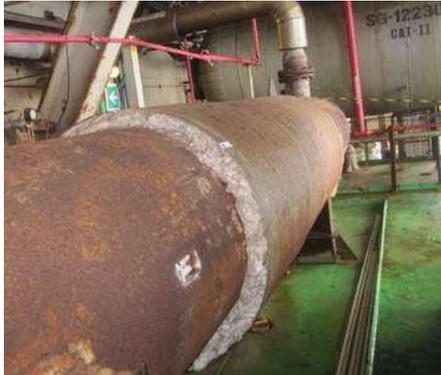
Location / Zone / Deck	Expected Hazardous Materials	Check procedure	Sample No.	Sample result	Quantity	Risk Level Assessment	Remarks
Deck El.31500 Deck	Asbestos	Sampling	A69	Not Contained			
g material and insulation-Insulation-Test Heater 2302 / Frame 108 PS

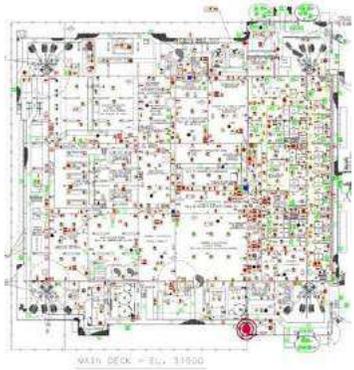
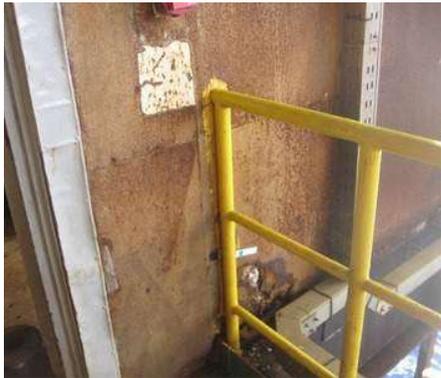
Deck El.31500 Deck	Asbestos	Sampling	A63	Not Contained			
ad plating-Insulation-Bulkhead insulation / 49 STB

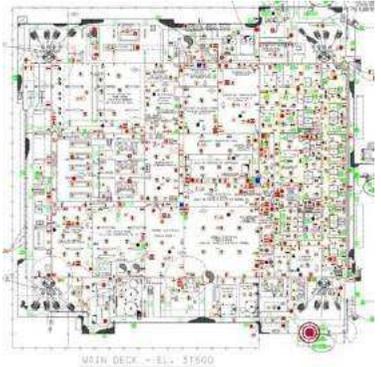
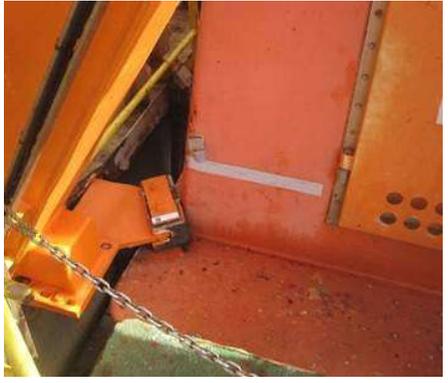
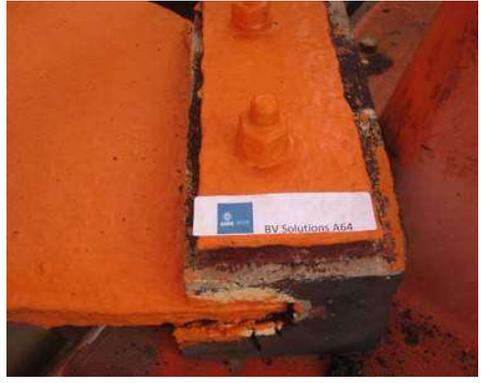
Location / Zone / Deck	Expected Hazardous Materials	Check procedure	Sample No.	Sample result	Quantity	Risk Level Assessment	Remarks
Deck El.31500 Deck	Asbestos	Sampling	A64	Not Contained			
Lift crane-Rubber applications-Lifeboat #3 davit Frame 19 STB

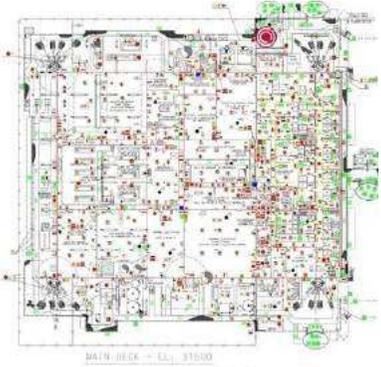
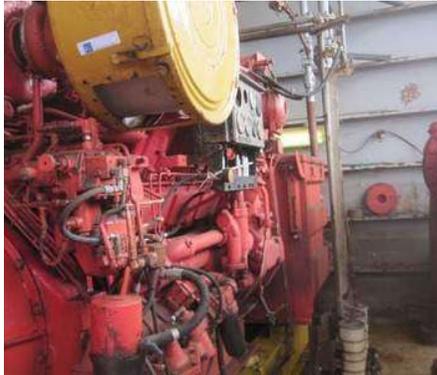
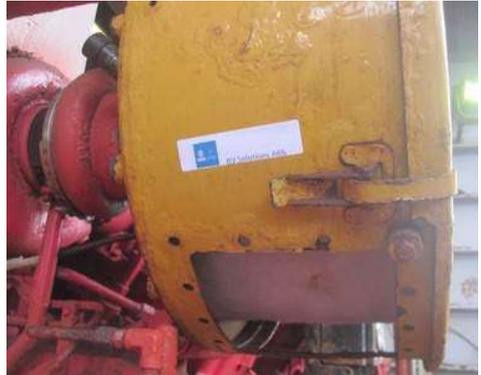
Location / Zone / Deck	Expected Hazardous Materials	Check procedure	Sample No.	Sample result	Quantity	Risk Level Assessment	Remarks
Deck EI.31500 Deck	Asbestos	Sampling	A66	Not Contained			
Engine-Mineral wool-Turbocharger filter / Fire Wood PS / Frame 45 PS

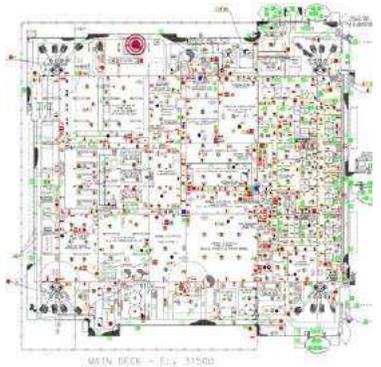
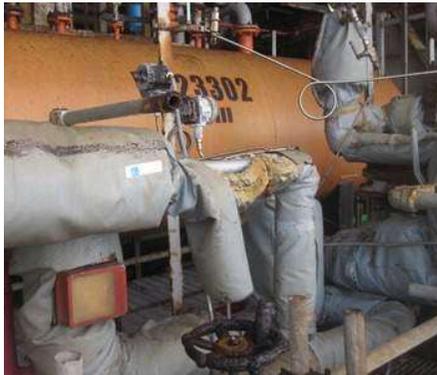
Deck EI.31500 Deck	Asbestos	Sampling	A68	Not Contained			
Miscellaneous-Insulation-Piping close to Tank 3302 / Frame 102 PS

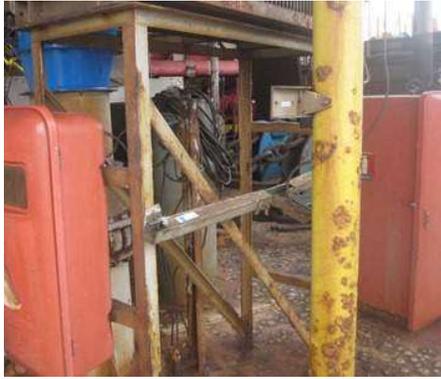
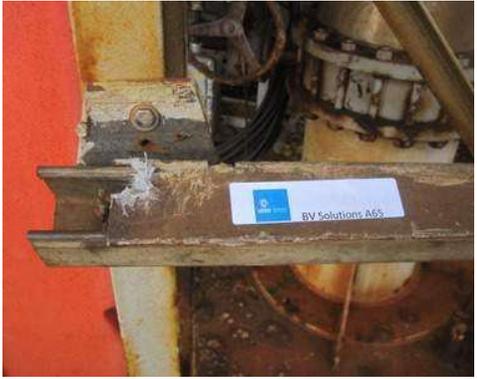
Location / Zone / Deck	Expected Hazardous Materials	Check procedure	Sample No.	Sample result	Quantity	Risk Level Assessment	Remarks
Deck EL.31500 Deck	Asbestos	Sampling	A65	Not Contained			
Electrical equipment-Equipment parts / Electrical support AE404A04 / Frame 24 PS

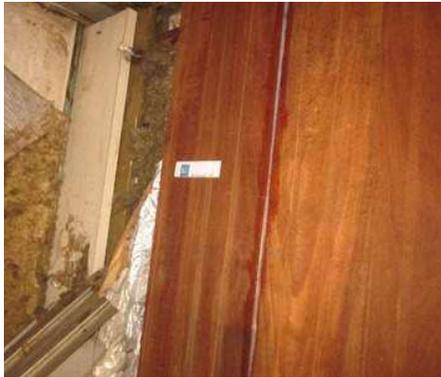
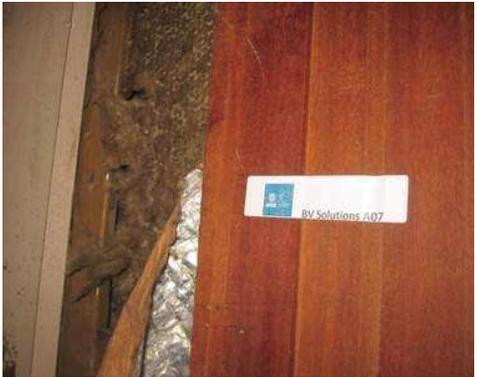
Location / Zone / Deck	Expected Hazardous Materials	Check procedure	Sample No.	Sample result	Quantity	Risk Level Assessment	Remarks
Line Deck 0/44000 Modification	Asbestos	Sampling	A7	Not Contained			
Modification - Wall-Insulation-Fitness room / Acoustic insulation / Fr. 20 - PS

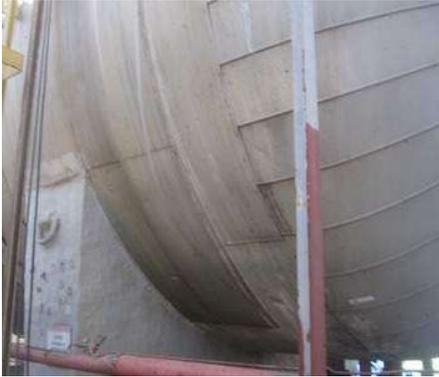
Line Deck 0/44000 Area	Asbestos	Sampling	A77	Not Contained				
g material and insulation-Insulation-Tank SG A / Frame 66 CL

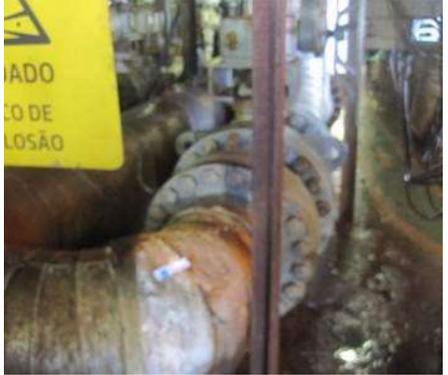
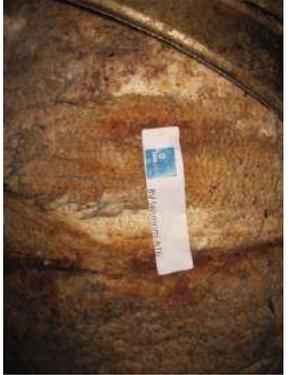
<p>SPIDER DECK EL. 25700</p>

<p>Deck El.25700 Area</p>	<p>Asbestos</p>	<p>Sampling</p>	<p>A74</p>	<p>Not Contained</p>			
<p>Miscellaneous-Insulation-Piping insulation / 125 PS</p>

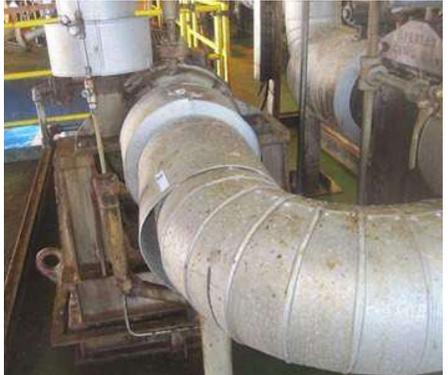
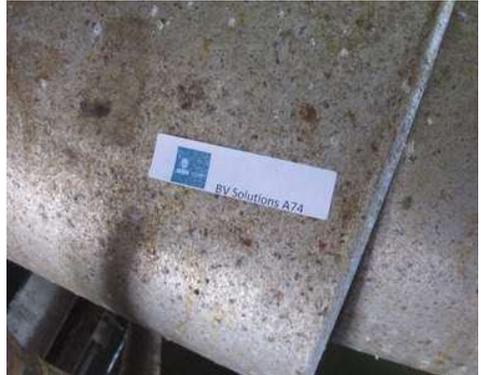
<p>SPIDER DECK EL. 25700</p>

<p>Deck El.25700 Area</p>	<p>Asbestos</p>	<p>Sampling</p>	<p>A73</p>	<p>Not Contained</p>

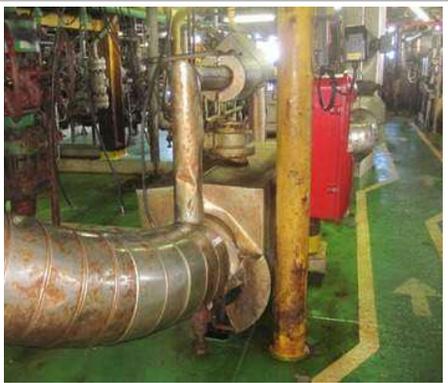
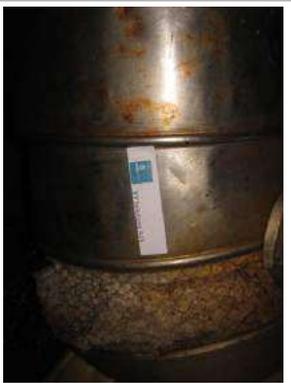
Miscellaneous-Insulation-Piping insulation / 105 PS Deck El.34500 notation		Asbestos	Sampling	A29	Not Contained		
hot water-Insulation-Hot Water Pump Room / 107 STB

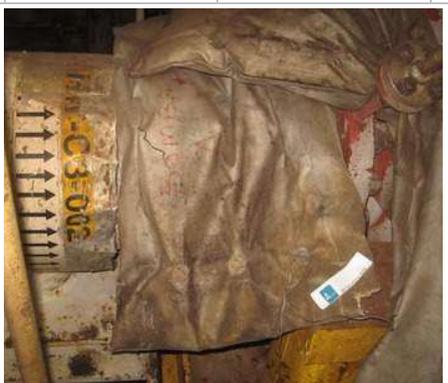
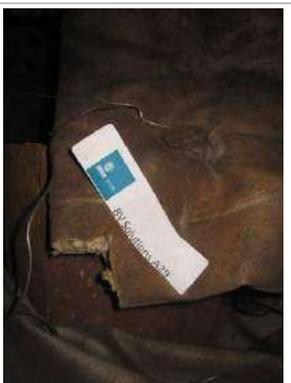
hot water-Insulation-Hot Water Pump Room / 107 STB		Asbestos	Sampling	A18	Not Contained

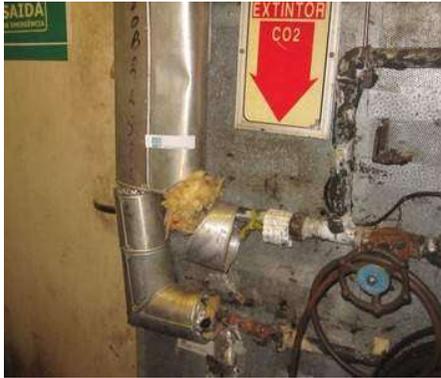
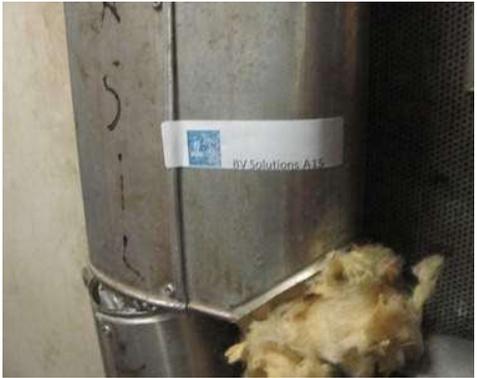
<p style="text-align: center; font-size: small;">TWEEN DECK - EL. 34500</p>

Deck El.34500 notation	Asbestos	Sampling	A22	Not Contained			
notation - Floor-Rubber applications-Essential room AC / Frame 30 PS

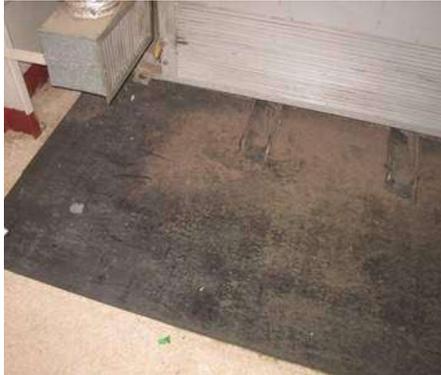
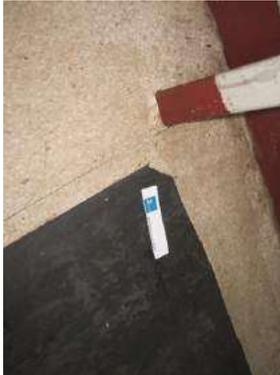
<p style="text-align: center; font-size: small;">TWEEN DECK - EL. 34500</p>

on / Zone / Deck	Expected Hazardous Materials	Check procedure	Sample No.	Sample result	Quantity	Risk Level Assessment	Remarks
Deck El.34500 notation	Asbestos	Sampling	A27	Not Contained

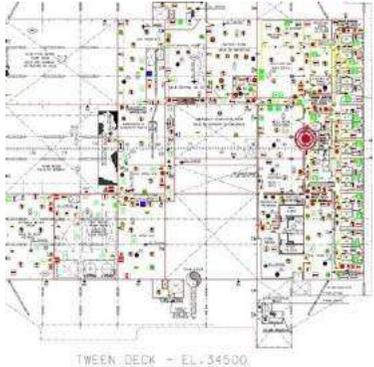
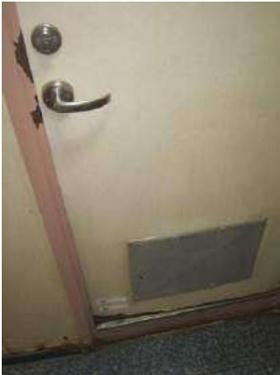
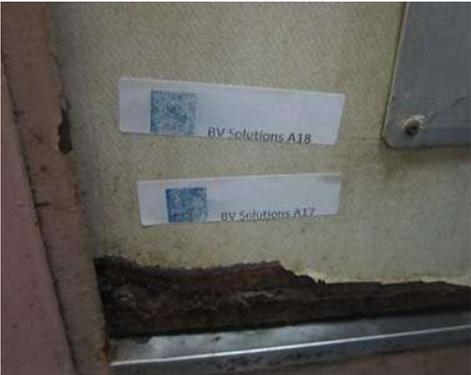
Fibrous-Insulation-Messroom corridor / Frame

Deck El.34500 notation	Asbestos	Sampling	A23	Not Contained			
---------------------------	----------	----------	-----	---------------	--	--	--

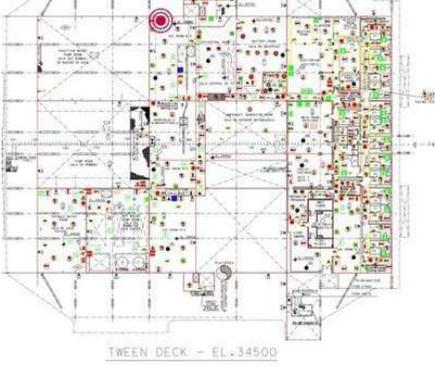
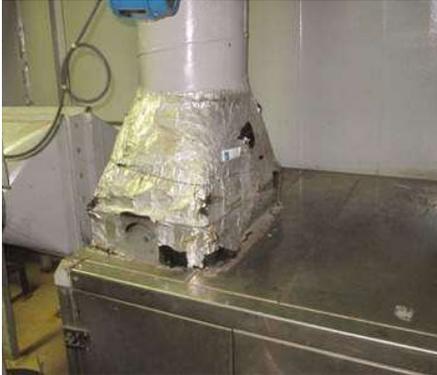
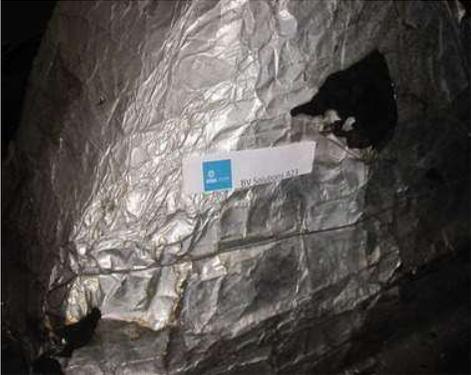
Air systems-Insulation-VAC Room No.5 / 39 PS

Location / Zone / Deck	Expected Hazardous Materials	Check procedure	Sample No.	Sample result	Quantity	Risk Level Assessment	Remarks
Deck El.34500 notation	Asbestos	Sampling	A21	Not Contained

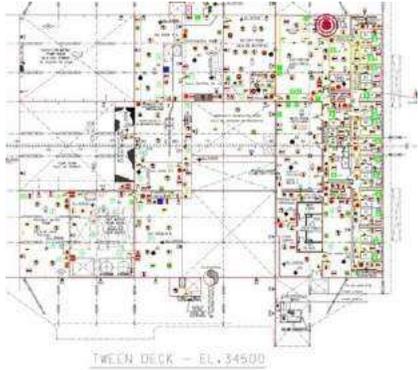
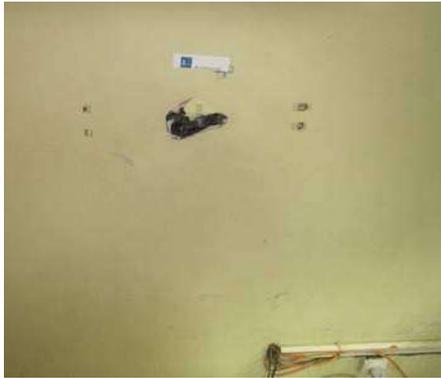
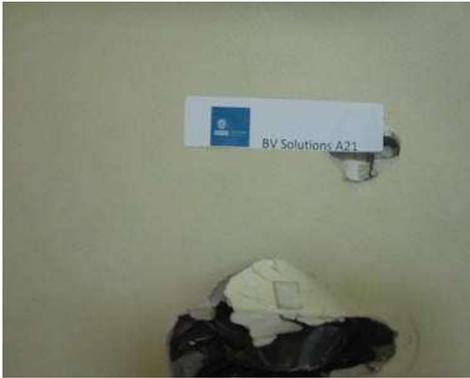
Location - Wall-Insulation-Reading Room / 34 Ps Deck El.34500 Location

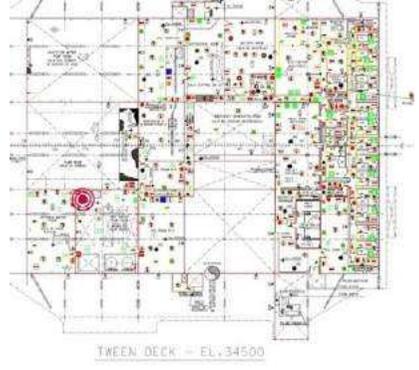
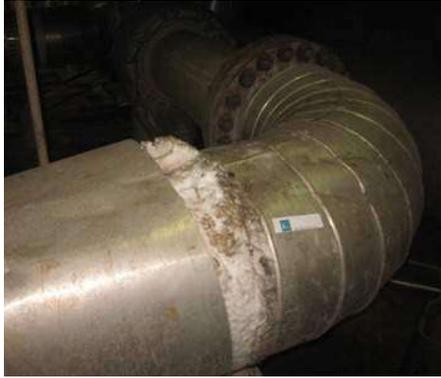
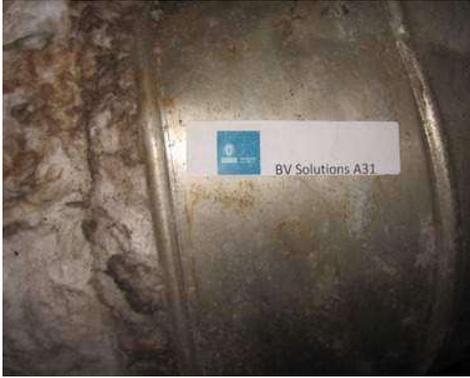
Deck El.34500 Location	Asbestos	Sampling	A31	Not Contained			
Hot water-Insulation-Hot Water Pump Room / 110 STB Location

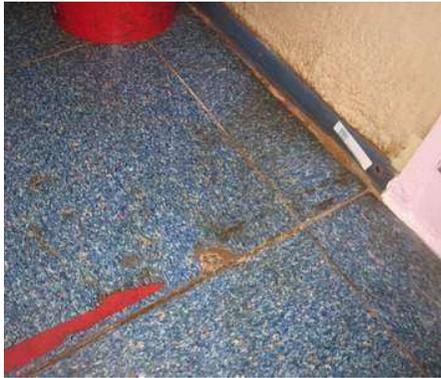
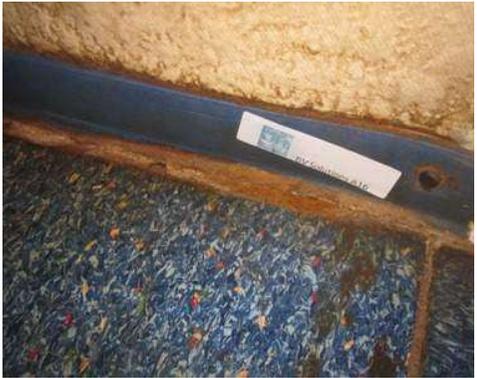
Location - Floor-Floor covering-Messroom Deck El.34500 / Floor cover / Frame 33 CL

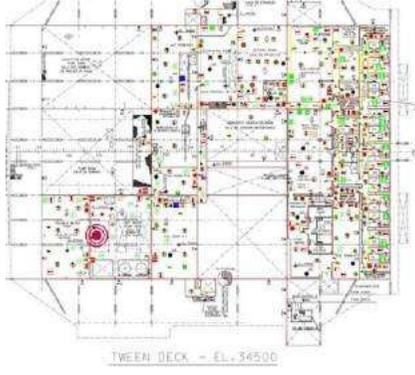
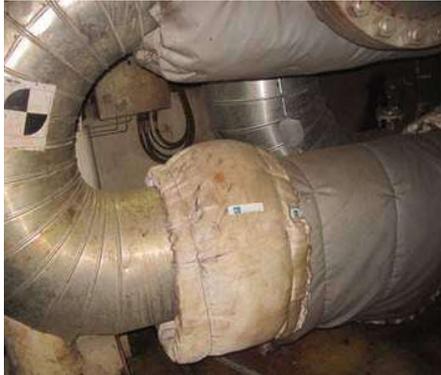
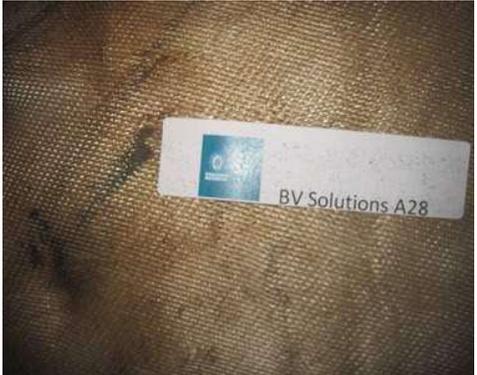
Deck El.34500 Location	Asbestos	Sampling	A28 Not Contained
Lagging material and insulation-Lagging material-Hot Pump Room / Frame 109 STB

Deck El.34500 Location	Asbestos	Sampling	A14 Not Contained

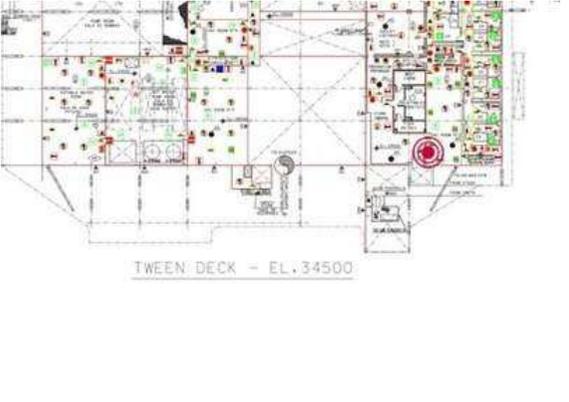
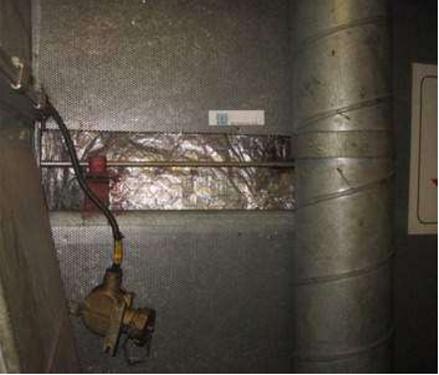
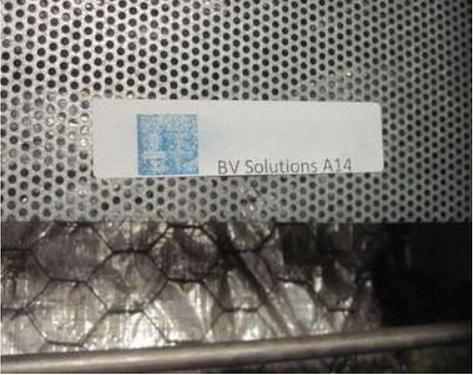
<p>Insulation - Wall-Insulation-VAC Room No.2 - 34 STB</p>

<p>Deck El.34500 Insulation</p>	<p>Asbestos</p>	<p>Sampling</p>	<p>A30</p>	<p>Not Contained</p>			
<p>Insulation material and insulation-Lagging material-Hot Pump Room / Frame 107 STB</p>

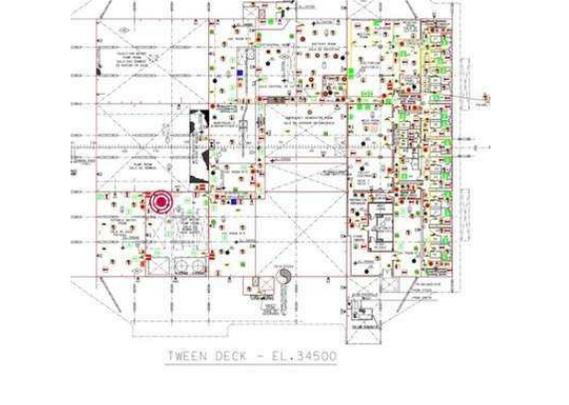
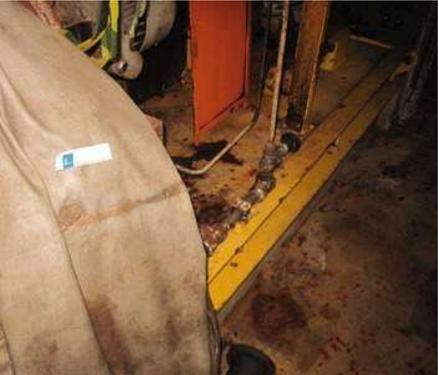
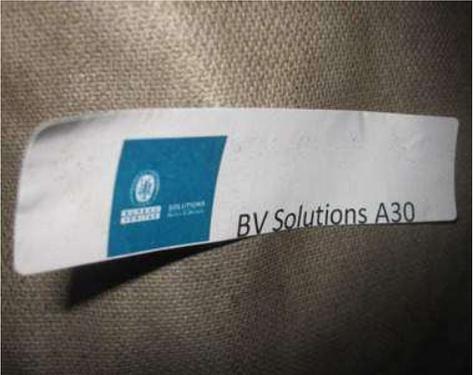
<p>Deck El.34500 Insulation</p>	<p>Asbestos</p>	<p>Sampling</p>	<p>A32</p>	<p>Not Contained</p>

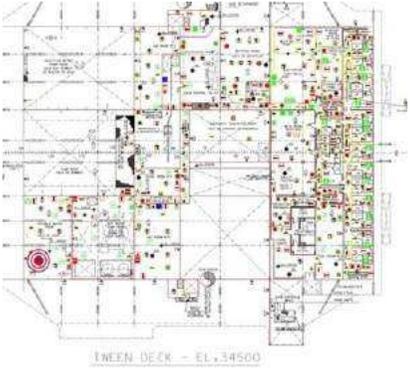
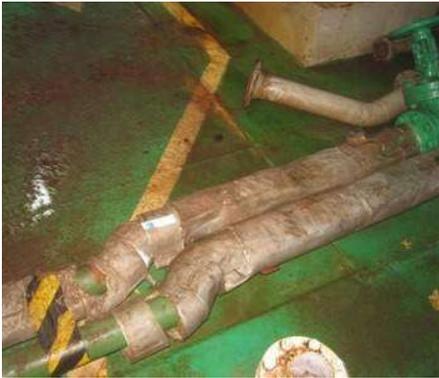
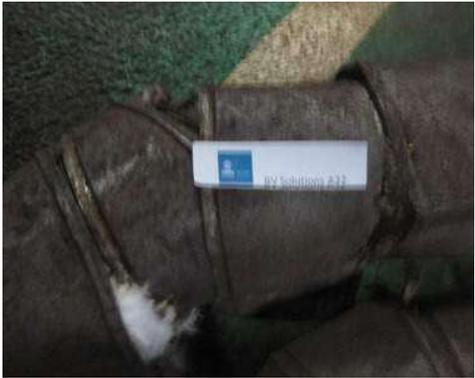
<p>Hot water-Insulation-Hot Water Pump Room / 124 STB</p>

Deck El.37500	Asbestos	Sampling	A12	Not Contained			
<p>Ammonia-Door Seal-Laboratory / rubber door / Fr. 20 - STB</p>

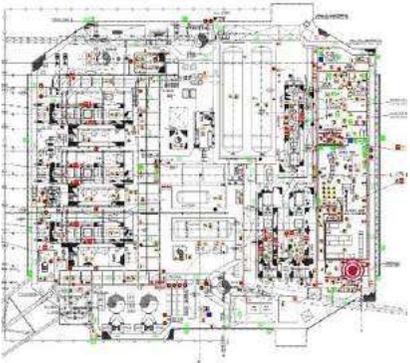
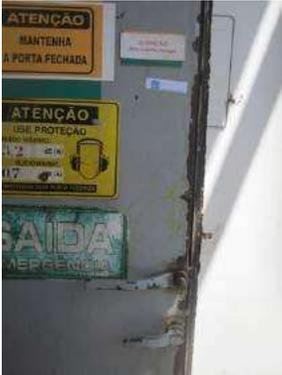
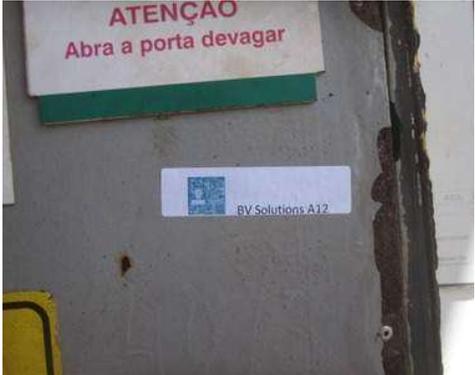
Deck El.37500	Asbestos	Sampling	A55	Not Contained

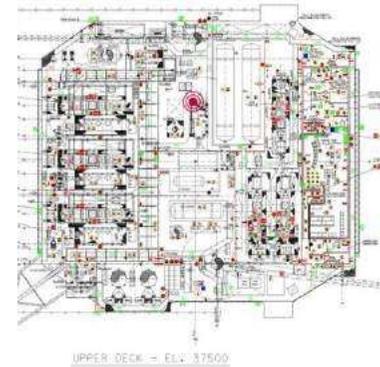
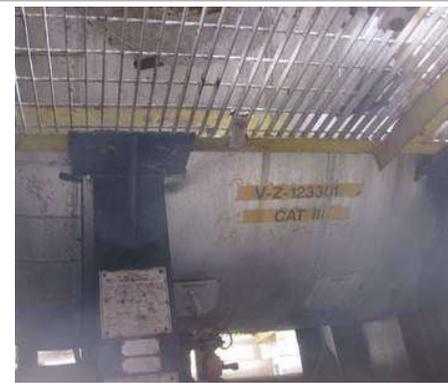
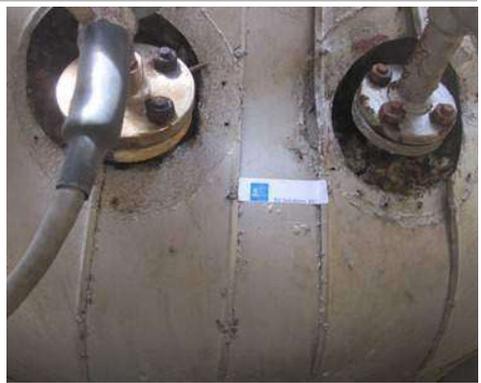
Miscellaneous-Insulation-Gas hydration Tank TQ 13 / Frame 68 PS Deck El.37500 Area

Sampling	A57	Not Contained
Miscellaneous-Insulation-Attached to TQ 11 / Frame 93 STB Deck El.37500 Area

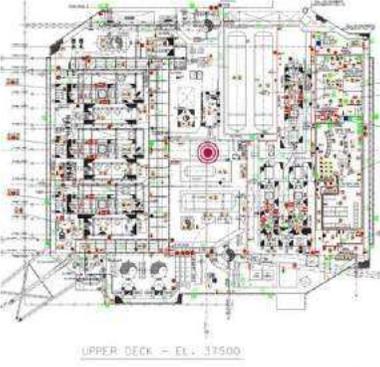
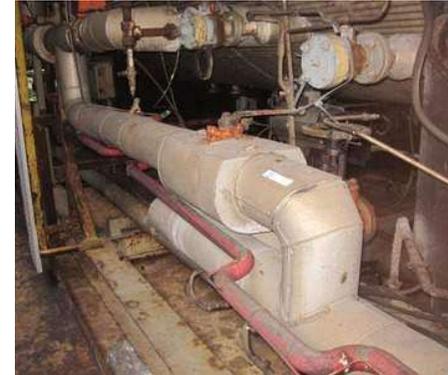
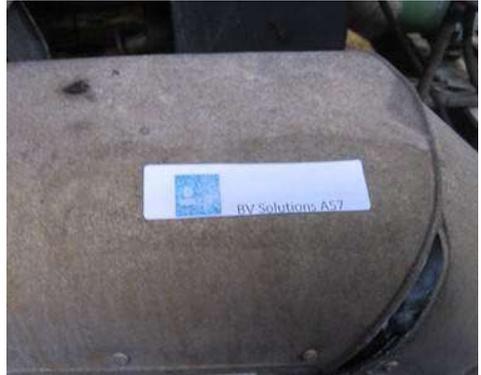
Sampling	A56	Not Contained

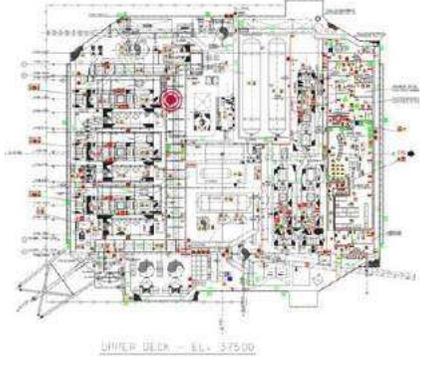
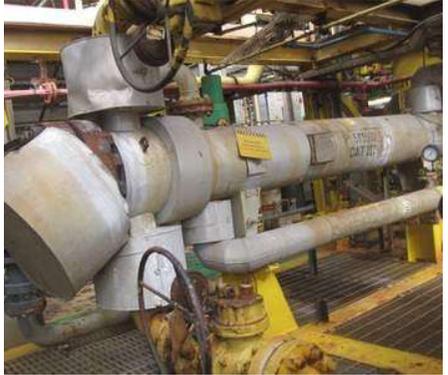
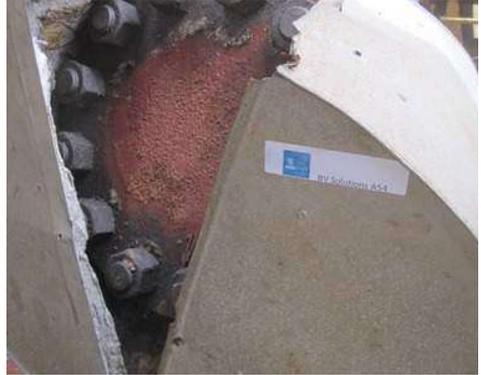
Miscellaneous-Insulation-Piping P513502

Deck El.43500	Asbestos	Sampling	A8	Not Contained			
---------------	----------	----------	----	---------------	--	--	--

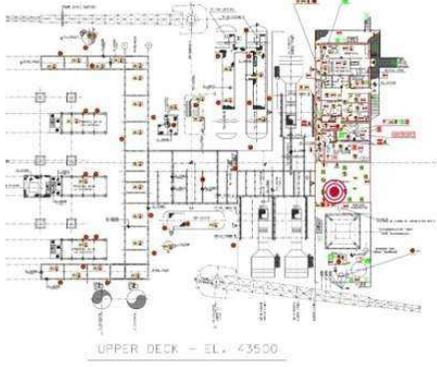
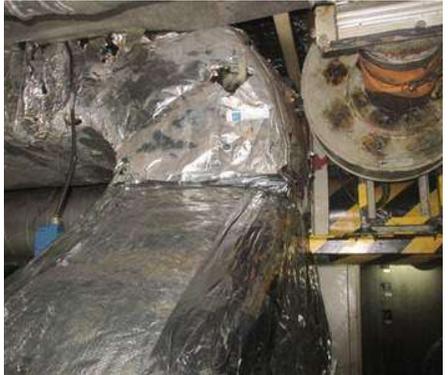
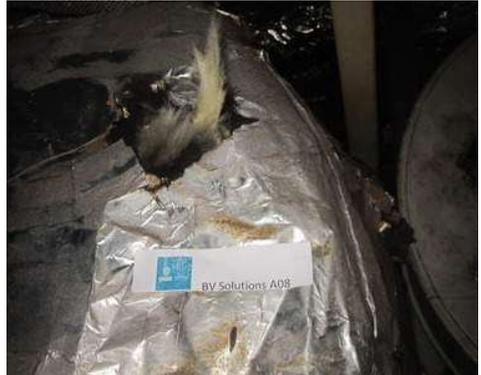
Item-Insulation-VAC room No.1 / piping on / Fr. 30 - STB

Location / Zone / Deck	Expected Hazardous Materials	Check procedure	Sample No.	Sample result	Quantity	Risk Level Assessment	Remarks
Deck El.43500 Location	Asbestos	Sampling	A10	Not Contained

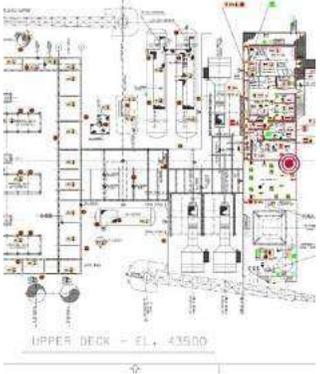
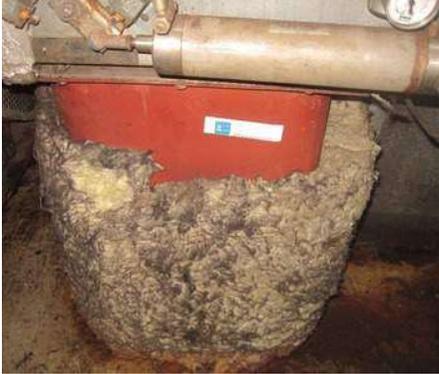
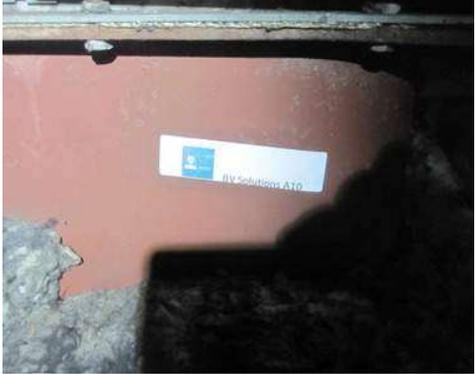
VAC room No. 1 / piping on / Fr. 17 STB

Deck El.43500	Asbestos	Sampling	A11	Not Contained			
---------------	----------	----------	-----	---------------	--	--	--

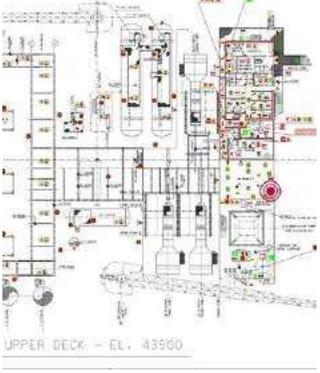
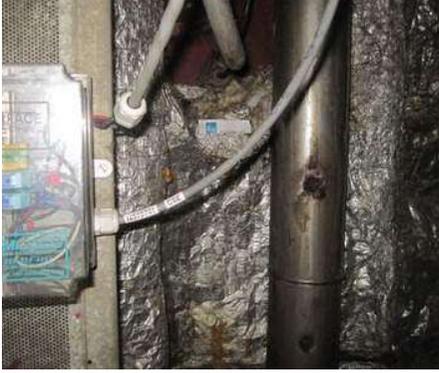
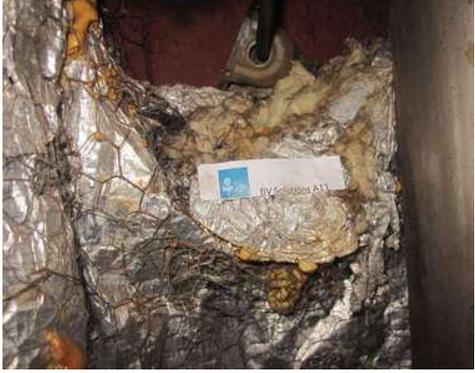
Wall-Insulation-VAC room No. 1 / id insulation / Fr. 15 STB

Location / Zone / Deck	Expected Hazardous Materials	Check procedure	Sample No.	Sample result	Quantity	Risk Level Assessment	Remarks
Deck El.43500 VAC room area	Asbestos	Sampling	A48	Not Contained

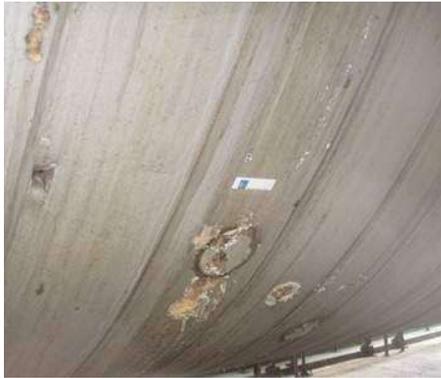
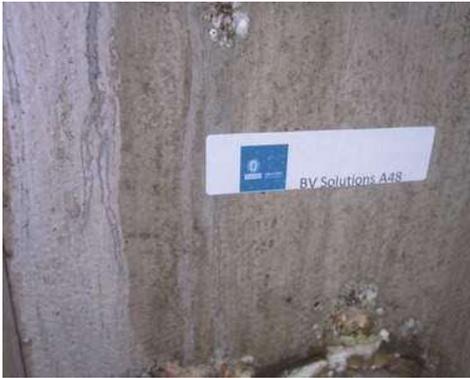
<p>aneous-Insulation-Desalter Tank - Tq 122301A/ 49 PS</p>

<p>Deck El.43500 Area</p>	<p>Asbestos</p>	<p>Sampling</p>	<p>A50</p>	<p>Not Contained</p>			
<p>Miscellaneous-Insulation-Attached to TQ B / Frame 59 PS</p>

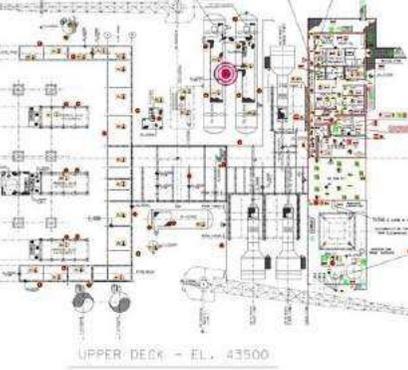
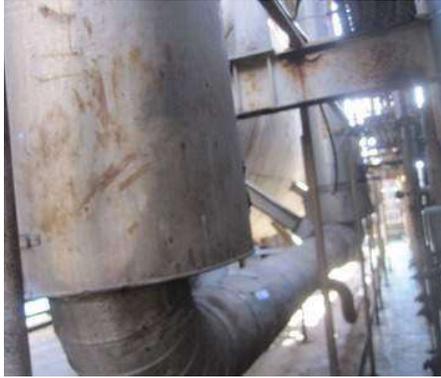
<p>Deck El.43500 Area</p>	<p>Asbestos</p>	<p>Sampling</p>	<p>A49</p>	<p>Not Contained</p>

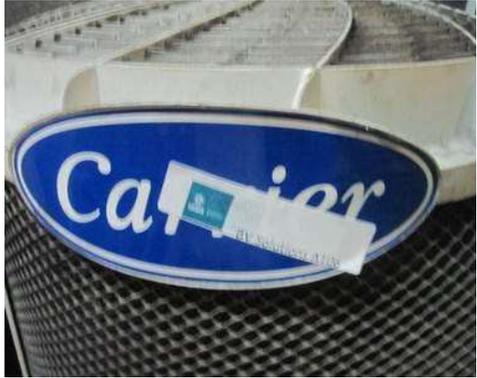
Location / Zone / Deck	Expected Hazardous Materials	Check procedure	Sample No.	Sample result	Quantity	Remarks
<p>Deck El.31500 Cabin 61 PS</p>	<p>ODS</p>	<p>Visual</p>	<p>A106</p>	<p>Not Contained</p>		
<p>Conditioner (compressor)-Refrigerants-Emergency room / Frame 61 PS</p>	<p>PFOS</p>	<p>Sampling</p>	<p>A34</p>	<p>Not Contained</p>

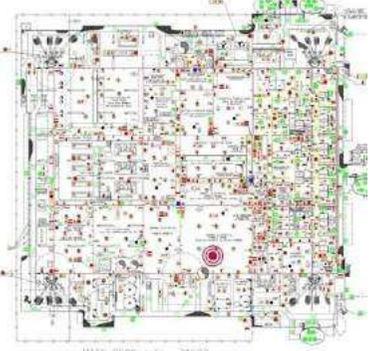
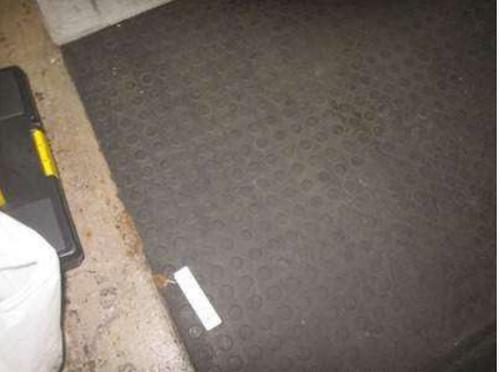
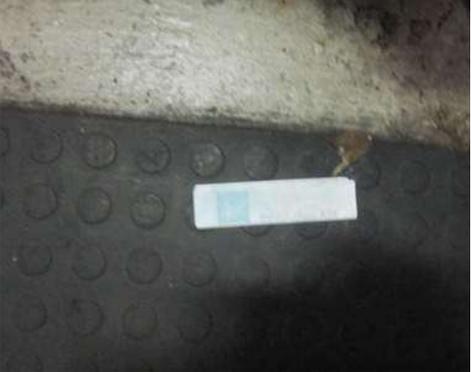
<p>Overlapping-Floor covering-Normal Electrical Panels Frame 52 STB</p>

Area / Zone / Deck	Expected Hazardous Materials	Check procedure	Sample No.	Sample result	Quantity	Remarks
<p>Deck EI.31500 Location</p>	<p>HBCDD</p>	<p>Sampling</p>	<p>A61</p>	<p>Not Contained</p>		
<p>Location - Floor-Floor covering-Cabin corridor / 24 STB</p>	<p>ODS</p>	<p>Sampling</p>	<p>A39</p>	<p>Not Contained</p>

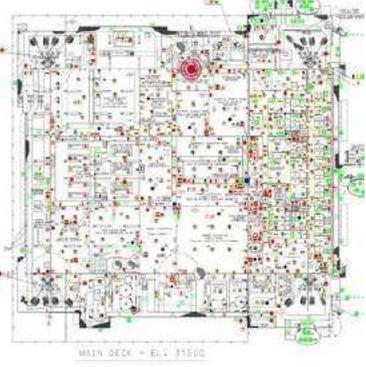
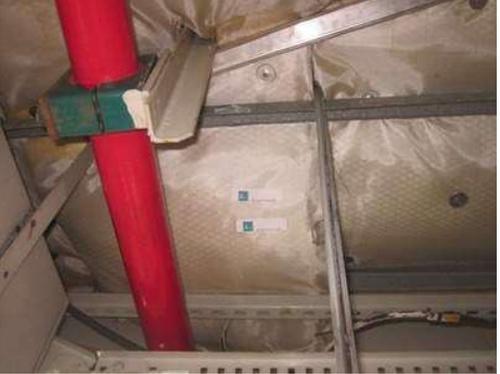
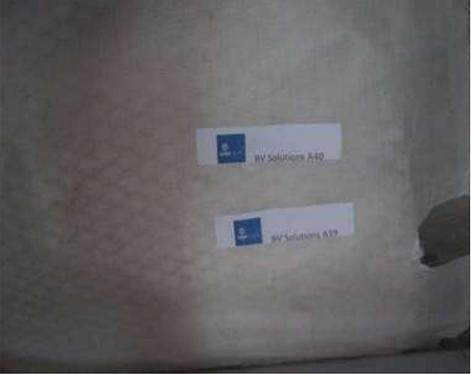
<p>Location - Ceiling-Insulation-Electrical Deck / Frame 34 PS</p>

Location / Zone / Deck	Expected Hazardous Materials	Check procedure	Sample No.	Sample result	Quantity	Remarks
Deck El.31500 Location	ODS	Visual	A105	Not Contained		
Compressor (compressor)-Refrigerants-Emergency Deck or room / Frame 50 PS	ODS	Sampling	A67	Not Contained

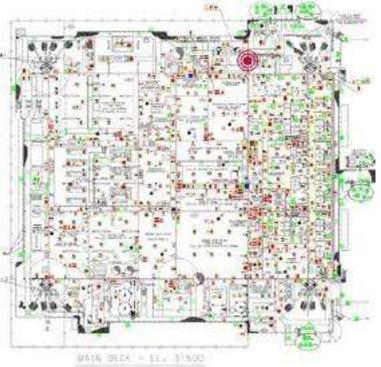
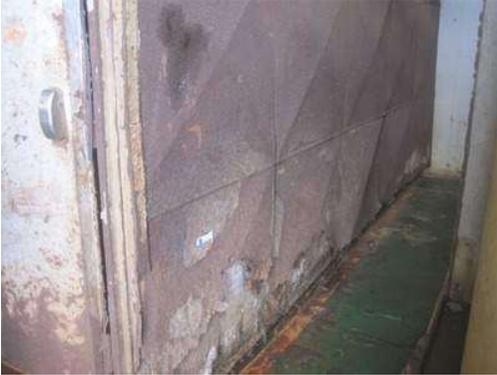
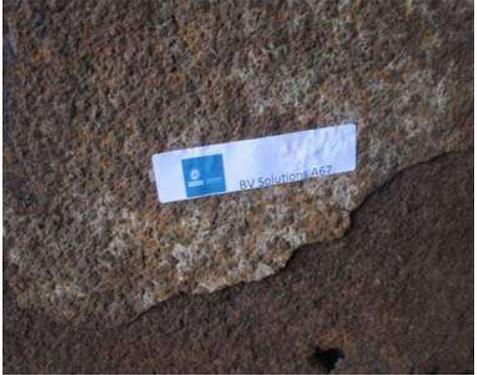
<p>Lead plating-Insulation-Bulkhead insulation / Deck E1.31500</p>

Area / Zone / Deck	Expected Hazardous Materials	Check procedure	Sample No.	Sample result	Quantity	Remarks
Deck E1.31500	ODS	Sampling	A72	Not Contained

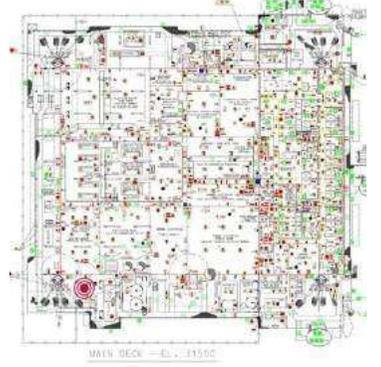
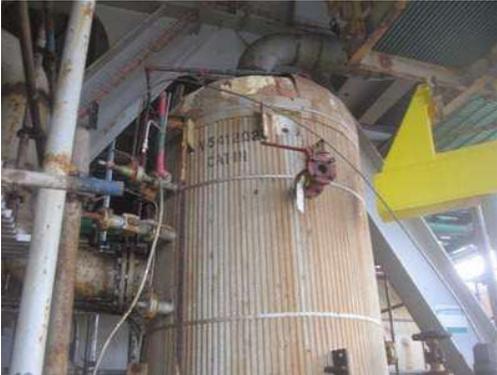
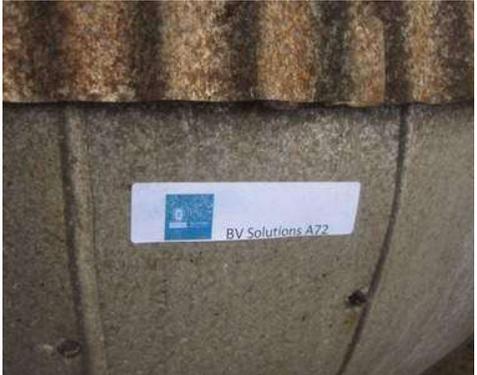
<p>Lead material and insulation-Insulation-Low Flare Q V541202 / Frame 108 STB</p>

Deck E1.31500	ODS	Visual	A111	Not Contained

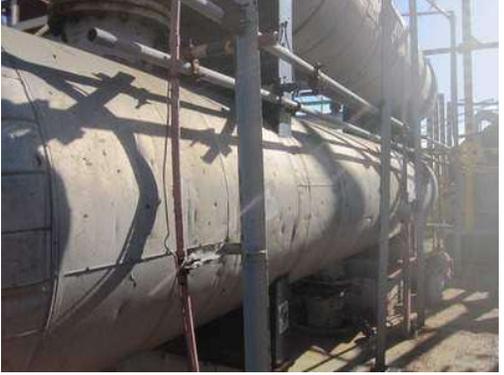
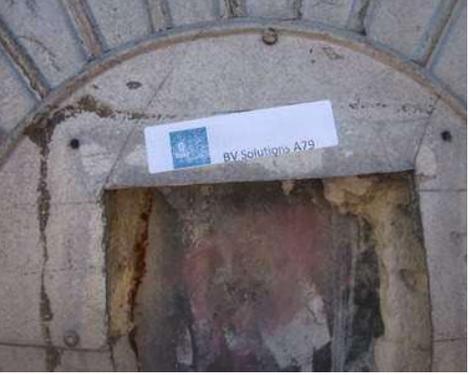
Line Deck 0/44000 Area	ODS	Sampling	A79	Not Contained		
<p>g material and insulation-Insulation-Tank P A / Frame 97 STB</p>

Location / Zone / Deck	Expected Hazardous Materials	Check procedure	Sample No.	Sample result	Quantity	Remarks
Line Deck 0/44000 Lineous	PFOS	Sampling	A3	Not Contained
