**BUREAU
VERITAS**

Inventory of Hazardous Materials Manual Part I

Ship / Vessel	PETROBRAS 26
name	PANAMA
Particulars of the ship	
Ship / Vessel name	Flag
Flag	
Distinctive No. / Letters	HP8997
Distinctive No. / Letters	
Port of Registry	PANAMA
Port of Registry	Port of Registry
Type of vessel	Type of vessel Offshore submersible unit
Gross Tonnage	Gross Tonnage 20313
IMO Number	IMO Number 8764169
Name of Shipbuilder	Name of Shipbuilder Vyborg
Shipyard	
Name of Shipowner	Petrobras Netherlands B.V.
Date of delivery	Name of Shipowner 31/10/1997
IHM Inventory Number	RJN0/2023/8764169/Xw5
Revision Number	Date of delivery 5.0
IHM Inventory Number	
Revision Number

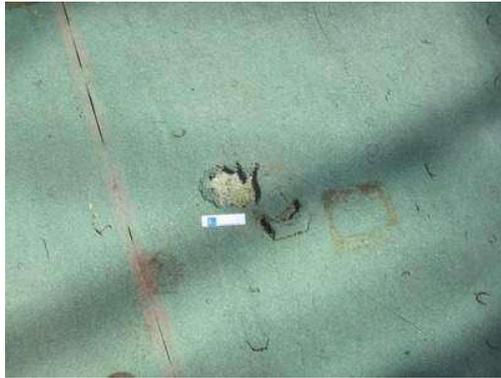
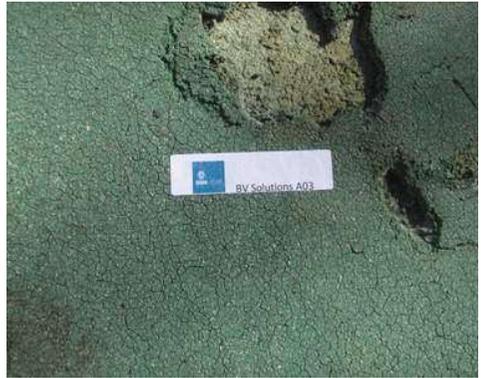
<p style="font-size: small; text-align: center;">HEL DECK/MF 22AN TNE - EL. 47000/44000</p>

Location: Decks-Floor covering-Football field / Fr. 20 - STB Deck El. 34500 Hazard: ODS

Sampling	A20	Not Contained		
--	--	----------	-----	---------------	--	--

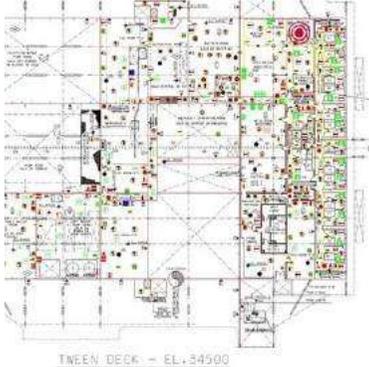
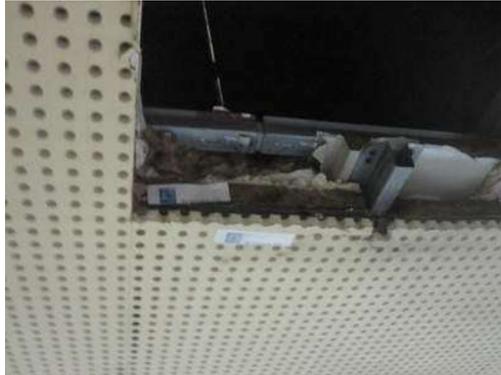
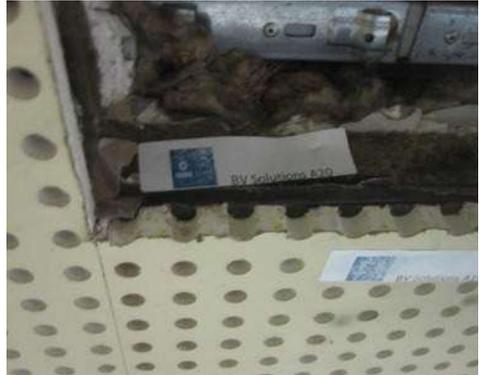
<p style="font-size: small; text-align: center;">TWEEN DECK - EL. 34500</p>

Location: Ceiling-Insulation-Reading Room / 30 PS Deck El. 37500 Hazard: HBCDD

Location / Zone / Deck	Expected Hazardous Materials	Check procedure	Sample No.	Sample result	Quantity	Remarks
Deck El. 37500 Location	HBCDD	Sampling	A1	Not Contained
