I-RL-3010.19-1320-970-TNA-001

TITLE: IHM Report – Part I

## Inventory of Hazardous Materials Manual Part I

Ship / Vessel name	PETROBRAS XIX
Flag	Panama
Distinctive No. / Letters	3FHI5
Port of Registry	PANAMA
Type of vessel	Floating storage unit
Gross Tonnage	22589
IMO Number	8753720
Name of Shipbuilder	
Name of Shipowner	BRASPETRO OIL SERVICES CO.
Date of delivery	31/12/1982
IHM Inventory Number	RJN0/2024/8753720/ssf
Revision Number	4.0

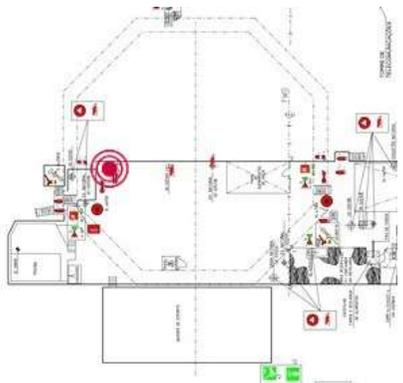
Location / Zone / Deck	Expected Hazardous Materials	Check procedure	Sample No.	Sample result	Quantity	Recommended Action
Helideck Miscellaneous	PFOS	Visual	A111	Contained	0.935 m3	No immediate action required
Fire protection/fighting system-Extinguishing agent-Foam tank (Tk 542401) / Fr.45 - PS

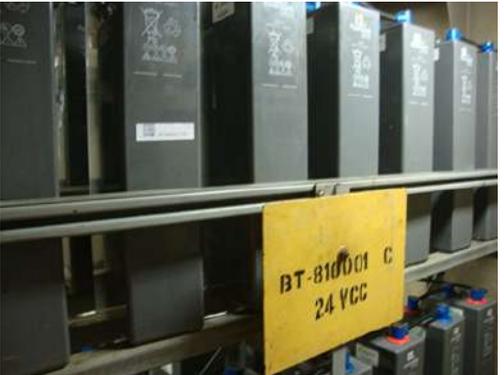
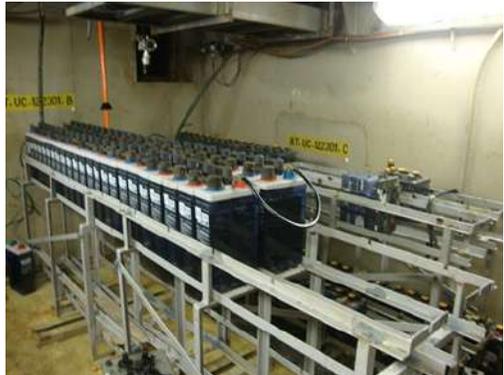
Location / Zone / Deck	Expected Hazardous Materials	Check procedure	Sample No.	Sample result	Quantity	Recommended Action
Lower Deck Cargo Area	Lead	Visual	A109	Contained	300 PCS	No immediate action required
Battery-Battery plates-Battery / Exportation pump room / Fr. 10 - PS

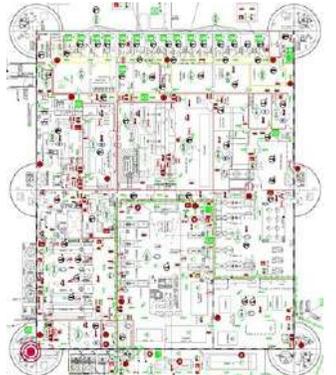
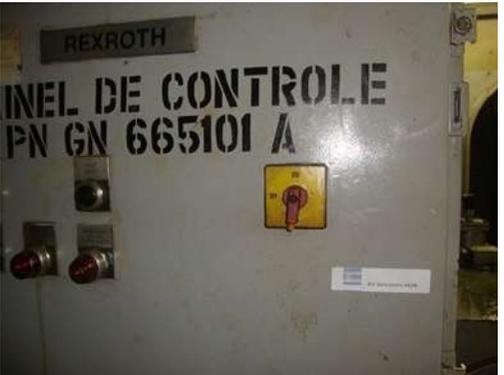
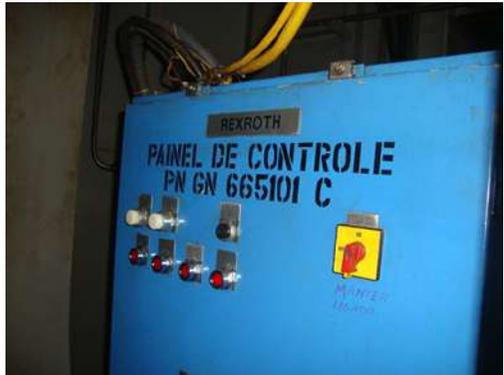
Lower Deck Miscellaneous	PFOS	Visual	A108	Contained	3.600 m3	No immediate action required
Mooring winches-Hydraulic oil-Anchorage winch UH GN665101A UH GN665101B UH GN665101C UH GN665101D / Columns FWD (P/S) AFT (P/S) / Fr. 6 - P/S Fr.45 - P/S

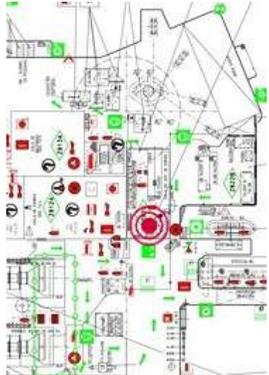
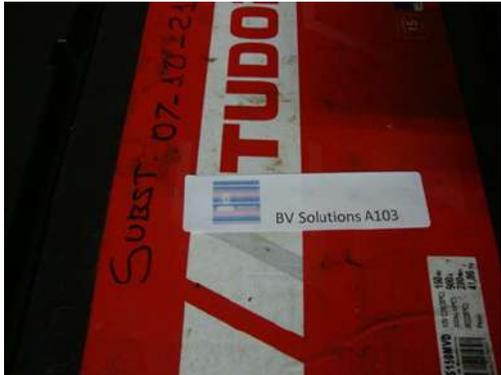
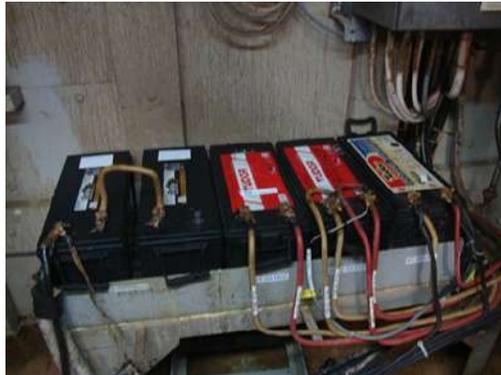
Location / Zone / Deck	Expected Hazardous Materials	Check procedure	Sample No.	Sample result	Quantity	Recommended Action
Main Deck Main Deck	Lead	Visual	A103	Contained	5 PCS	No immediate action required
Battery-Battery plates-Emergency generator room (DGE 514002) / Fr. 39 - STB

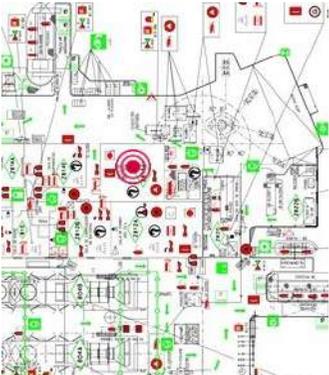
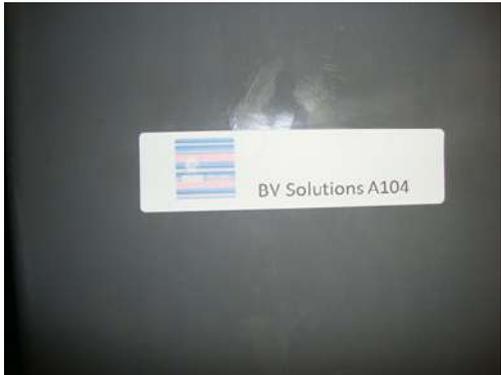
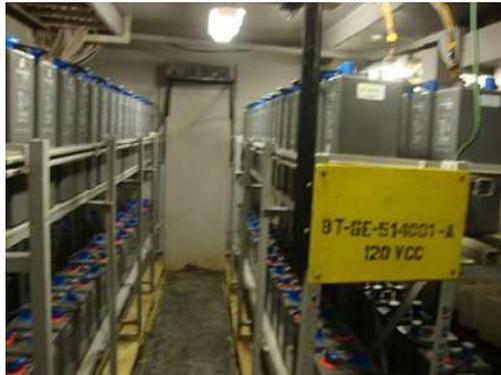
Main Deck Main Deck	Lead	Visual	A104	Contained	313 PCS	No immediate action required
Battery-Battery plates-Battery room / Fr. 44 - STB

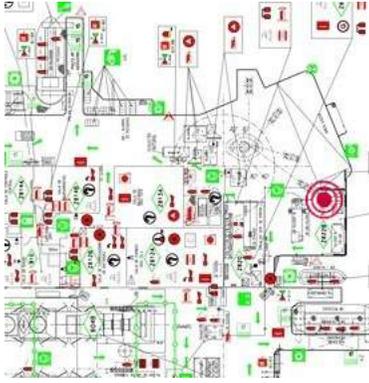
Location / Zone / Deck	Expected Hazardous Materials	Check procedure	Sample No.	Sample result	Quantity	Recommended Action
Main Deck Main Deck	Lead	Visual	A102	Contained	4 PCS	No immediate action required
Battery-Battery plates-Diesel Fire Pump MB-UB-542001B / Fr. 44 - STB

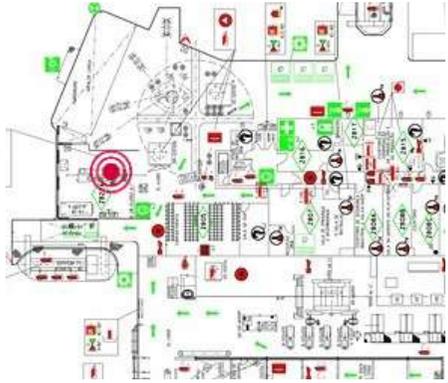
Main Deck Main Deck	Lead	Visual	A101	Contained	4 PCS	No immediate action required
Battery-Battery plates-Diesel Fire Pump MB-UB-542001A / Fr. 44 - PS

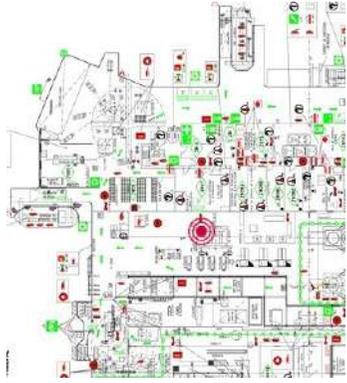
Location / Zone / Deck	Expected Hazardous Materials	Check procedure	Sample No.	Sample result	Quantity	Recommended Action
Upper Deck Cargo Area	PFOS	Visual	A112	Contained	0.75 m3	No immediate action required
Fire protection/fighting system-Extinguishing agent-Foam tank (Tk 5424500B) / Fr. 35 - PS

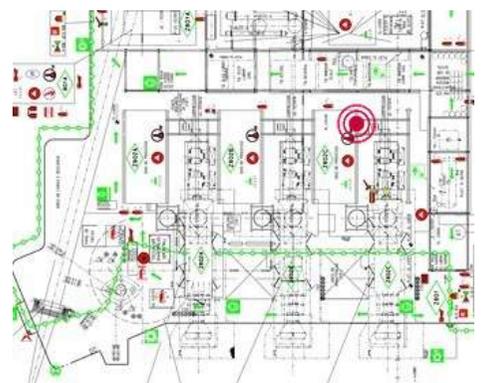
Upper Deck Cargo Area	PFOS	Visual	A113	Contained	0.75 m3	No immediate action required
Fire protection/fighting system-Extinguishing agent-Foam tank (Tk 542500A) / Fr. 18 - PS

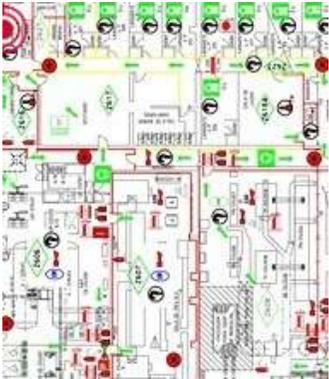
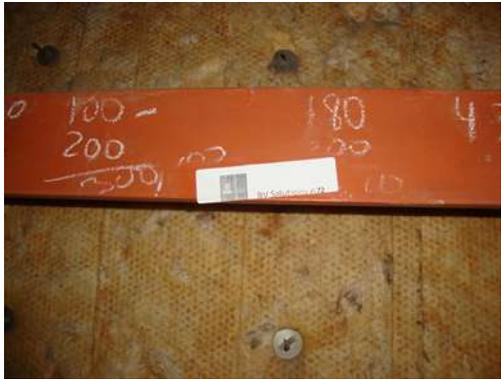
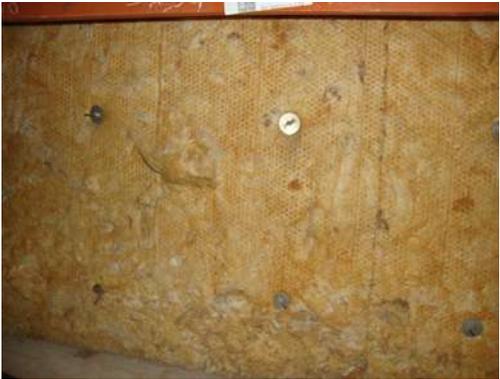
Location / Zone / Deck	Expected Hazardous Materials	Check procedure	Sample No.	Sample result	Quantity	Risk Level Assessment	Remarks
Lower Deck Accommodation	Asbestos	Sampling	A72	Not Contained			
Accommodation - Wall-Insulation-Bulkhead insulation / Laboratory / Fr. 40 - PS

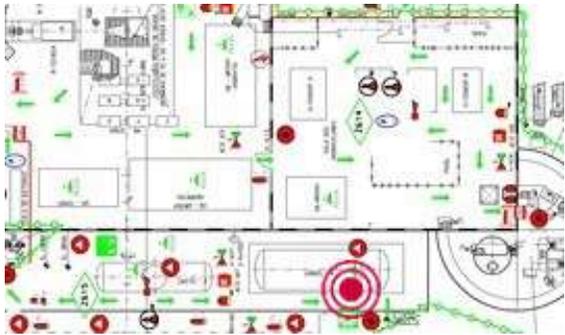
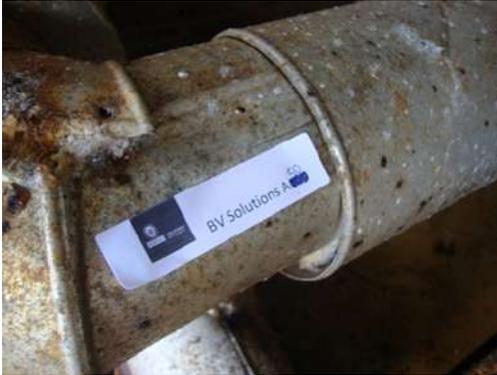
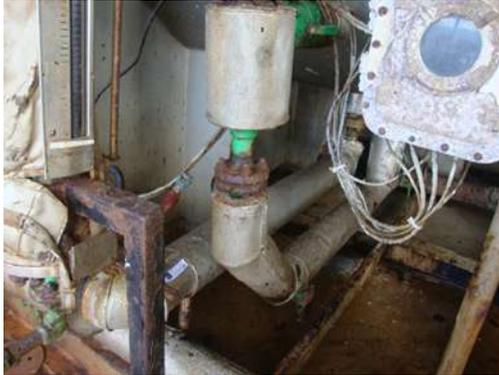
Location / Zone / Deck	Expected Hazardous Materials	Check procedure	Sample No.	Sample result	Quantity	Risk Level Assessment	Remarks
Lower Deck Cargo Area	Asbestos	Sampling	A50	Not Contained			
Piping - Miscellaneous-Insulation-External area / Piping insulation (attached Tk V533601) / Fr. 6 - STB

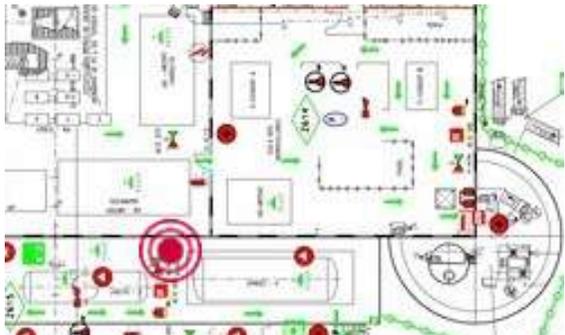
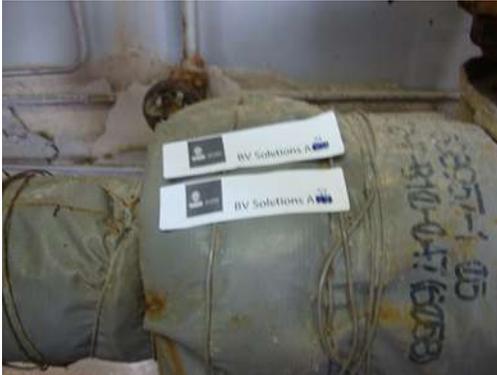
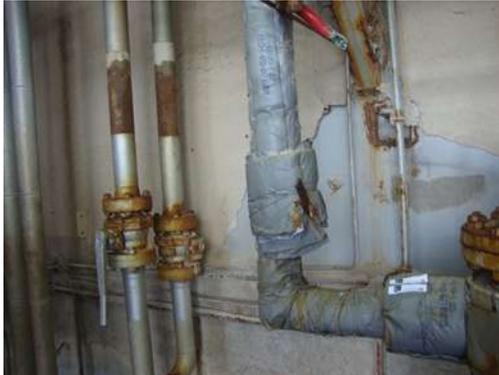
Lower Deck Cargo Area	Asbestos	Sampling	A52	Not Contained			
Piping - Miscellaneous-Insulation-External area / Piping insulation (attached Tk V541203) / Fr. 8 - STB

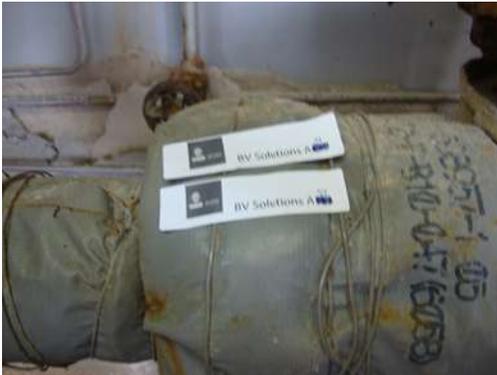
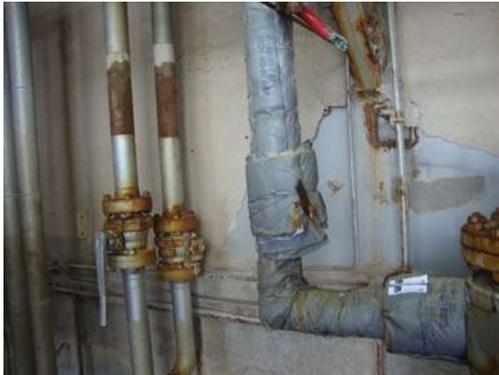
Location / Zone / Deck	Expected Hazardous Materials	Check procedure	Sample No.	Sample result	Quantity	Risk Level Assessment	Remarks				
Lower Deck Cargo Area	Asbestos	Sampling	A51	Not Contained							
Lagging material and insulation-Lagging material-External area / Piping insulation (attached Tk V541203) / Fr. 8 - STB

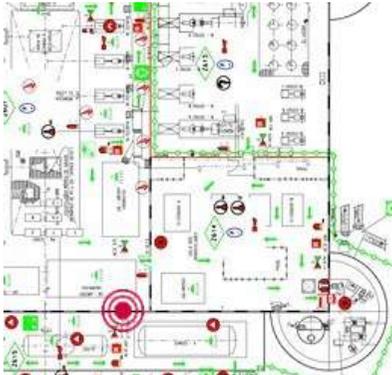
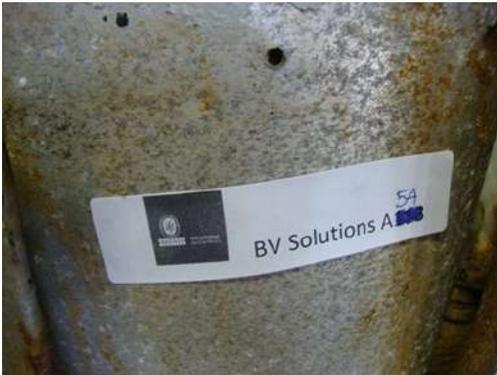
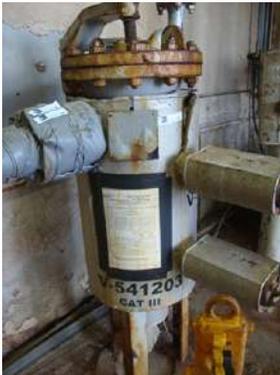
Lower Deck Cargo Area	Asbestos	Sampling	A54	Not Contained			
Miscellaneous-Insulation-External area / Tk V541203 insulation / Fr. 8 - STB

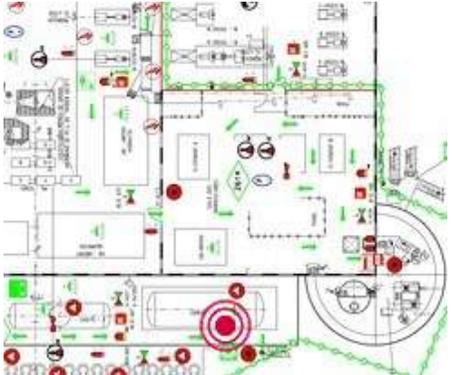
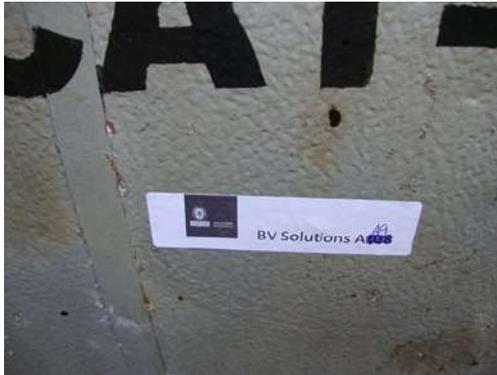
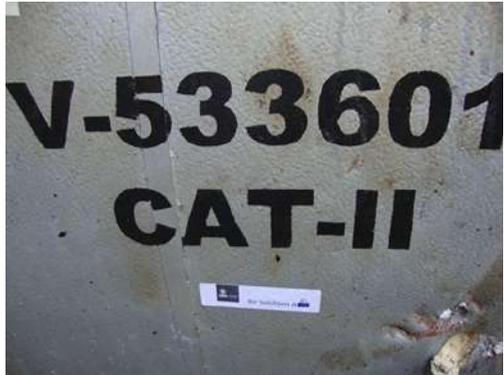
Location / Zone / Deck	Expected Hazardous Materials	Check procedure	Sample No.	Sample result	Quantity	Risk Level Assessment	Remarks
Lower Deck Cargo Area	Asbestos	Sampling	A49	Not Contained			
Miscellaneous-Insulation-External area / Tk V533601 insulation / Fr. 6 - STB

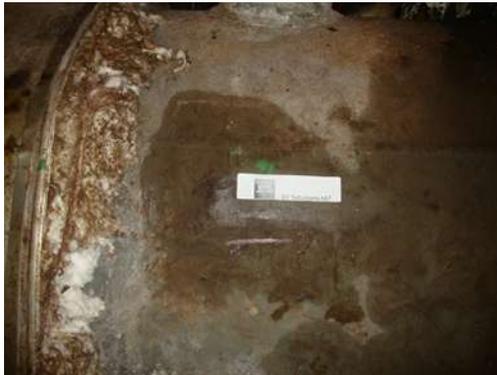
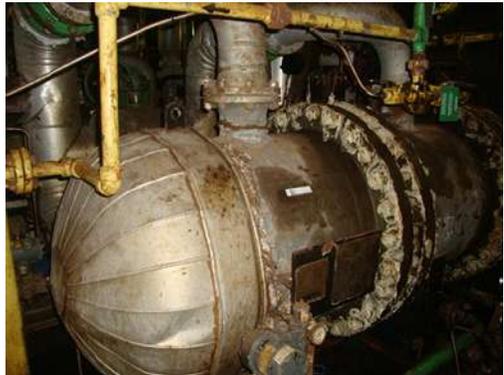
Lower Deck Engine Room	Asbestos	Sampling	A67	Not Contained			
Miscellaneous-Insulation-Hydrocyclone CI 5336501B insulation / Hydrocyclone room / Fr. 14 - STB

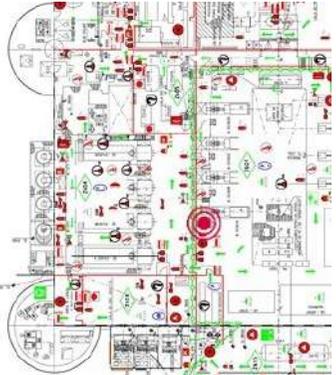
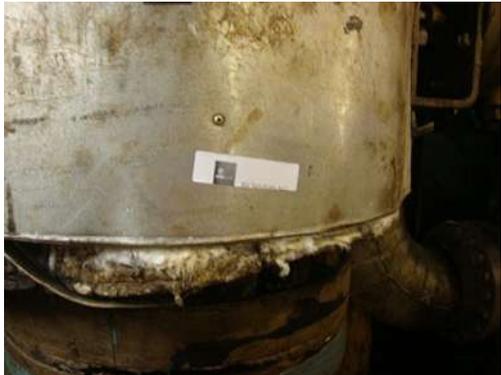
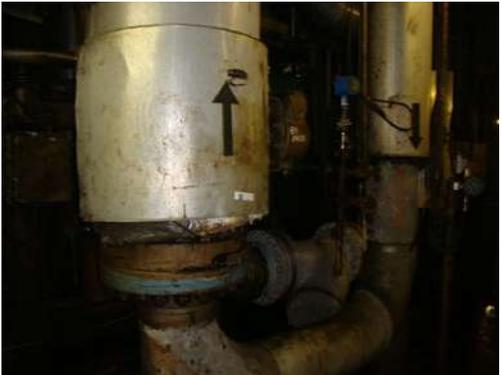
Location / Zone / Deck	Expected Hazardous Materials	Check procedure	Sample No.	Sample result	Quantity	Risk Level Assessment	Remarks
Lower Deck Engine Room	Asbestos	Sampling	A62	Not Contained			
Piping - Miscellaneous-Insulation-Piping insulation (close to pump \B 122302A) / Exportation pumps room / Fr. 16 - PS

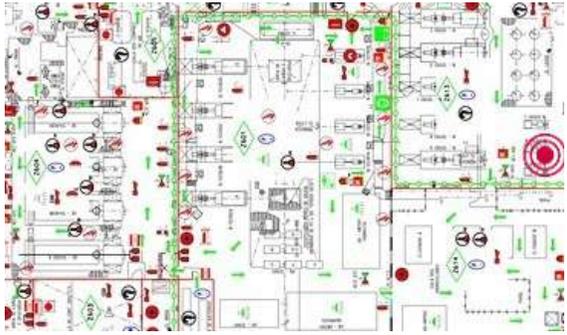
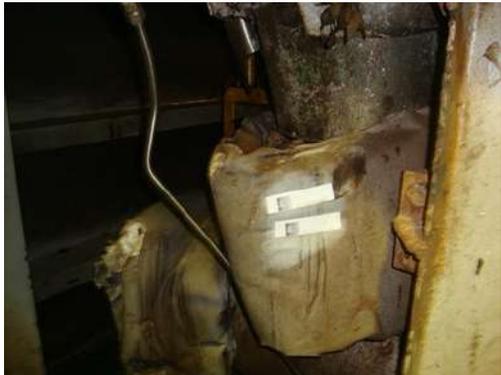
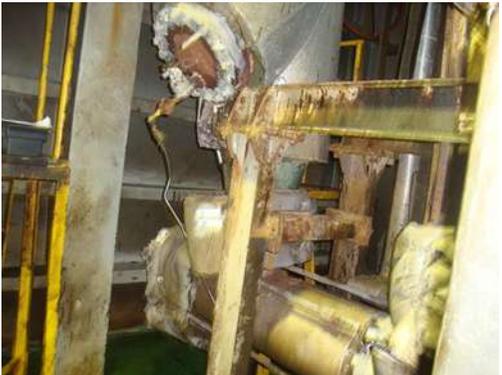
Lower Deck Engine Room	Asbestos	Sampling	A66	Not Contained			
Piping - Miscellaneous-Insulation-Piping insulation - Pump MB 5125001-B / Injection water pumps room / Fr. 19 - STB

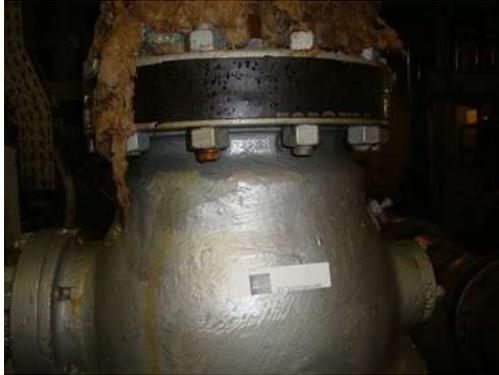
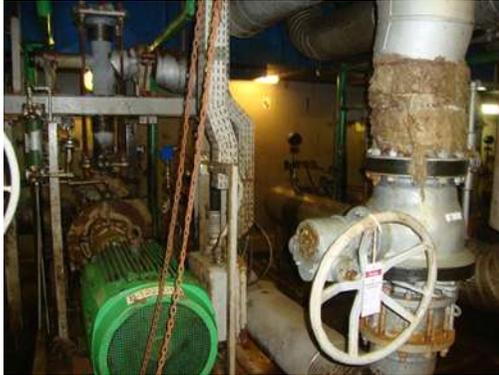
Location / Zone / Deck	Expected Hazardous Materials	Check procedure	Sample No.	Sample result	Quantity	Risk Level Assessment	Remarks
Lower Deck Engine Room	Asbestos	Sampling	A64	Not Contained			
Piping - Miscellaneous-Insulation-Piping insulation close to pump \B122301D\ / Exportation pumps room / Fr. 23 - STB

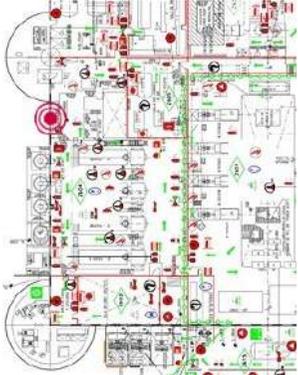
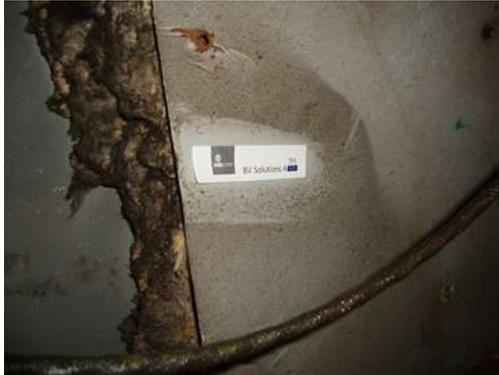
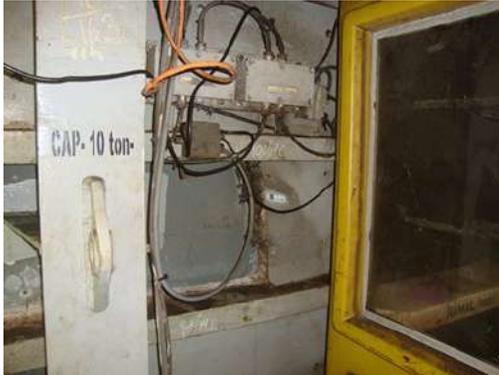
Lower Deck Engine Room	Asbestos	Sampling	A59	Not Contained			
Bulkhead plating-Insulation-Bulkhead insulation / Auxiliary generators room / Fr. 21 - PS

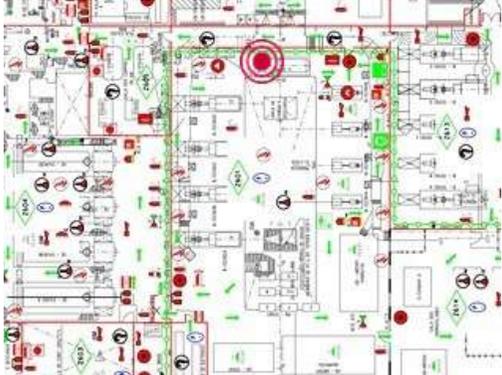
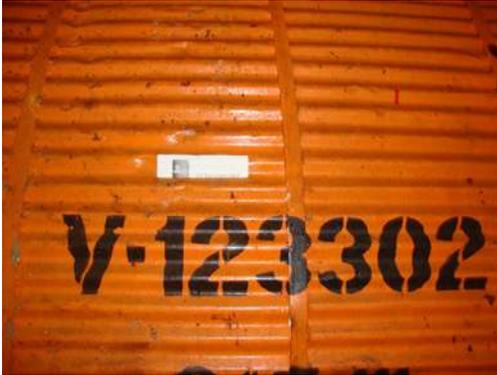
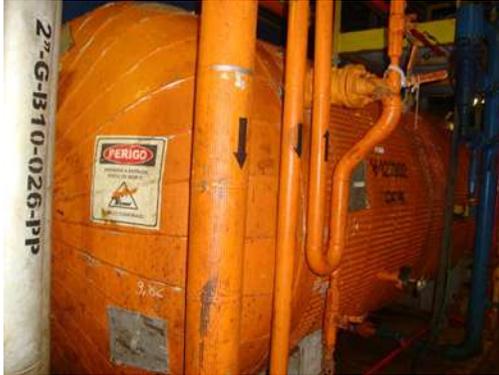
Location / Zone / Deck	Expected Hazardous Materials	Check procedure	Sample No.	Sample result	Quantity	Risk Level Assessment	Remarks
Lower Deck Engine Room	Asbestos	Sampling	A63	Not Contained			
Miscellaneous-Insulation-Tk V123302 insulation / Exportation pumps room / Fr. 25 - CL

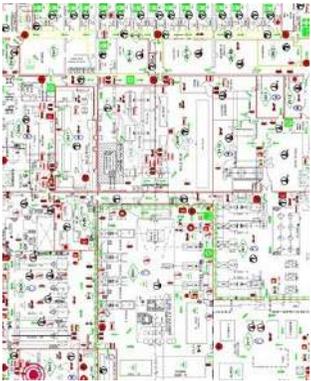
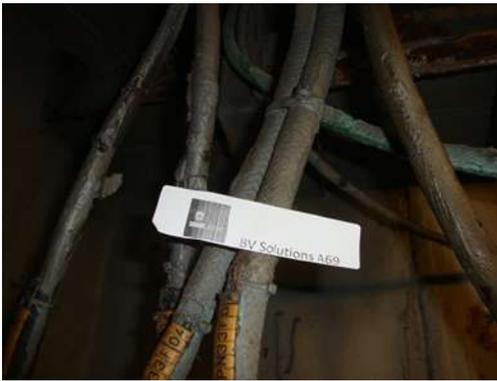
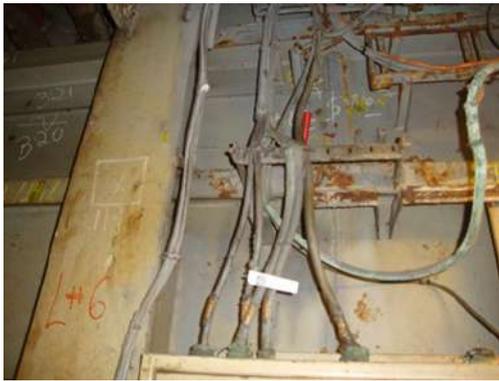
Lower Deck Engine Room	Asbestos	Sampling	A69	Not Contained			
Electric cabling-Cable sheathing-Electrical cable insulation / Main deck / Lower Deck / General places

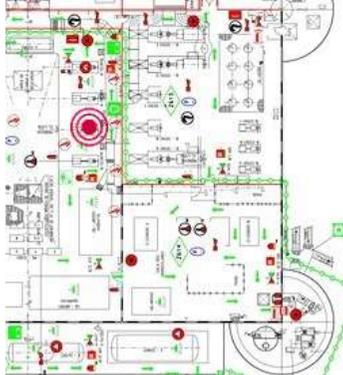
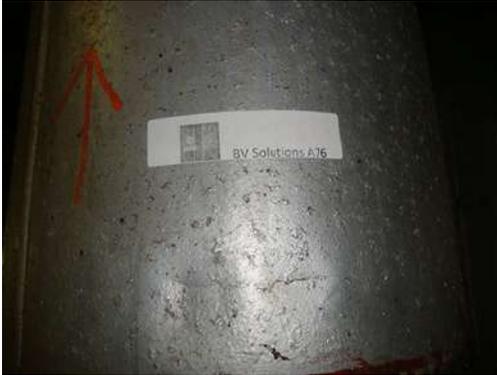
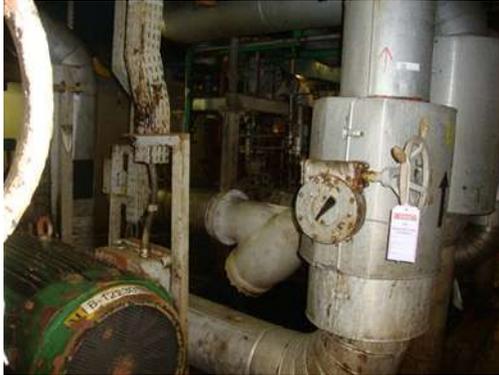
Location / Zone / Deck	Expected Hazardous Materials	Check procedure	Sample No.	Sample result	Quantity	Risk Level Assessment	Remarks
Lower Deck Engine Room	Asbestos	Sampling	A76	Not Contained			
Piping - Miscellaneous-Insulation-Piping insulation (attached Pump B122301B) / Exportation pumps room / Fr. 20 - STB

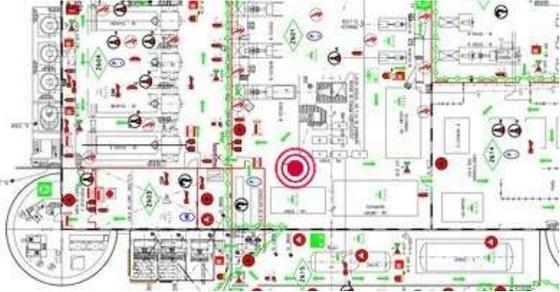
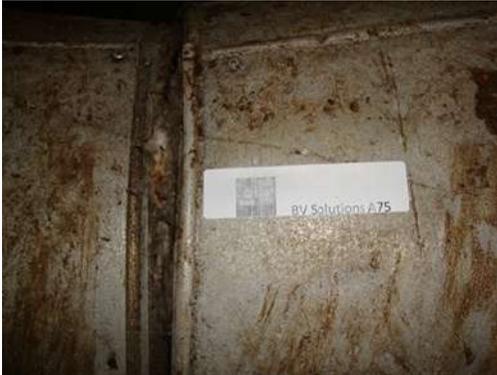
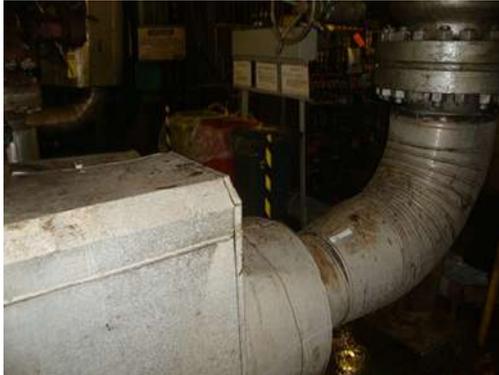
Lower Deck Engine Room	Asbestos	Sampling	A75	Not Contained			
Piping - Miscellaneous-Insulation-Piping insulation / Exportation pumps room / Fr. 12 - PS

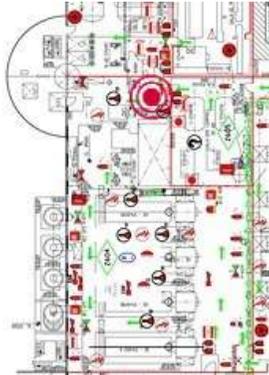
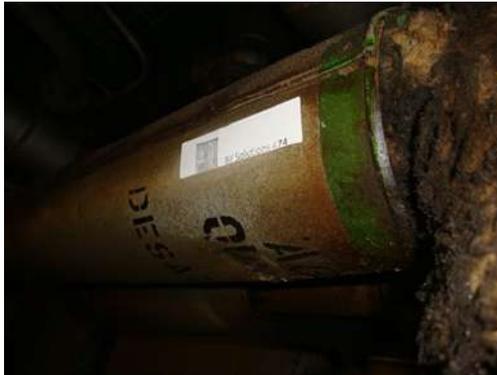
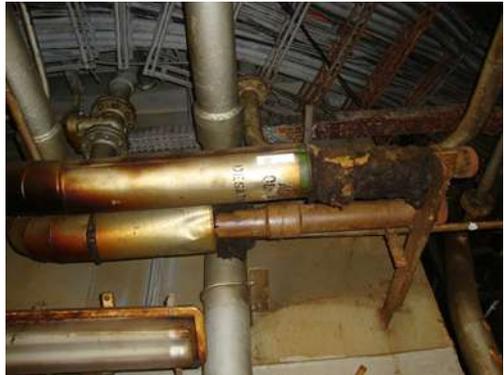
Location / Zone / Deck	Expected Hazardous Materials	Check procedure	Sample No.	Sample result	Quantity	Risk Level Assessment	Remarks
Lower Deck Engine Room	Asbestos	Sampling	A74	Not Contained			
Piping - Miscellaneous-Insulation-Piping insulation / Auxiliary generators room / Fr. 25 - PS

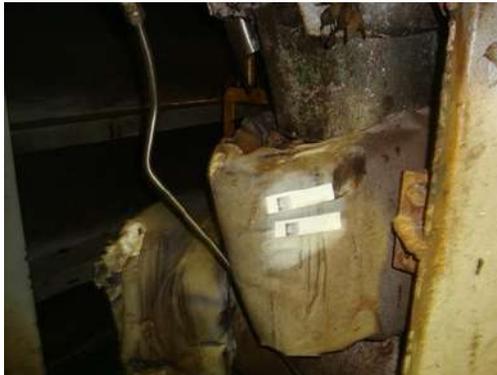
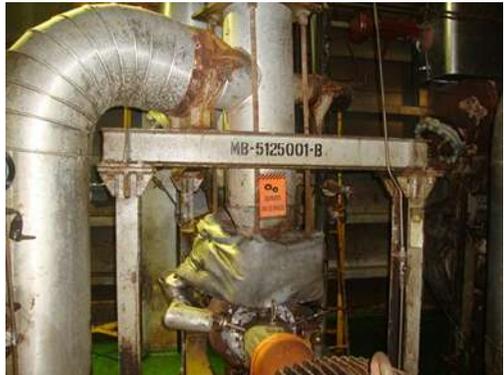
Lower Deck Engine Room	Asbestos	Sampling	A65	Not Contained			
Piping - Miscellaneous-Lagging material-Piping insulation - Pump MB 5125001-B / Injection water pumps room / Fr. 19 - STB

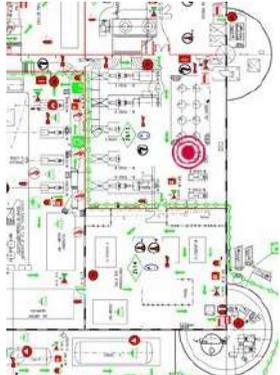
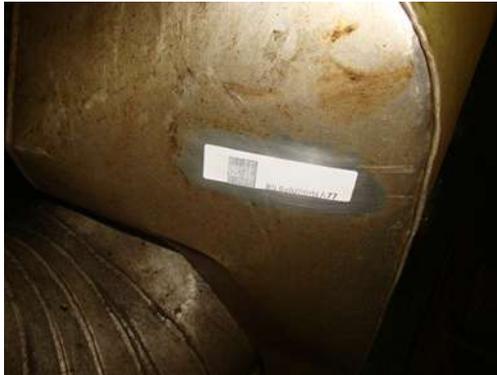
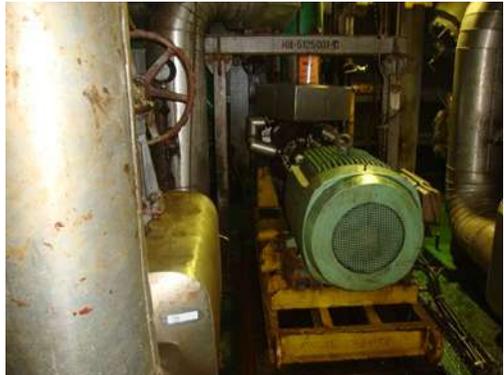
Location / Zone / Deck	Expected Hazardous Materials	Check procedure	Sample No.	Sample result	Quantity	Risk Level Assessment	Remarks
Lower Deck Engine Room	Asbestos	Sampling	A77	Not Contained			
Piping - Miscellaneous-Insulation-Piping insulation (attached MB5125001C) / Injection water pumps room / Fr. 20 - STB

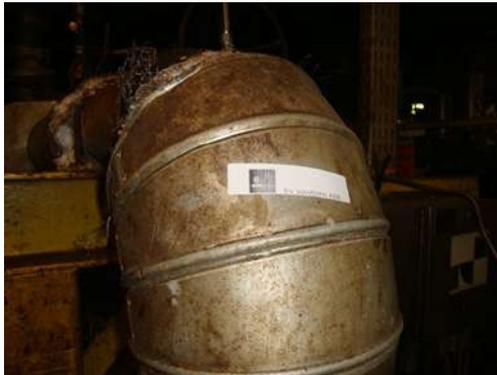
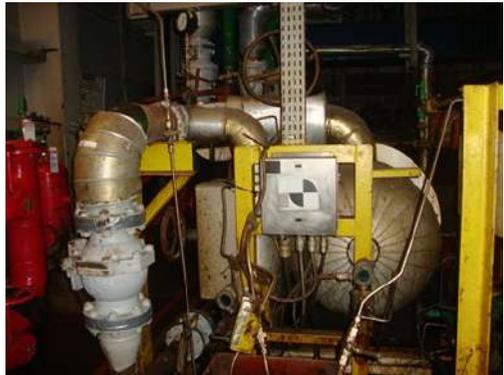
Lower Deck Engine Room	Asbestos	Sampling	A68	Not Contained			
Piping - Miscellaneous-Insulation-Piping insulation attached to hydrocyclone CI 533601A / Hydrocyclone room / Fr. 14 - STB

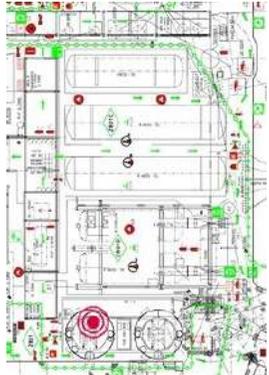
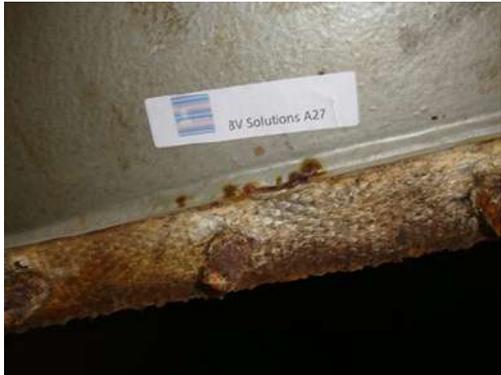
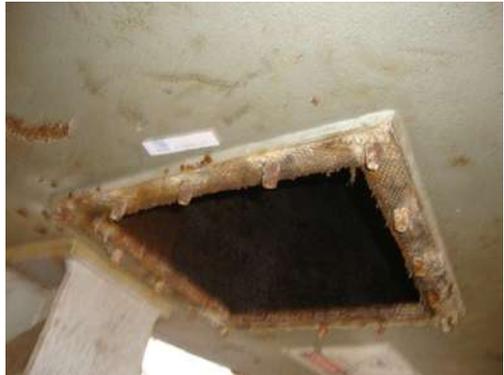
Location / Zone / Deck	Expected Hazardous Materials	Check procedure	Sample No.	Sample result	Quantity	Risk Level Assessment	Remarks
Main Deck Cargo Area	Asbestos	Sampling	A27	Not Contained			
Cargo hatch-Gasket for manhole-Manhole packing - Furnance F512501A / Fr. 9 - STB

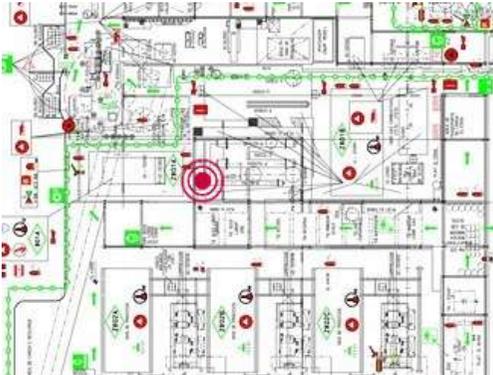
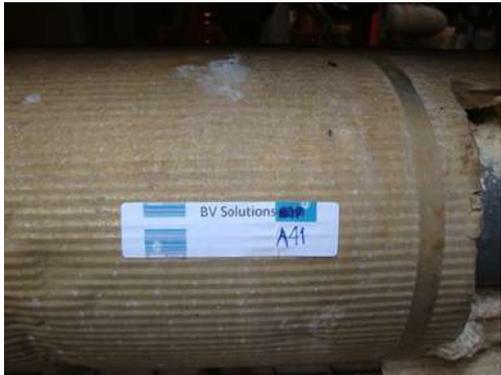
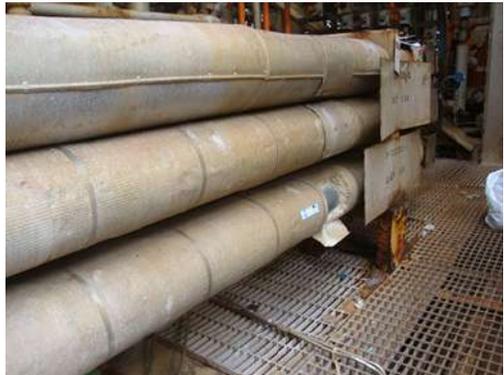
Main Deck Cargo Area	Asbestos	Sampling	A41	Not Contained			
Miscellaneous-Insulation-External area / Tk P123302A insulation / Fr. 23 - PS

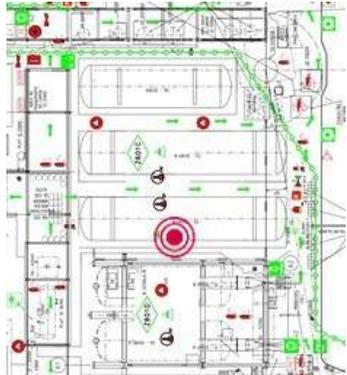
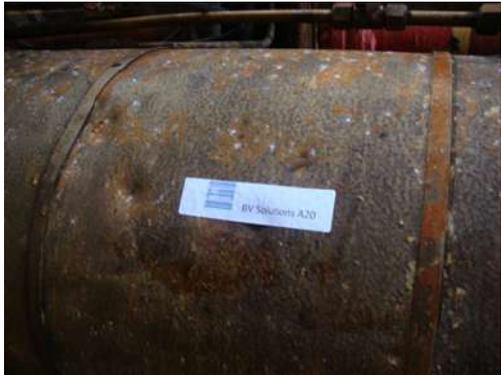
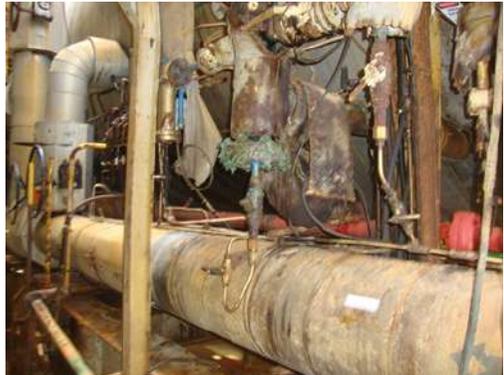
Location / Zone / Deck	Expected Hazardous Materials	Check procedure	Sample No.	Sample result	Quantity	Risk Level Assessment	Remarks				
Main Deck Cargo Area	Asbestos	Sampling	A20	Not Contained							
Piping - Miscellaneous-Insulation-External area / Piping insulation (attached Tk 122301A) / Fr. 19 - STB

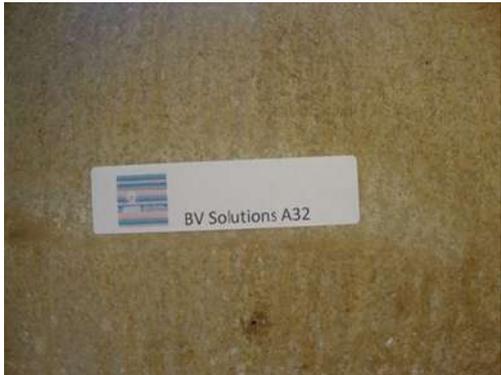
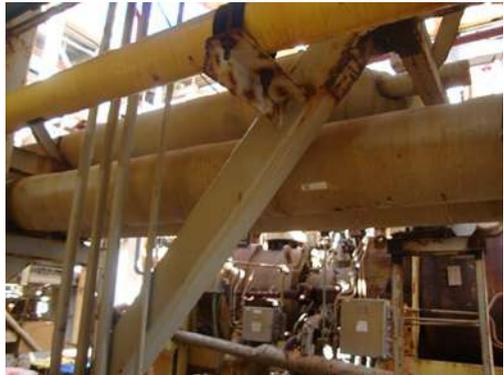
Main Deck Cargo Area	Asbestos	Sampling	A32	Not Contained			
Piping - Miscellaneous-Insulation-External area / Piping insulation / Fr. 14 - PS

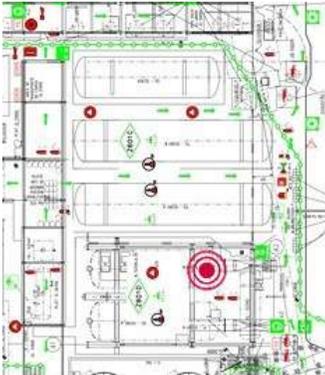
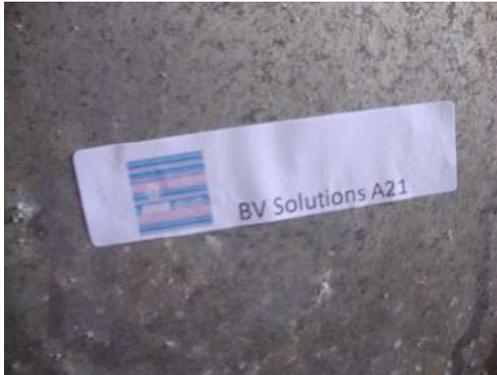
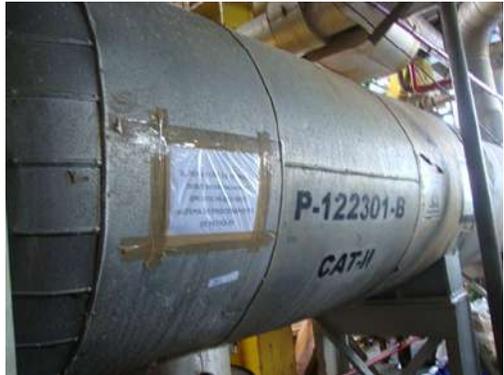
Location / Zone / Deck	Expected Hazardous Materials	Check procedure	Sample No.	Sample result	Quantity	Risk Level Assessment	Remarks
Main Deck Cargo Area	Asbestos	Sampling	A21	Not Contained			
Miscellaneous-Insulation-External area / Tank P122301B insulation / Fr. 15 - STB

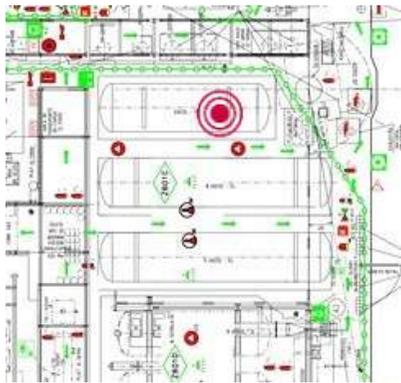
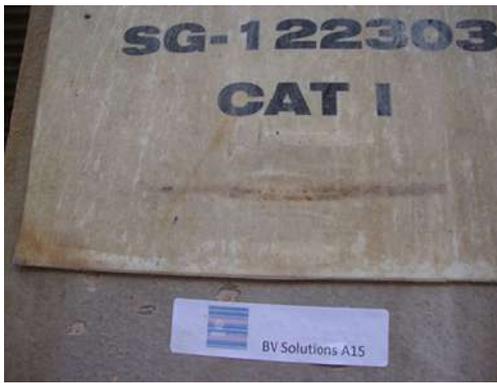
Main Deck Cargo Area	Asbestos	Sampling	A15	Not Contained			
Miscellaneous-Insulation-External area / Separator tank SG 122303 insulation / Fr. 25 STB

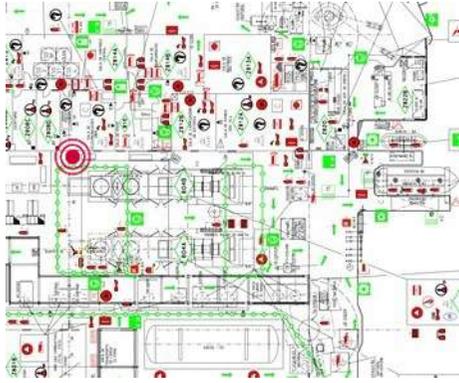
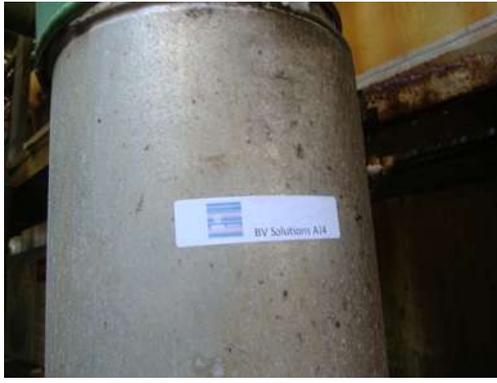
Location / Zone / Deck	Expected Hazardous Materials	Check procedure	Sample No.	Sample result	Quantity	Risk Level Assessment	Remarks
Main Deck Cargo Area	Asbestos	Sampling	A14	Not Contained			
Piping - Miscellaneous-Insulation-External area / Piping insulation / Fr. 37 - CL

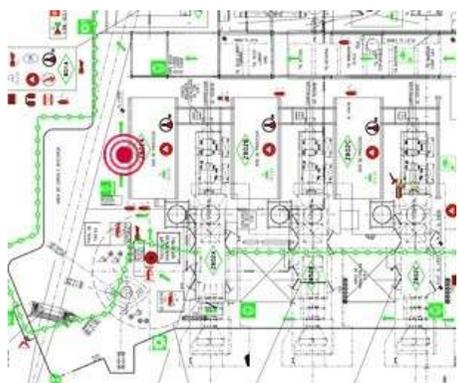
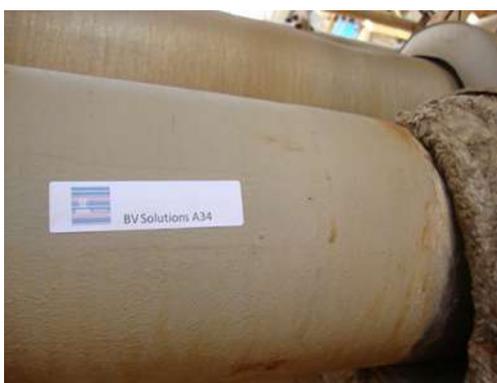
Main Deck Cargo Area	Asbestos	Sampling	A34	Not Contained			
Piping - Miscellaneous-Insulation-External area / Piping insulation / Fr. 15 - PS

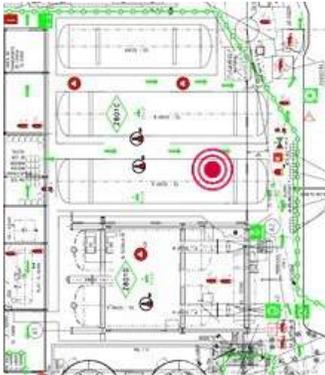
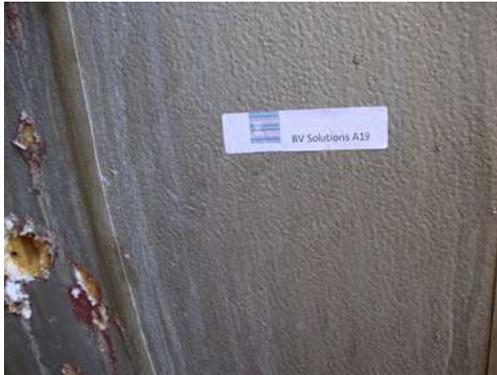
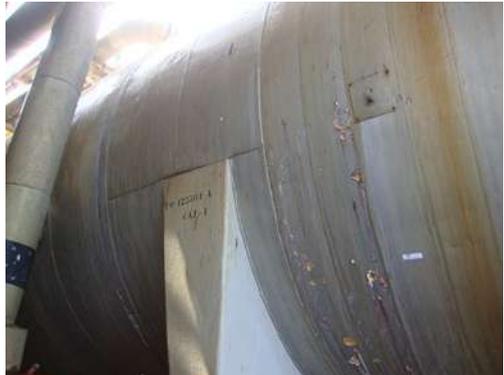
Location / Zone / Deck	Expected Hazardous Materials	Check procedure	Sample No.	Sample result	Quantity	Risk Level Assessment	Remarks
Main Deck Cargo Area	Asbestos	Sampling	A19	Not Contained			
Miscellaneous-Insulation-External area / Tank 122301A insulation / Fr. 19 - STB

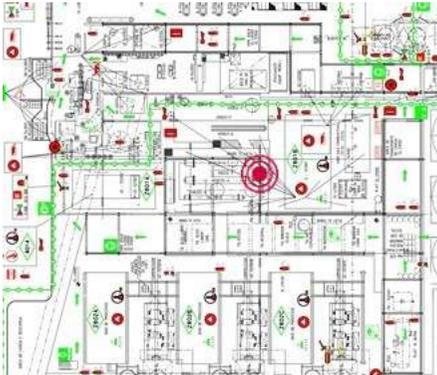
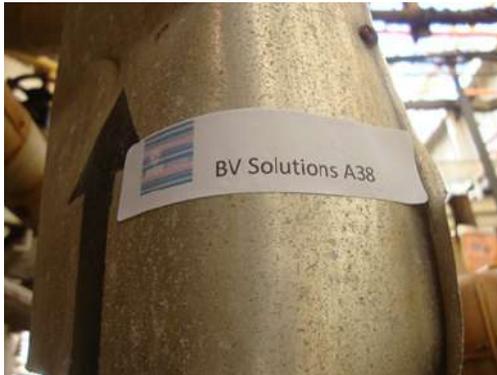
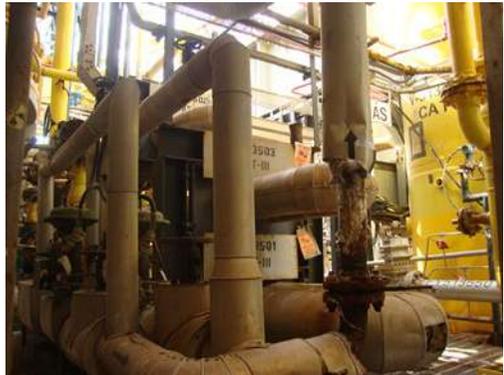
Main Deck Cargo Area	Asbestos	Sampling	A38	Not Contained			
Piping - Miscellaneous-Insulation-External area / Piping insulation / Fr. 23 - PS

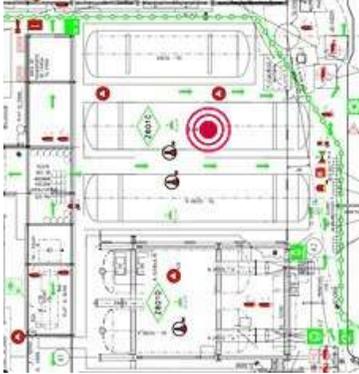
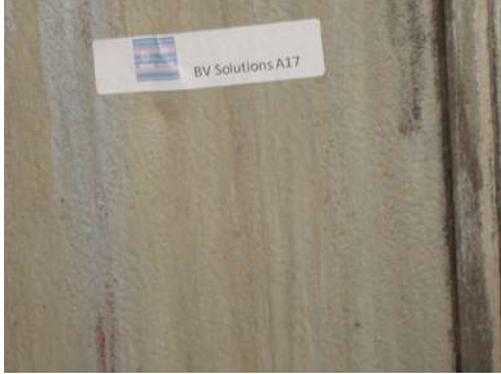
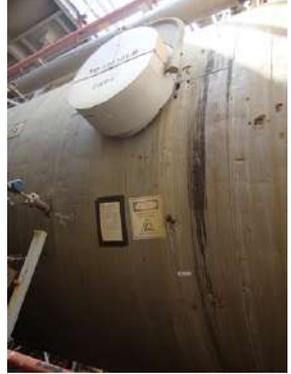
Location / Zone / Deck	Expected Hazardous Materials	Check procedure	Sample No.	Sample result	Quantity	Risk Level Assessment	Remarks
Main Deck Cargo Area	Asbestos	Sampling	A17	Not Contained			
Miscellaneous-Insulation-External area / Tank 122301B insulation / Fr. 22 - STB

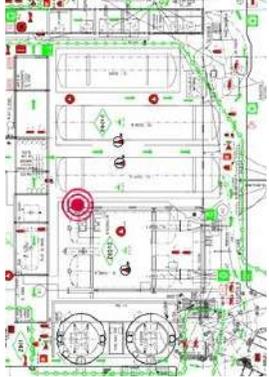
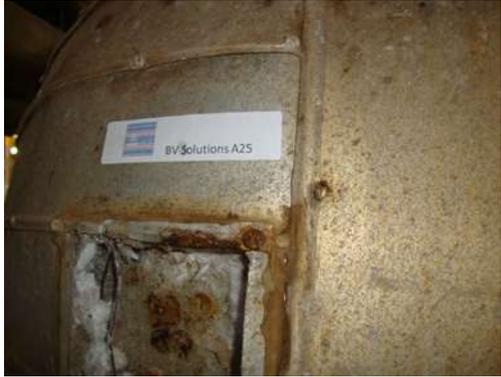
Main Deck Cargo Area	Asbestos	Sampling	A25	Not Contained			
Miscellaneous-Insulation-External area / Tank P122302A insulation / Fr. 14 - STB

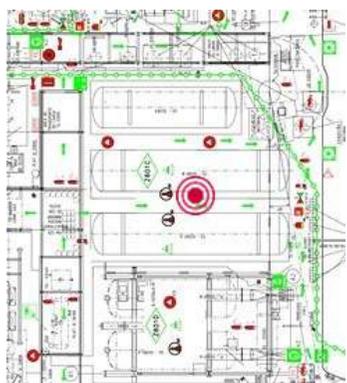
Location / Zone / Deck	Expected Hazardous Materials	Check procedure	Sample No.	Sample result	Quantity	Risk Level Assessment	Remarks
Main Deck Cargo Area	Asbestos	Sampling	A18	Not Contained			
Piping - Miscellaneous-Insulation-External area / Piping insulation (attached Tk 122301B) / Fr. 22 - STB

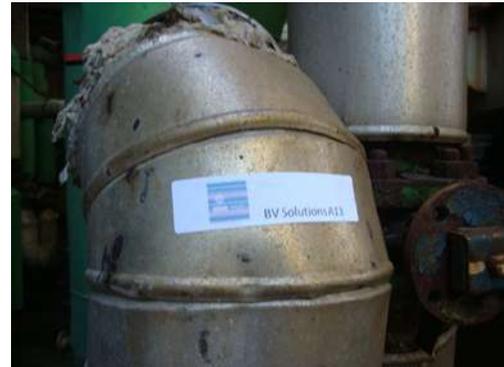
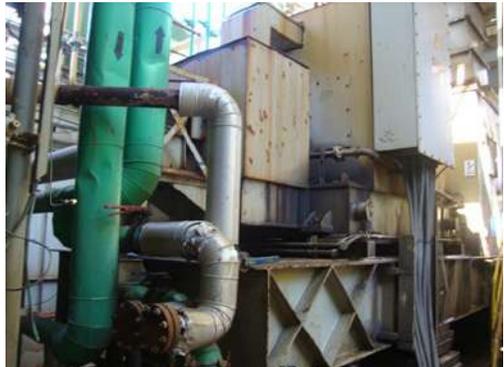
Main Deck Cargo Area	Asbestos	Sampling	A13	Not Contained			
Cargo space-Insulation-External area / Piping insulation / Fr. 35 - STB

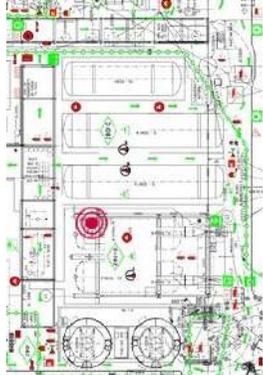
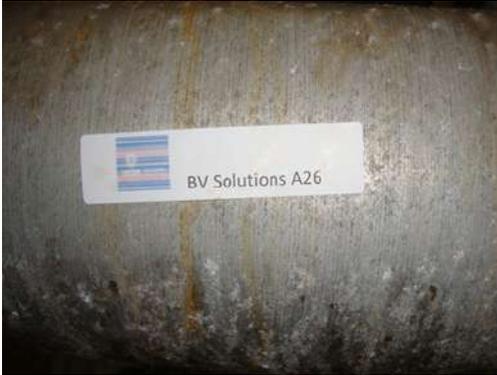
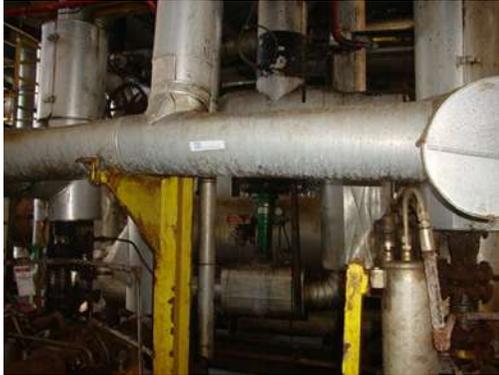
Location / Zone / Deck	Expected Hazardous Materials	Check procedure	Sample No.	Sample result	Quantity	Risk Level Assessment	Remarks
Main Deck Cargo Area	Asbestos	Sampling	A26	Not Contained			
Piping - Miscellaneous-Insulation-External Area / Piping insulation (btw MB122304B / MB122304A) / Fr. 15 - STB

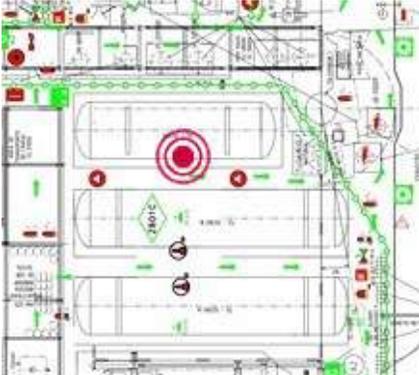
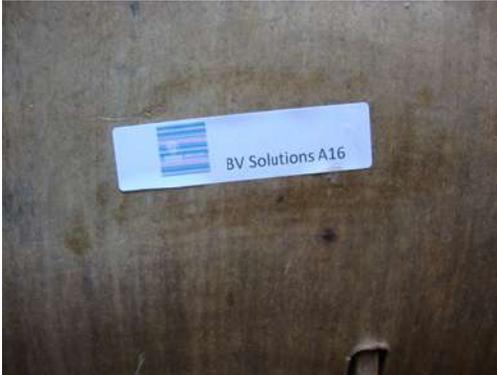
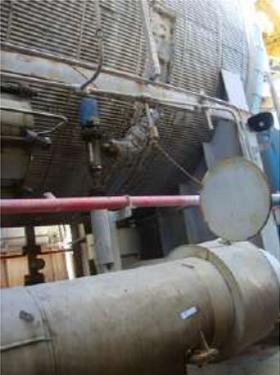
Main Deck Cargo Area	Asbestos	Sampling	A16	Not Contained			
Piping - Miscellaneous-Insulation-External area / Piping insulation (attached Tk SG 122303) / Fr. 25 - STB

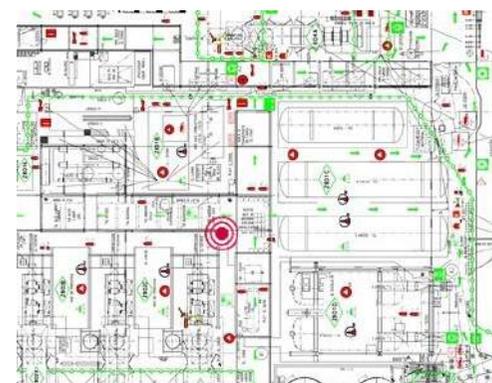
Main Deck Cargo Area	Asbestos	Sampling	A30	Not Contained			
Cargo space-Insulation-External area / Piping insulation / Fr. 18 - STB

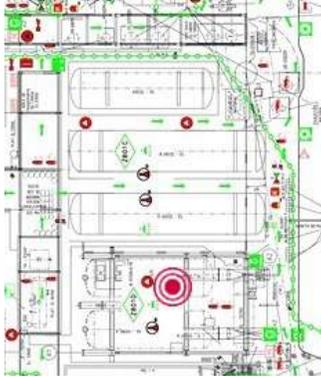
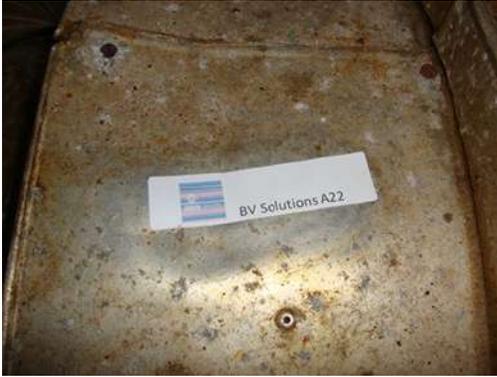
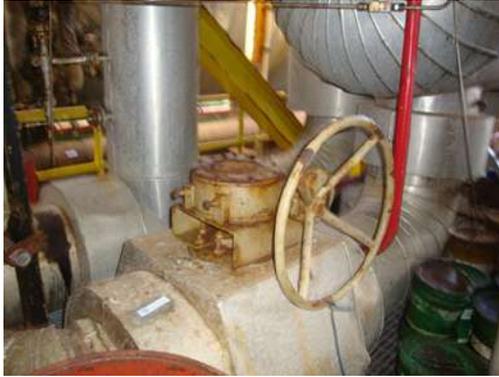
Location / Zone / Deck	Expected Hazardous Materials	Check procedure	Sample No.	Sample result	Quantity	Risk Level Assessment	Remarks
Main Deck Cargo Area	Asbestos	Sampling	A22	Not Contained			
Piping - Miscellaneous-Insulation-External area / Piping insulation (attached Tk P122301B) / Fr. 15 - STB

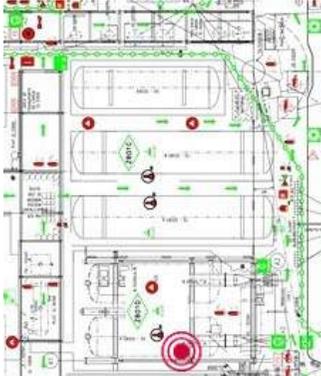
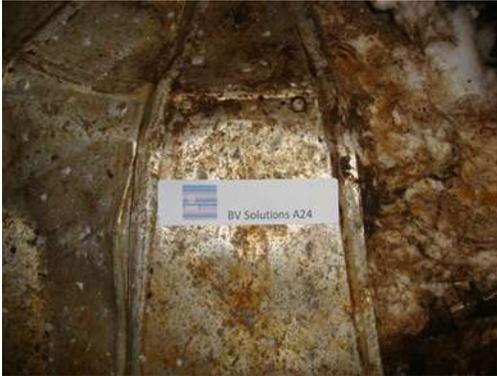
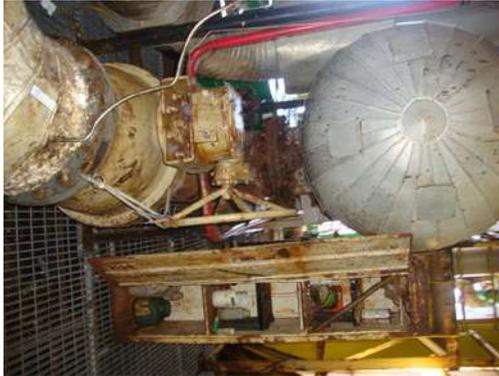
Main Deck Cargo Area	Asbestos	Sampling	A24	Not Contained			
Piping - Miscellaneous-Insulation-External area / Piping insulation (attached Tk P122301A) / Fr. 13 - STB
