I-RL-3010.19-1320-970-TNA-001

TITLE: IHM Report – Part I

## Inventory of Hazardous Materials Manual Part I

Ship / Vessel name	PETROBRAS XIX
Flag	Panama
Distinctive No. / Letters	3FHI5
Port of Registry	PANAMA
Type of vessel	Floating storage unit
Gross Tonnage	22589
IMO Number	8753720
Name of Shipbuilder	
Name of Shipowner	BRASPETRO OIL SERVICES CO.
Date of delivery	31/12/1982
IHM Inventory Number	RJN0/2024/8753720/ssf
Revision Number	4.0

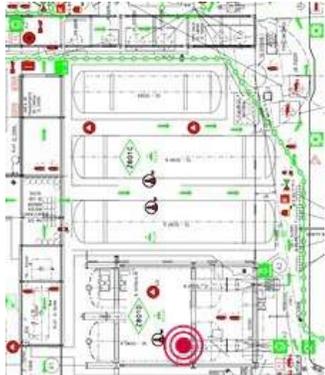
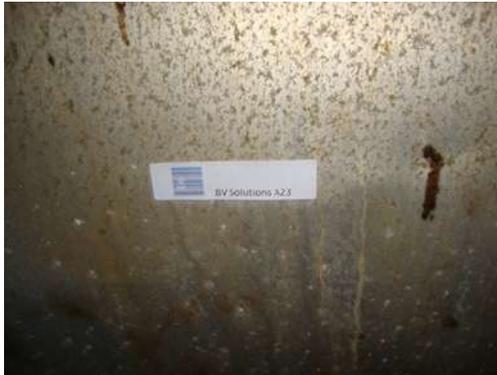
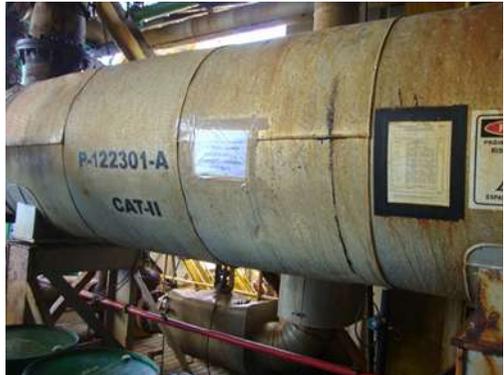
Location / Zone / Deck	Expected Hazardous Materials	Check procedure	Sample No.	Sample result	Quantity	Risk Level Assessment	Remarks
Main Deck Cargo Area	Asbestos	Sampling	A23	Not Contained			
Miscellaneous-Insulation-External area / Tank P122301A insulation / Fr. 13 - STB

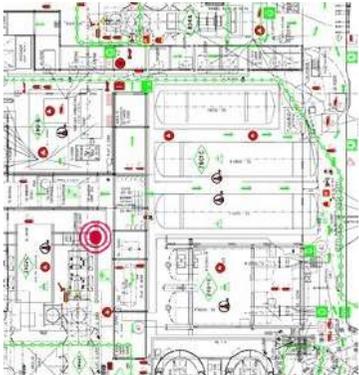
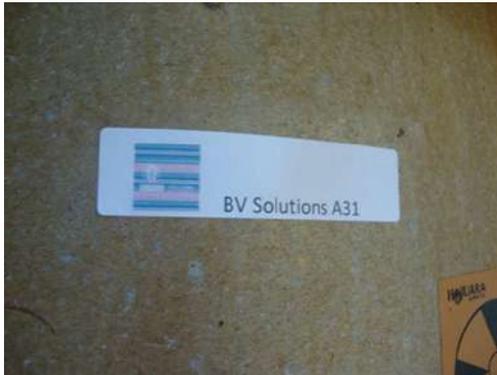
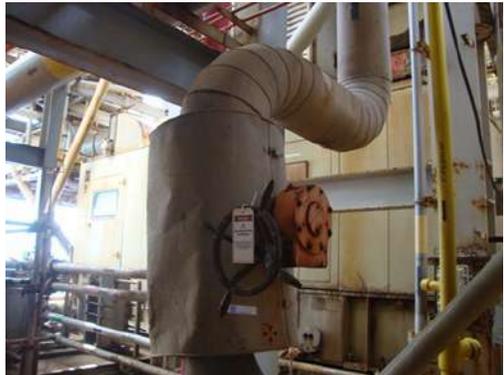
Main Deck Cargo Area	Asbestos	Sampling	A31	Not Contained			
Piping - Miscellaneous-Insulation-External area / Piping insulation / Fr. 17 - STB

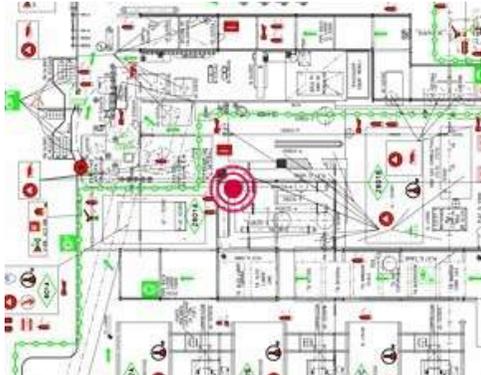
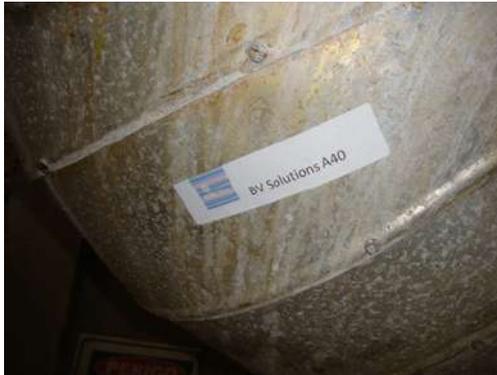
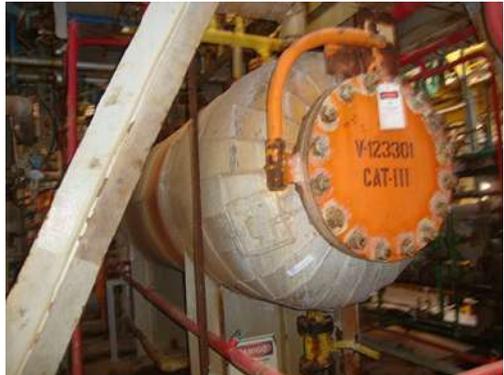
Location / Zone / Deck	Expected Hazardous Materials	Check procedure	Sample No.	Sample result	Quantity	Risk Level Assessment	Remarks
Main Deck Cargo Area	Asbestos	Sampling	A40	Not Contained			
Miscellaneous-Insulation-External area / Tk V133301 insulation / Fr. 24 - PS

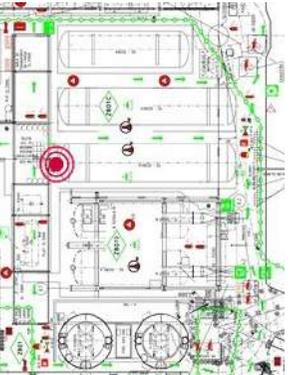
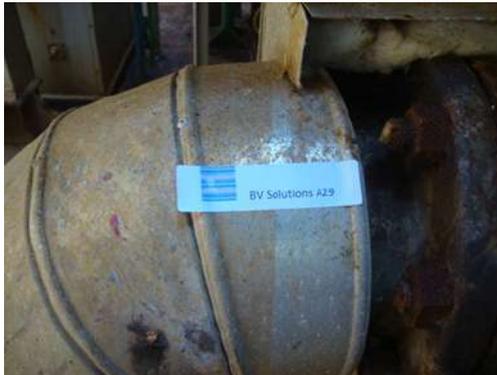
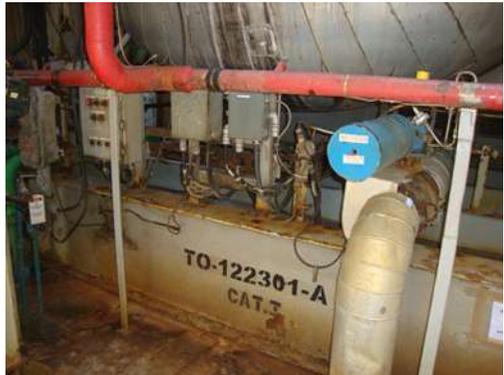
Main Deck Cargo Area	Asbestos	Sampling	A29	Not Contained			
Piping - Miscellaneous-Insulation-External area / Piping insulation (close to Tk 122301A) / Fr. 18 - STB

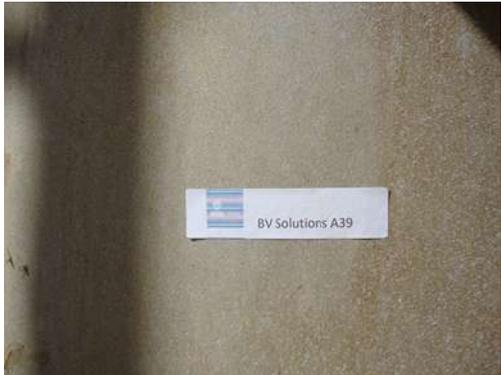
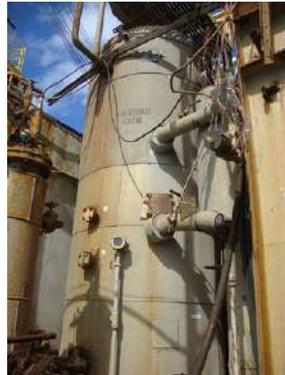
Location / Zone / Deck	Expected Hazardous Materials	Check procedure	Sample No.	Sample result	Quantity	Risk Level Assessment	Remarks
Main Deck Cargo Area	Asbestos	Sampling	A39	Not Contained			
Miscellaneous-Insulation-External area / TK V-UC-122302 (Booster) insulation / Fr. 28 - PS

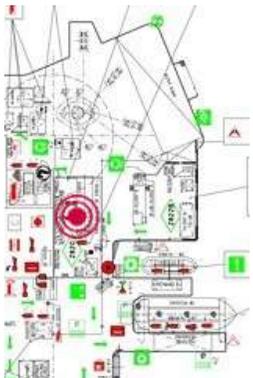
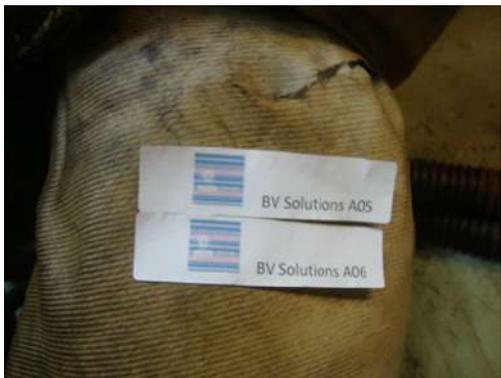
Main Deck Main Deck	Asbestos	Sampling	A05	Not Contained			
Lagging material - exhaust pipe-Lagging material-Exhaust gas - Emergency generator - DGE 514002 / Fr. 42 - STB

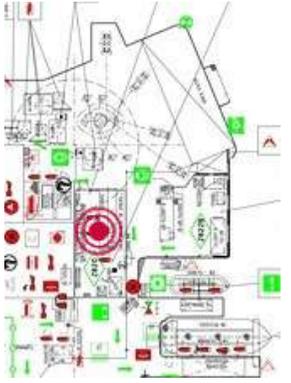
Location / Zone / Deck	Expected Hazardous Materials	Check procedure	Sample No.	Sample result	Quantity	Risk Level Assessment	Remarks
Main Deck Main Deck	Asbestos	Sampling	A06	Not Contained			
Exhaust gas system-Insulation-Exhaust gas - Emergency generator - DGE 514002 / Fr. 42 - STB

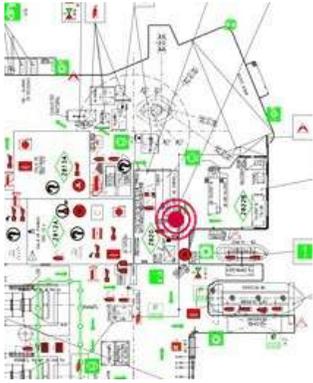
Main Deck Main Deck	Asbestos	Sampling	A07	Not Contained			
Bulkhead plating-Insulation-Bulkhead insulation / Emergency generator room / Fr. 42 - STB

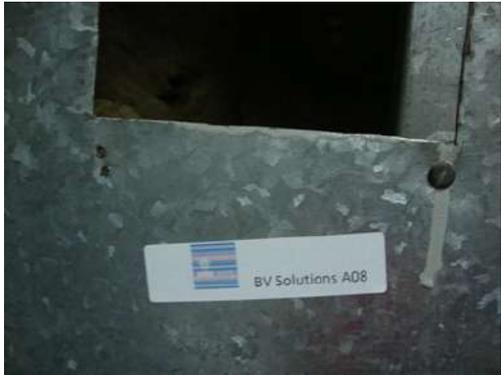
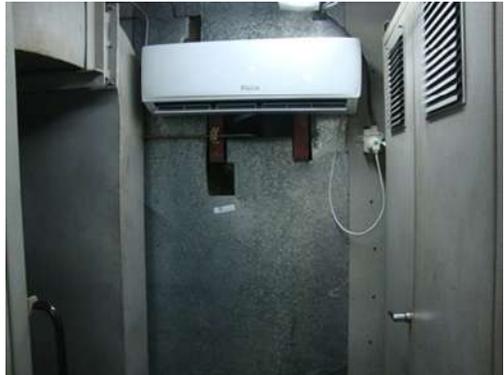
Location / Zone / Deck	Expected Hazardous Materials	Check procedure	Sample No.	Sample result	Quantity	Risk Level Assessment	Remarks
Main Deck Main Deck	Asbestos	Sampling	A08	Not Contained			
Bulkhead plating-Insulation-Bulkhead insulation / Battery charger room / Fr. 41 - STB

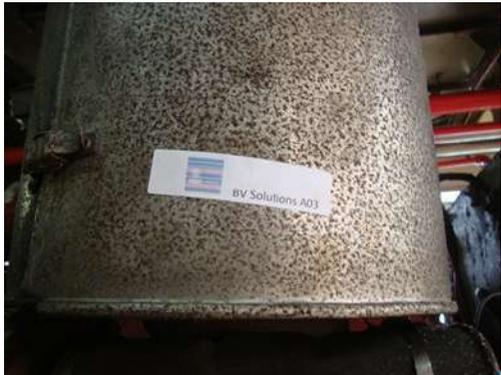
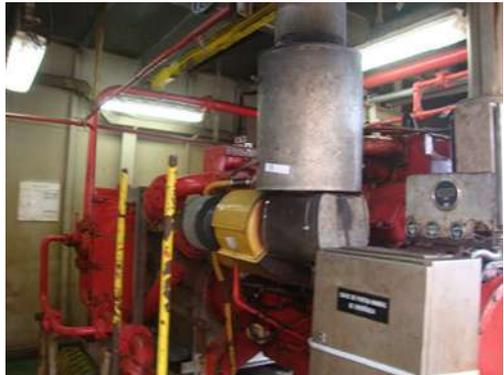
Main Deck Main Deck	Asbestos	Sampling	A03	Not Contained			
Diesel Engine-Insulation-External area / Diesel Fire Pump PS - MB-UB 542001A / Fr.43 - PS

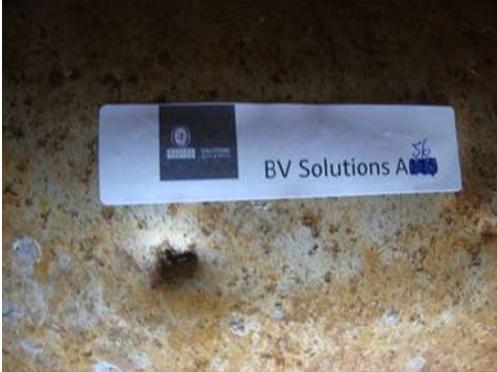
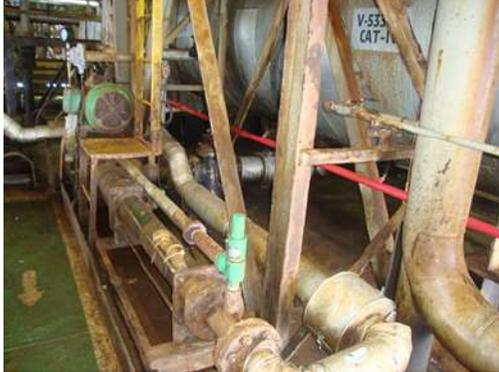
Location / Zone / Deck	Expected Hazardous Materials	Check procedure	Sample No.	Sample result	Quantity	Risk Level Assessment	Remarks
Spider Deck Cargo Area	Asbestos	Sampling	A56	Not Contained			
Piping - Miscellaneous-Insulation-Piping insulation (attached Tk V533602) / Fr. 15 - STB

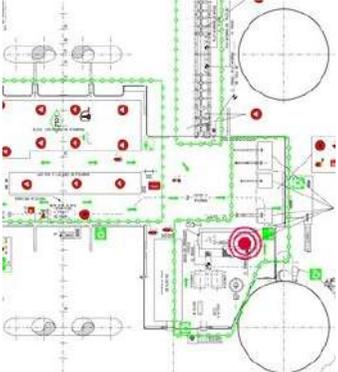
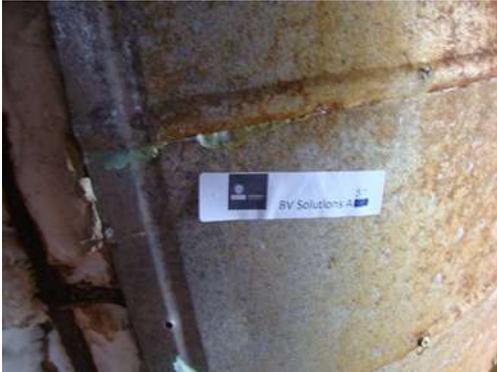
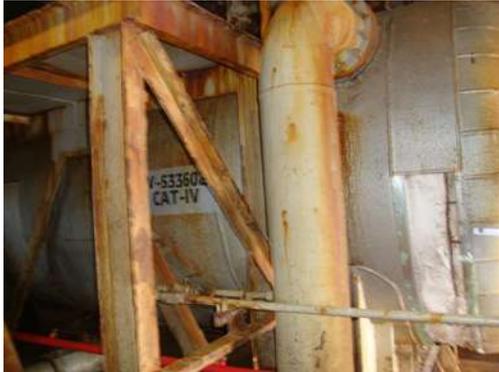
Spider Deck Cargo Area	Asbestos	Sampling	A55	Not Contained			
Miscellaneous-Insulation-TkV533602 insulation / Fr. 15 - STB

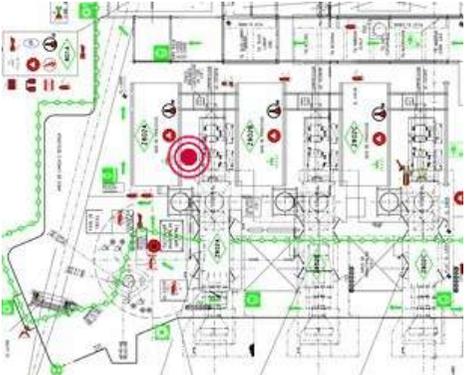
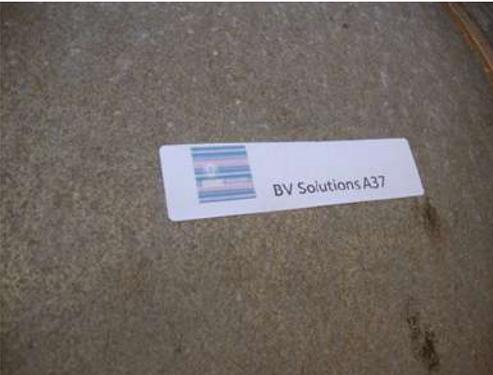
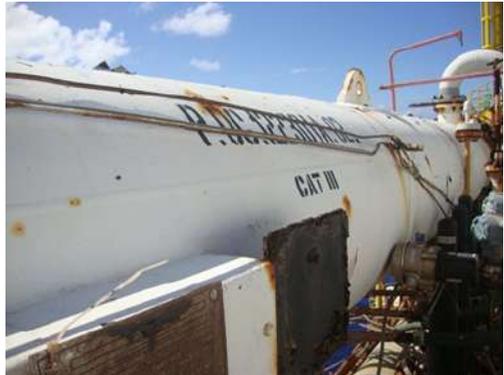
Location / Zone / Deck	Expected Hazardous Materials	Check procedure	Sample No.	Sample result	Quantity	Risk Level Assessment	Remarks
Upper Deck Cargo Area	Asbestos	Sampling	A37	Not Contained			
Miscellaneous-Insulation-External area / Tk P.UC.122301A-02 insulation / Fr. 13 - PS

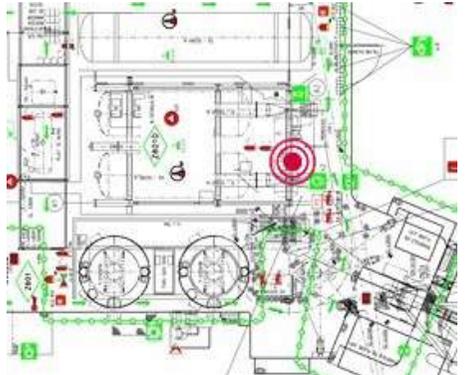
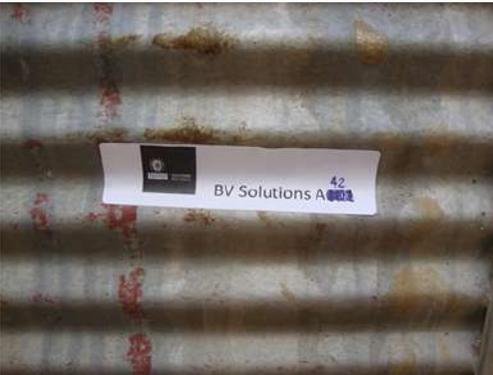
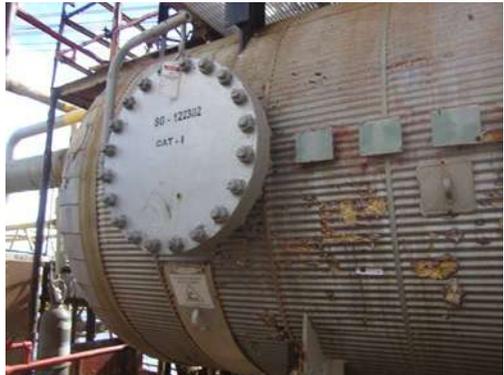
Upper Deck Cargo Area	Asbestos	Sampling	A42	Not Contained			
Miscellaneous-Insulation-External area / Tk SG123302 insulation / Fr. 13 - STB

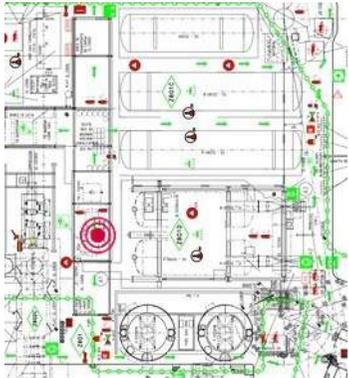
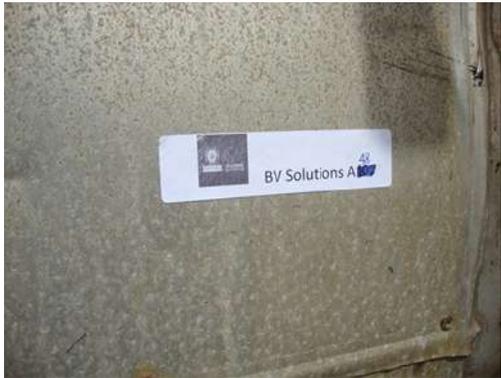
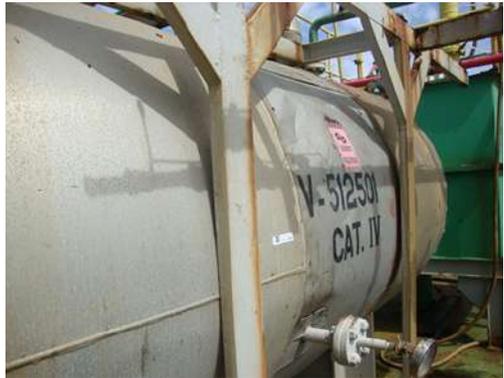
Upper Deck Cargo Area	Asbestos	Sampling	A48	Not Contained			
Miscellaneous-Insulation-External area / Tk V512501 insulation / Fr. 13 - STB

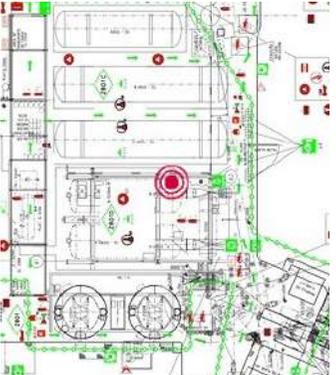
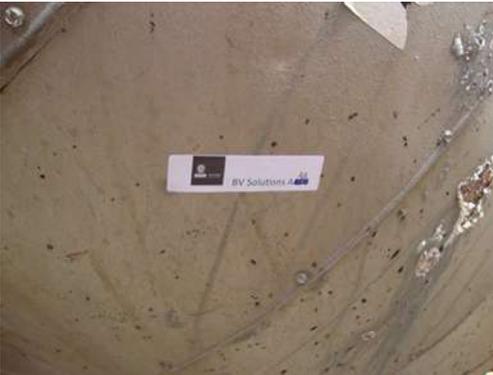
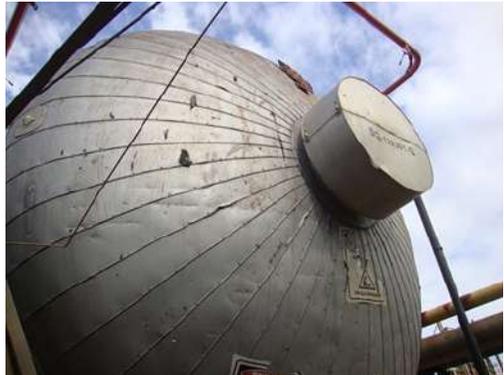
Location / Zone / Deck	Expected Hazardous Materials	Check procedure	Sample No.	Sample result	Quantity	Risk Level Assessment	Remarks
Upper Deck Cargo Area	Asbestos	Sampling	A44	Not Contained			
Miscellaneous-Insulation-External area / TK SG123301-B insulation / Fr. 15 - STB

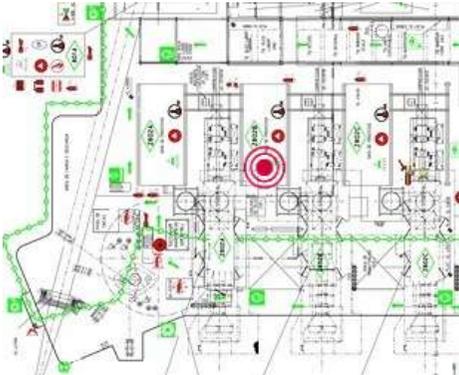
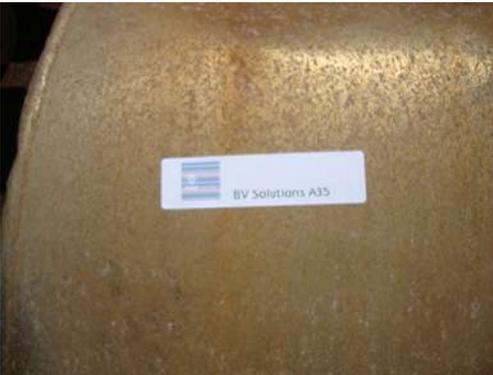
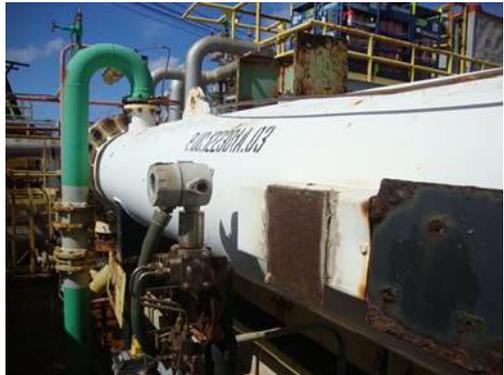
Upper Deck Cargo Area	Asbestos	Sampling	A35	Not Contained			
Miscellaneous-Insulation-External area / TK P.UC.122301A-03 insulation / Fr. 13 - PS

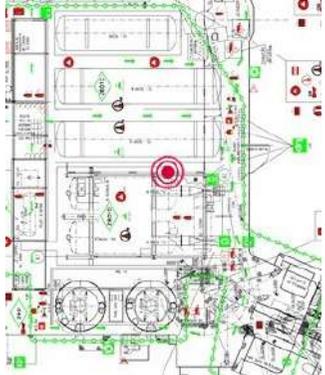
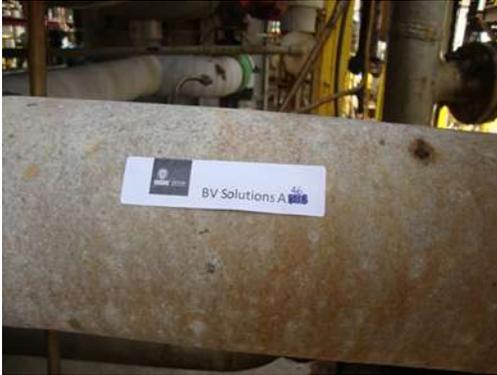
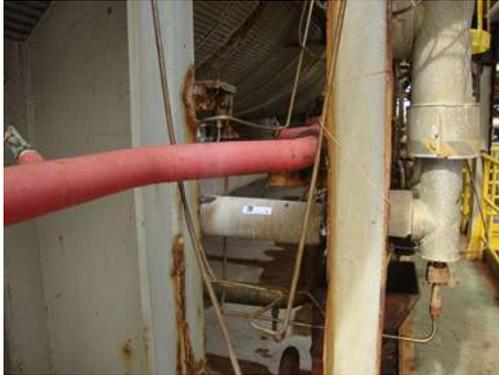
Location / Zone / Deck	Expected Hazardous Materials	Check procedure	Sample No.	Sample result	Quantity	Risk Level Assessment	Remarks
Upper Deck Cargo Area	Asbestos	Sampling	A46	Not Contained			
Piping - Miscellaneous-Insulation-External area / Piping insulation (attached Tk SG122301-B) / Fr. 15 - STB

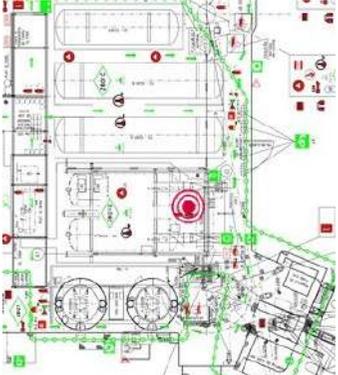
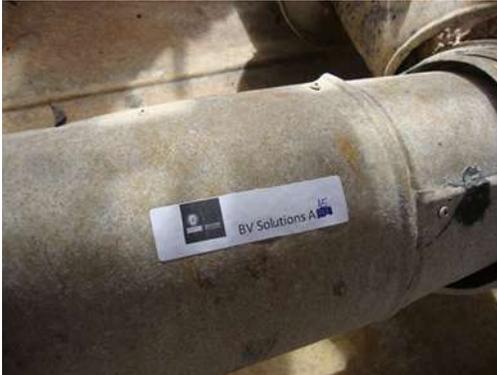
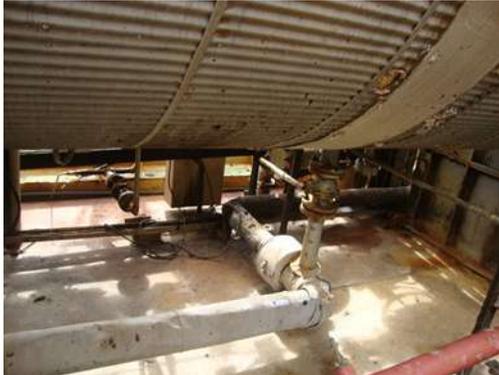
Upper Deck Cargo Area	Asbestos	Sampling	A45	Not Contained			
Piping - Miscellaneous-Insulation-External area / Piping insulation (attached Tk SG122302) / Fr. 13 - STB

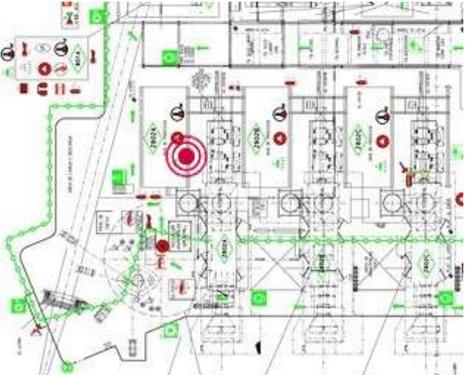
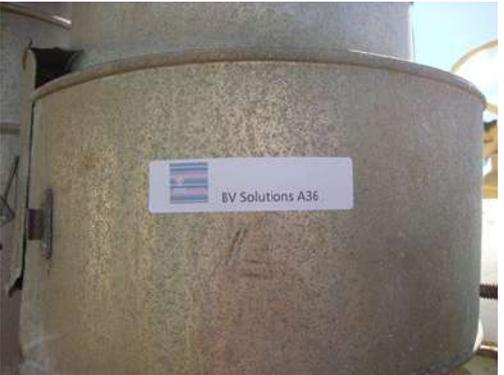
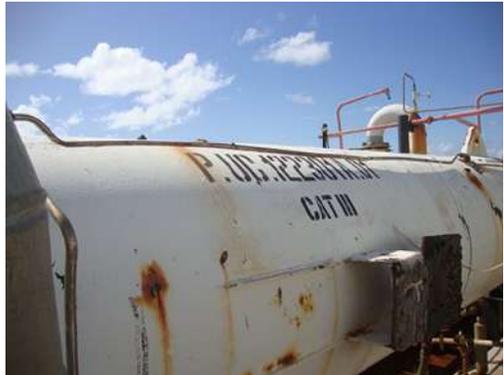
Location / Zone / Deck	Expected Hazardous Materials	Check procedure	Sample No.	Sample result	Quantity	Risk Level Assessment	Remarks
Upper Deck Cargo Area	Asbestos	Sampling	A36	Not Contained			
Miscellaneous-Insulation-External area / TK P.UC.122301A-01 insulation / Fr. 13 - PS

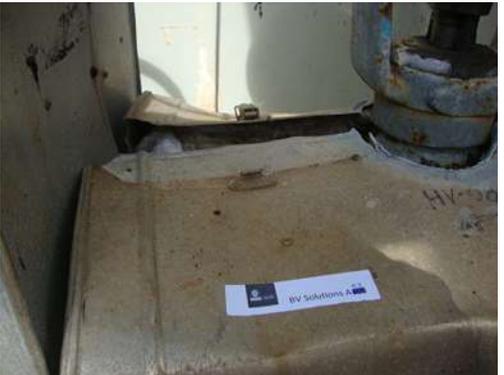
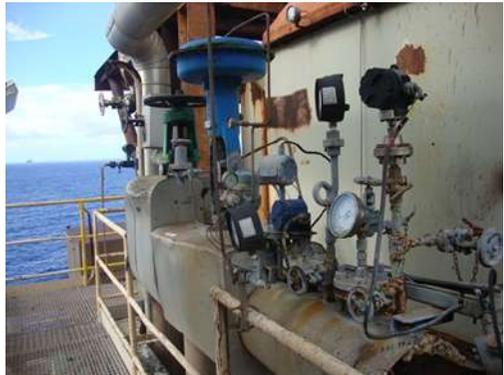
Upper Deck Cargo Area	Asbestos	Sampling	A47	Not Contained			
Piping - Miscellaneous-Insulation-External area / Piping insulation (attached discharge Turbo Compressor \C) / Fr. 15 - PS

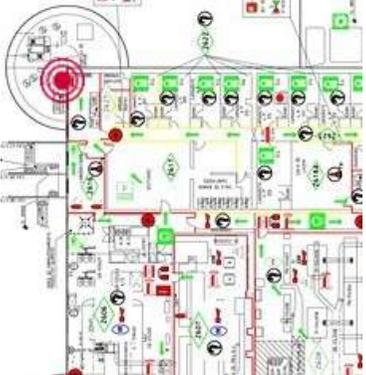
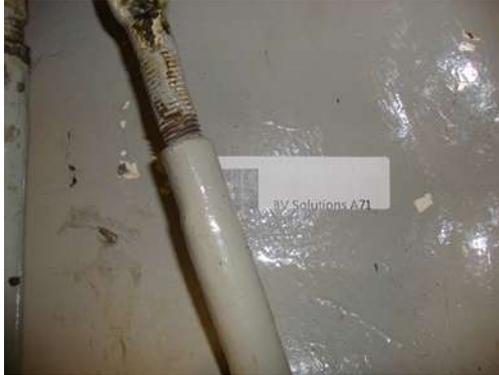
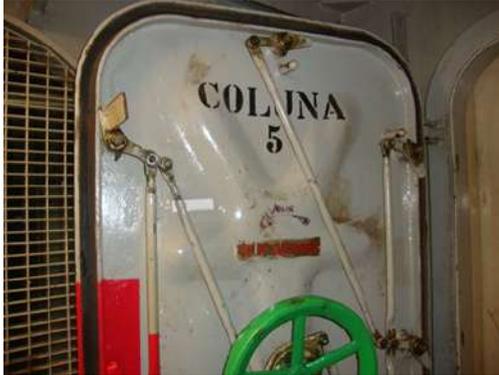
Location / Zone / Deck	Expected Hazardous Materials	Check procedure	Sample No.	Sample result	Quantity	Remarks				
Lower Deck Accommodation	PCB	Sampling	A71	Not Contained						
Miscellaneous-Rubber applications-Ruuber packing door / Access to column 5 (FWdD- PS) / Fr. 45 - PS

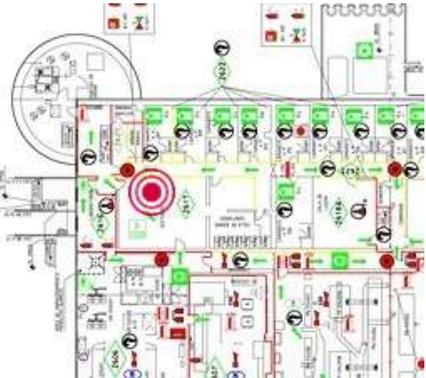
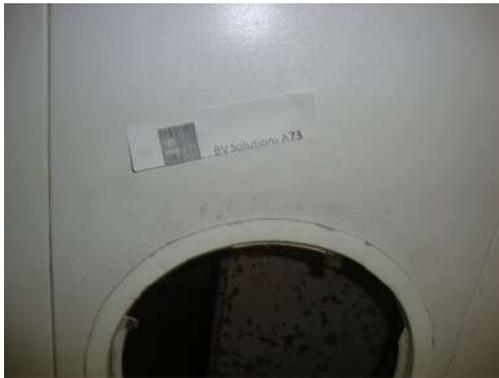
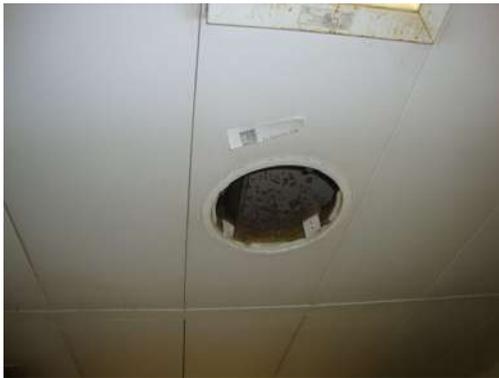
Lower Deck Accommodation	ODS	Sampling	A73	Not Contained		
Accommodation - Ceiling-Insulation-Ceiling insulation / Changing room / FR. 39 - PS

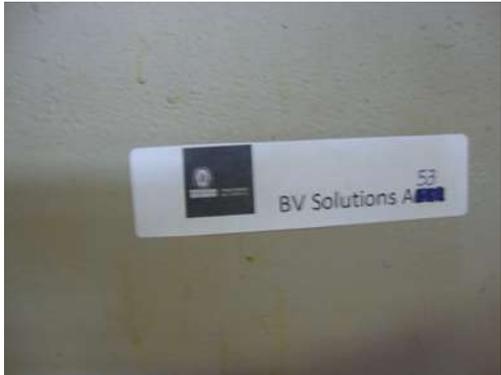
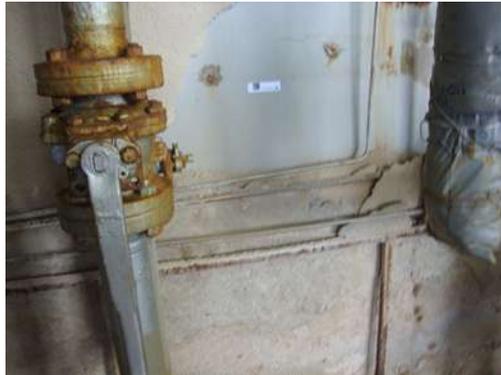
Location / Zone / Deck	Expected Hazardous Materials	Check procedure	Sample No.	Sample result	Quantity	Remarks					
Lower Deck Cargo Area	HBCDD	Sampling	A53	Not Contained							
Bulkhead plating-Concrete-Passive protection transverse beam / Fr. 9 - STB

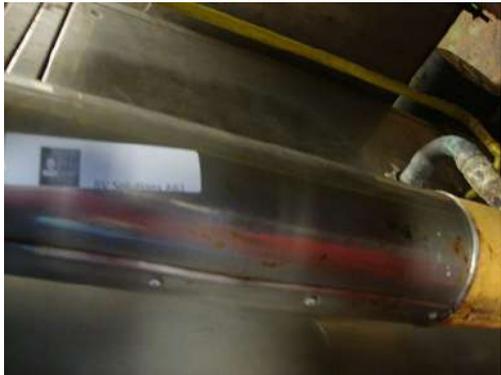
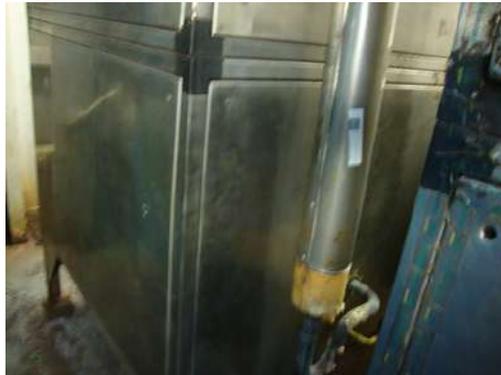
Lower Deck Engine Room	PCB	Sampling	A61	Not Contained		
AC system-Insulation-Air Conditionary Plant insulation / PS AFT column / Fr. 10 - PS

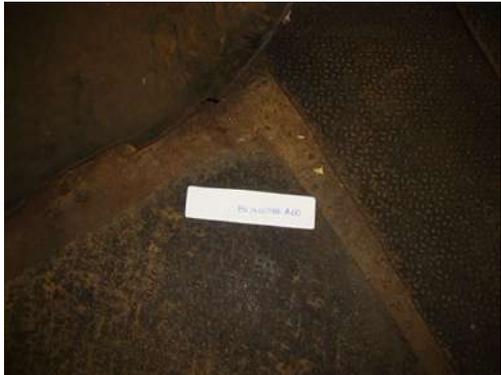
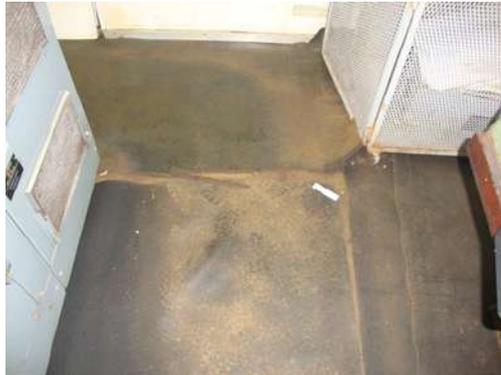
Location / Zone / Deck	Expected Hazardous Materials	Check procedure	Sample No.	Sample result	Quantity	Remarks
Lower Deck Engine Room	PCB	Sampling	A60	Not Contained		
Electrical equipment-Rubber applications-Electrical Rubber floor / TGs control room / Fr. 11 - PS

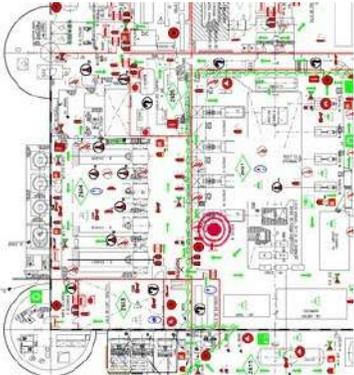
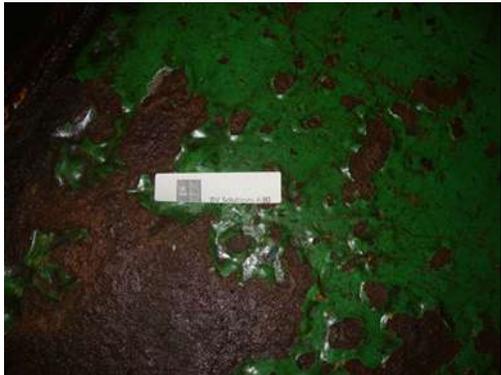
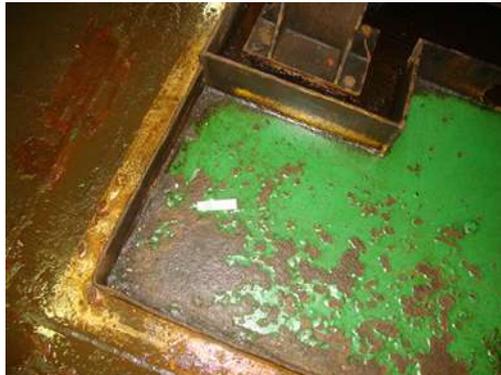
Lower Deck Engine Room	TBT	Sampling	A80	Not Contained		
Deck coatings-Coatings & paint-Deck painting / Exportation pumps room / FR. 16 - PS

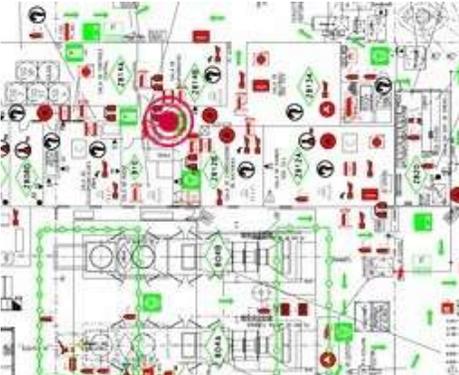
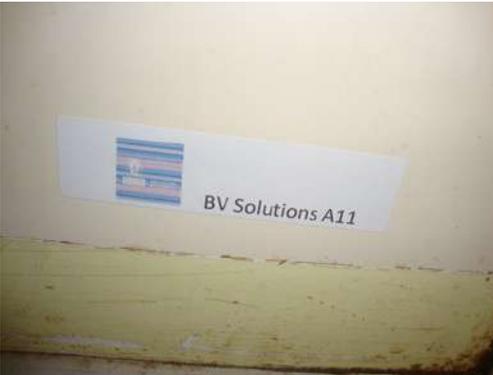
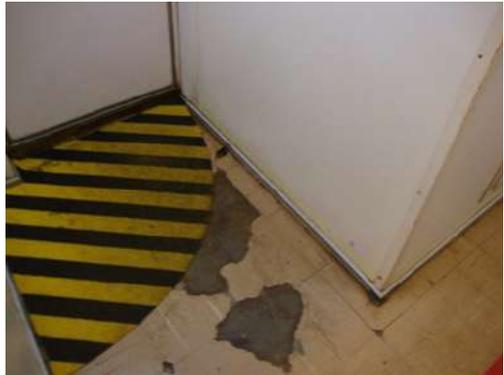
Location / Zone / Deck	Expected Hazardous Materials	Check procedure	Sample No.	Sample result	Quantity	Remarks				
Main Deck Accommodation	PFOS	Sampling	A11	Not Contained						
Accommodation - Floor-Corridor lining-Floor covering / Corridor / Fr. 41 - STB

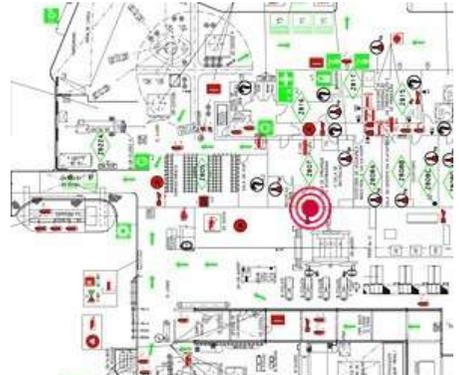
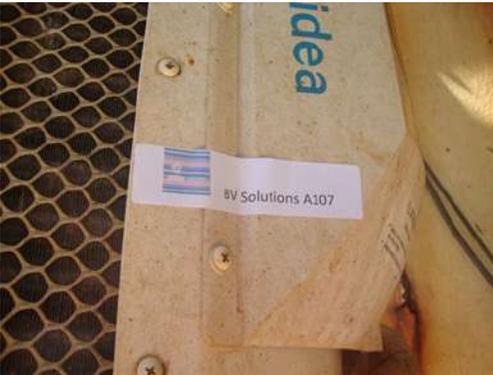
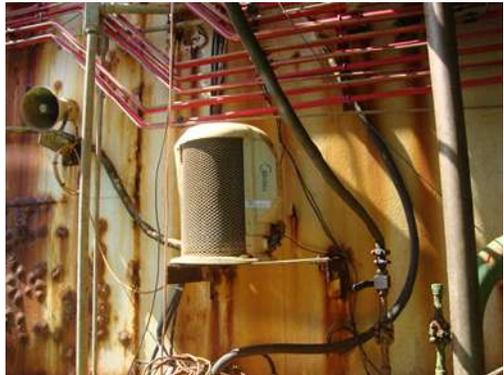
Main Deck Cargo Area	ODS	Visual	A107	Not Contained		
Air Conditioner (compressor)-Refrigerants-External area / Air conditioner / Fr. 38 - PS

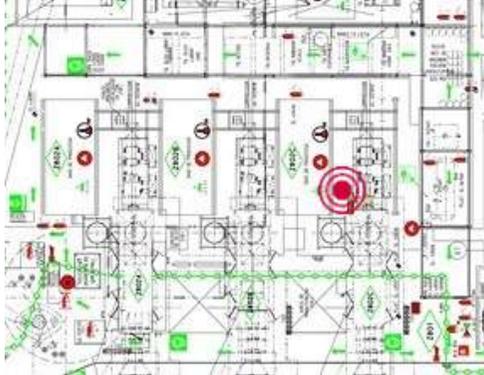
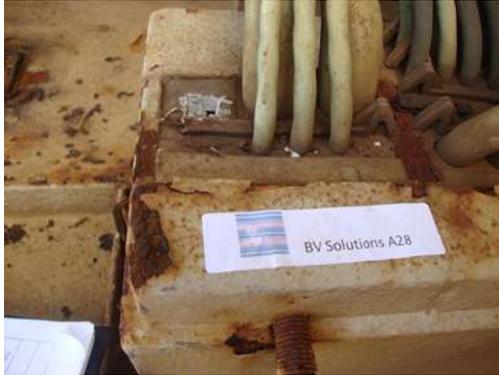
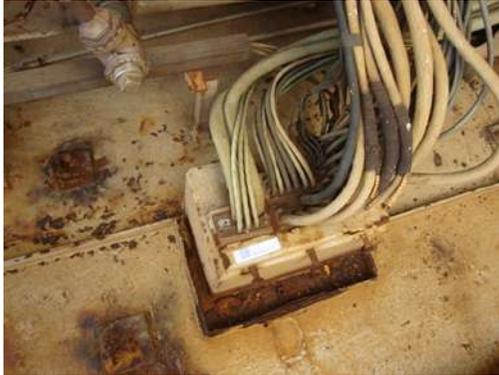
Location / Zone / Deck	Expected Hazardous Materials	Check procedure	Sample No.	Sample result	Quantity	Remarks
Main Deck Cargo Area	HBCDD	Sampling	A28	Not Contained		
Electric cable penetrations-Putty-External area / MCT mass (close to Turbo-compressor C) / Fr. 13 - STB

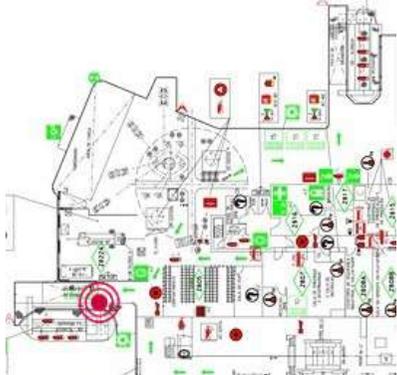
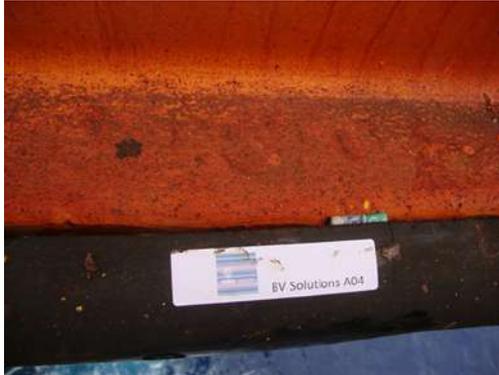
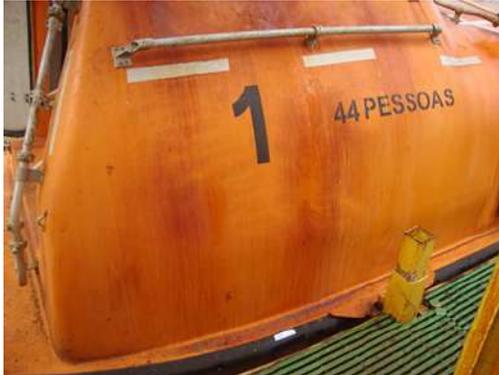
Main Deck Main Deck	PCB	Sampling	A04	Not Contained		
Miscellaneous-Rubber applications-External area / Lifeboat #1 - Rubber fender / Fr. 38 - PS

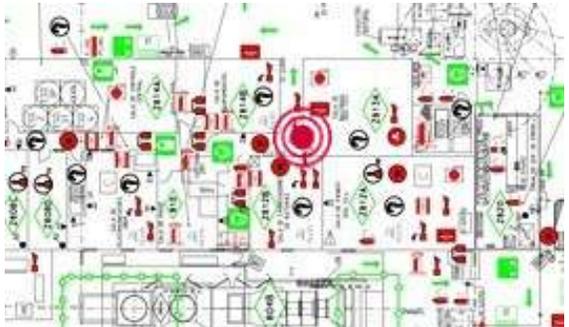
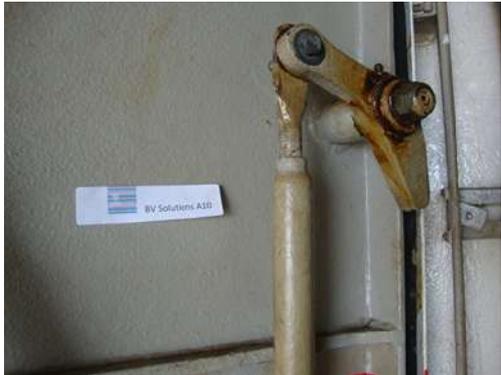
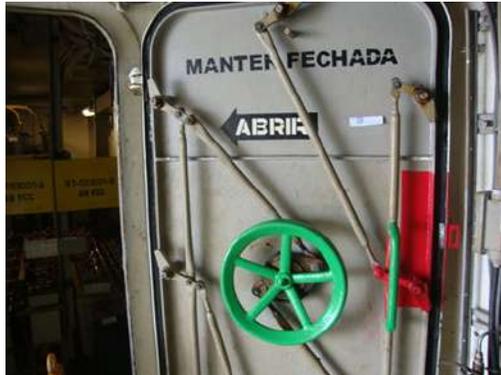
Location / Zone / Deck	Expected Hazardous Materials	Check procedure	Sample No.	Sample result	Quantity	Remarks
Main Deck Main Deck	PCB	Sampling	A10	Not Contained		
Miscellaneous-Rubber applications-Rubber door packing / TGs battery room / Fr. 42 - STB

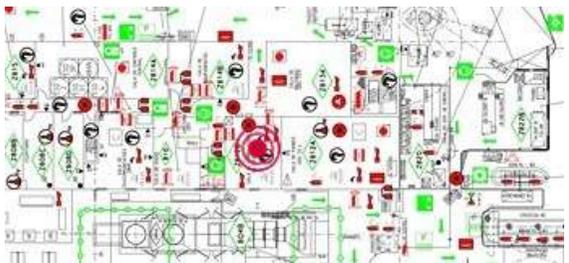
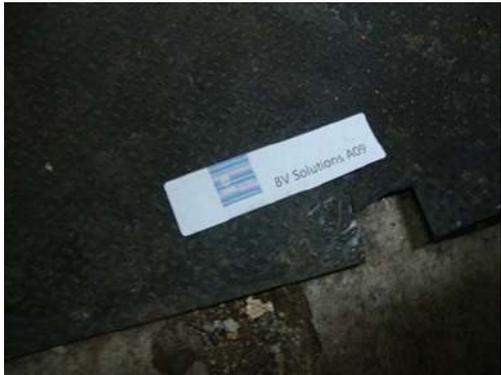
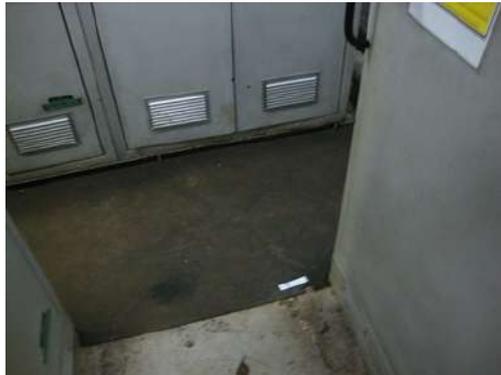
Not Contained		
Main Deck Main Deck	PCB	Sampling	A09	Not Contained		
Electrical equipment-Rubber applications-Electrical Rubber floor / Battery charger room / Fr. 41 - STB

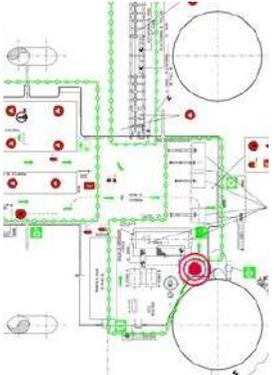
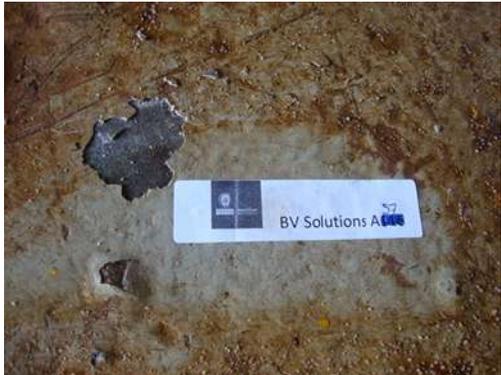
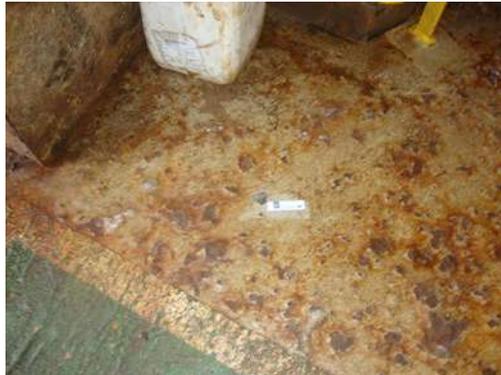
Location / Zone / Deck	Expected Hazardous Materials	Check procedure	Sample No.	Sample result	Quantity	Remarks					
Spider Deck Cargo Area	TBT	Sampling	A57	Not Contained							
Deck coatings-Coatings & paint-Deck painting / Fr. 15 - STB

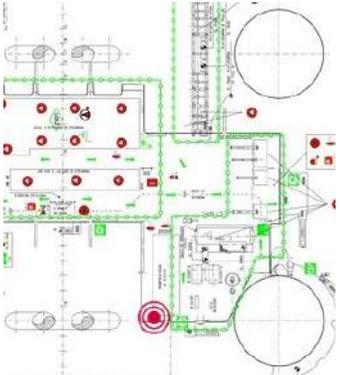
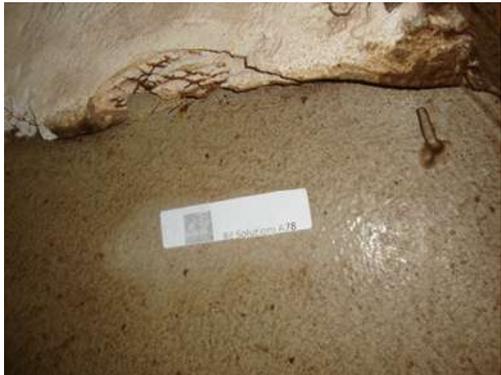
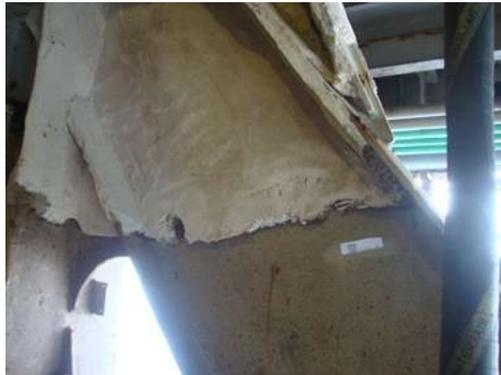
Spider Deck Cargo Area	PCB	Sampling	A78	Not Contained		
Cargo space-Concrete-External area / Passive protection transverse beam / Fr. 9 - STB

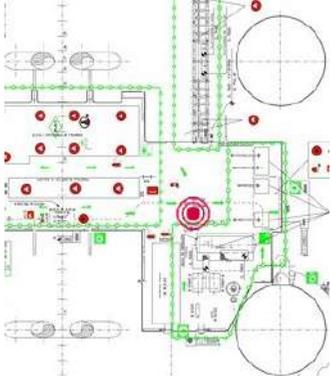
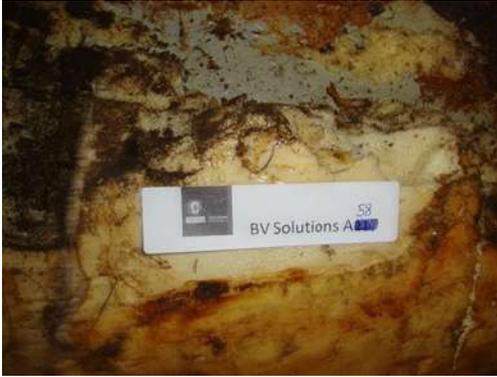
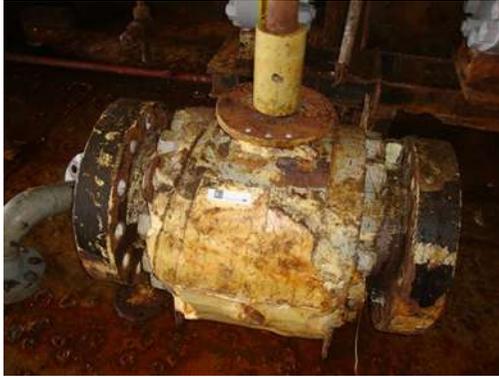
Location / Zone / Deck	Expected Hazardous Materials	Check procedure	Sample No.	Sample result	Quantity	Remarks
Spider Deck Cargo Area	PCB	Sampling	A58	Not Contained		
Piping - Miscellaneous-Insulation-Piping insulation / Fr. 17 - STB

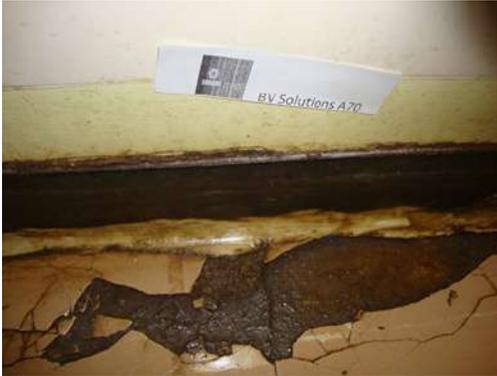
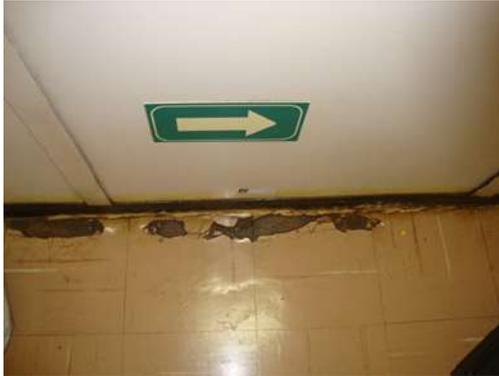
Tween Deck 1 Accommodation	PFOS	Sampling	A70	Not Contained		
Accommodation - Floor-Floor covering-Floor covering / Corridor / Fr. 42 - PS

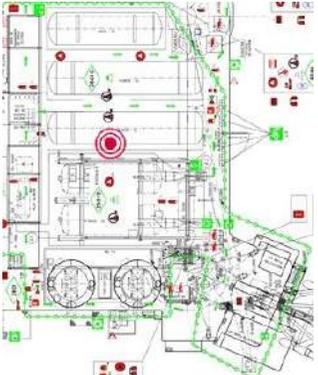
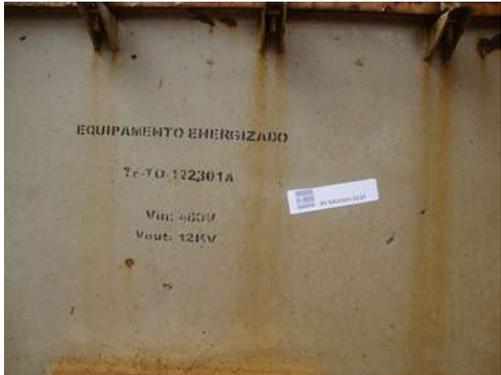
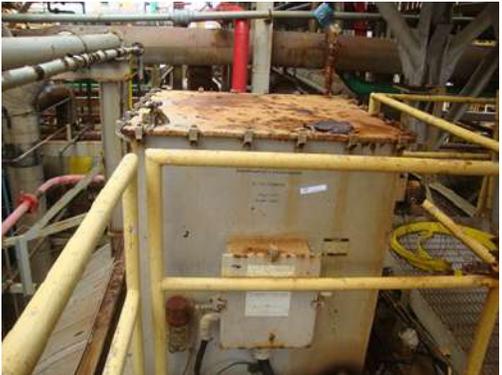
Location / Zone / Deck	Expected Hazardous Materials	Check procedure	Sample No.	Sample result	Quantity	Remarks
Upper Deck Cargo Area	PCB	Visual	A114	Not Contained		
Transformer-Insulating oil-Electrical transformer - TF-TQ122301A / Fr. 18 - STB

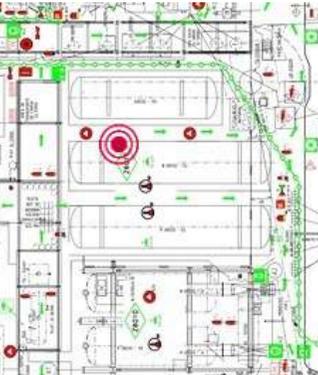
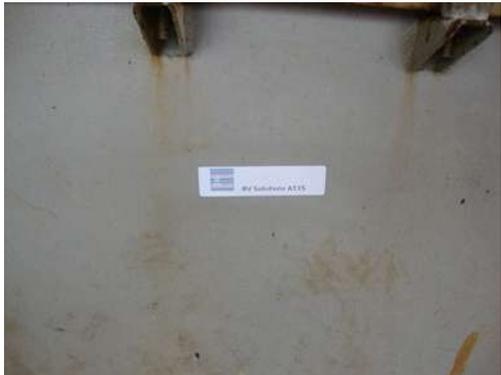
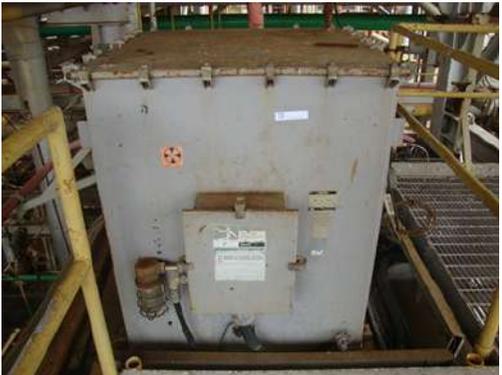
Upper Deck Cargo Area	PCB	Visual	A115	Not Contained		
Transformer-Insulating oil-Electrical transformer - TF-TQ122301B / Fr. 22 - STB

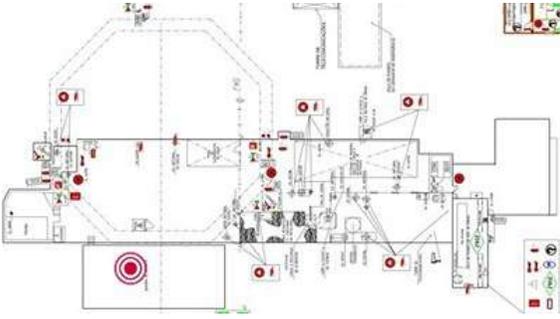
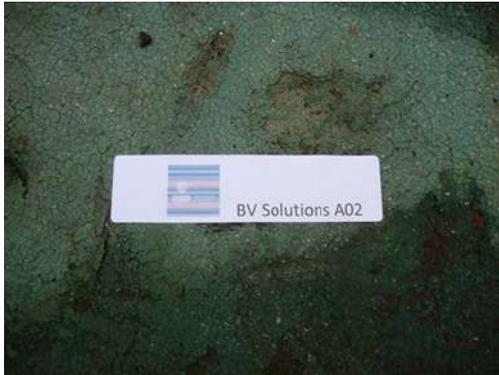
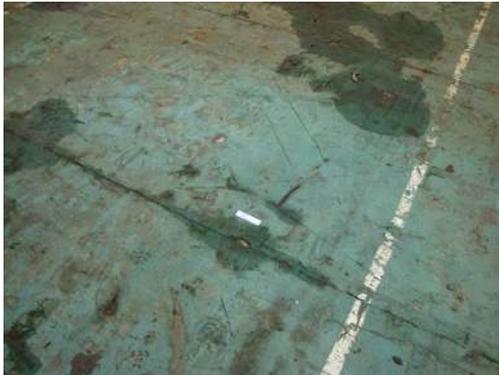
Location / Zone / Deck	Expected Hazardous Materials	Check procedure	Sample No.	Sample result	Quantity	Remarks
Upper Deck Miscellaneous	PCB	Sampling	A02	Not Contained		
Deck covering-Rubber applications-External area / Football field / Fr. 37 - PS

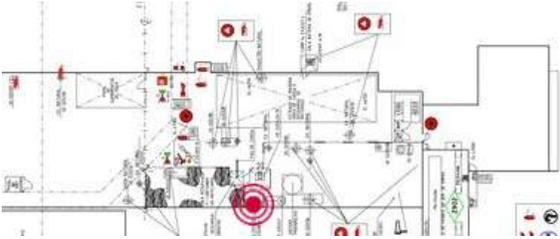
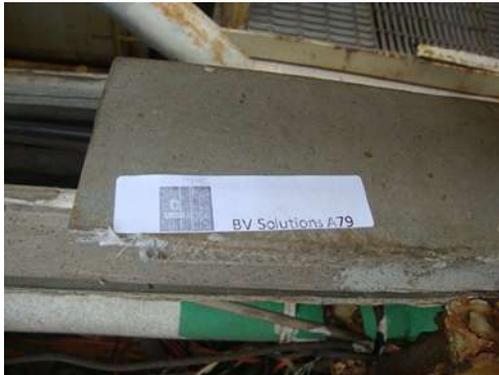
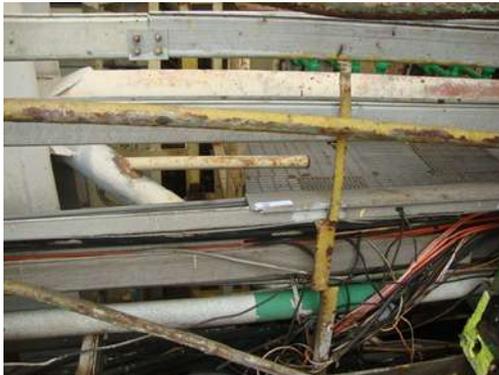
Upper Deck Miscellaneous	HBCDD
Electrical equipment-Equipment parts / spares-External area / Electric cable tray / Fr. 38 - STB

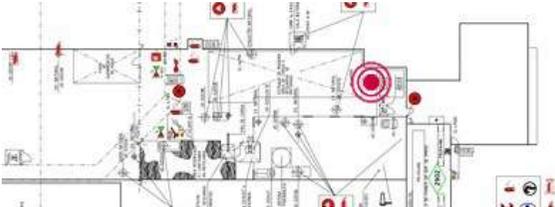
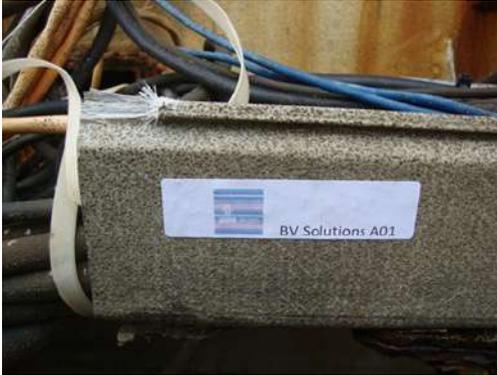
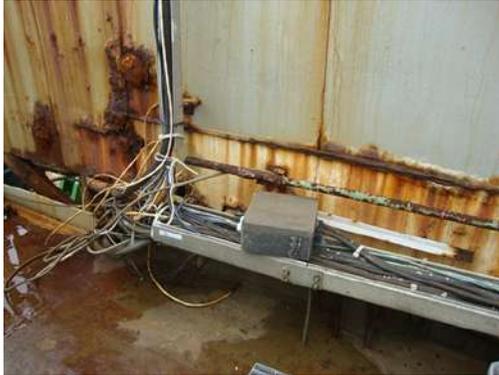
Location / Zone / Deck	Expected Hazardous Materials	Check procedure	Sample No.	Sample result	Quantity	Remarks
Upper Deck Miscellaneous	ODS	Sampling	A01	Not Contained		
Electrical equipment-Equipment parts / spares-External area / Electric cable tray / Fr. 43 - STB

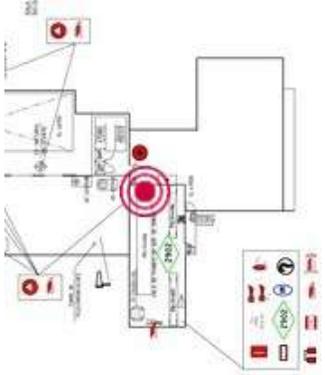
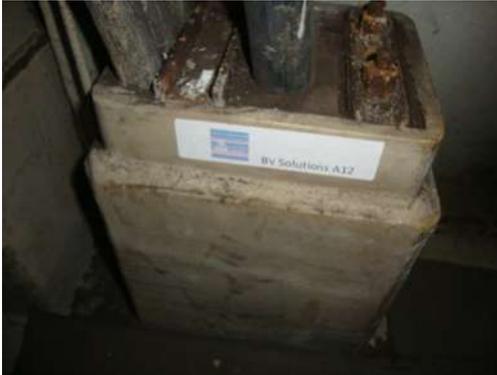
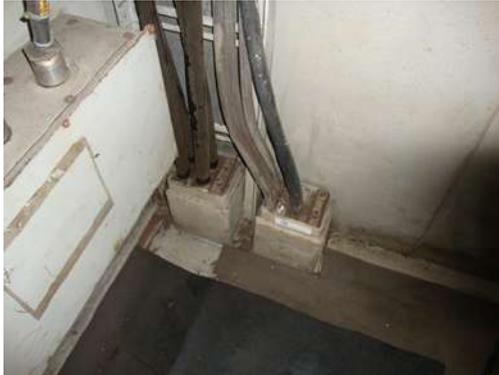
Upper Deck Miscellaneous	PCB	Sampling	A12	Not Contained		
Deck penetrations-Putty-MCT mass / Essential panel room / Fr. 40 - STB

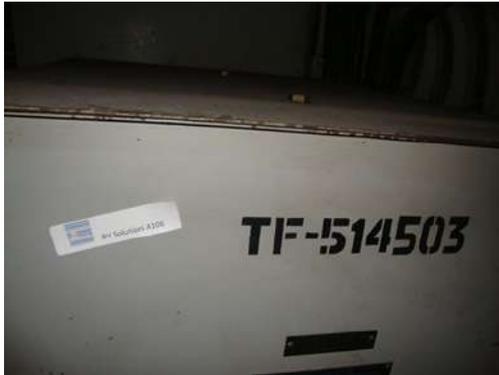
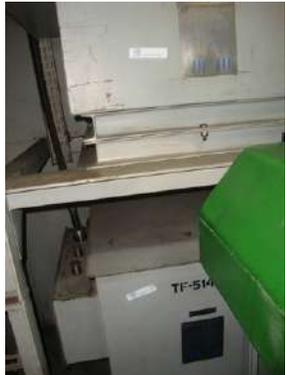
Location / Zone / Deck	Expected Hazardous Materials	Check procedure	Sample No.	Sample result	Quantity	Remarks
Upper Deck Superstructure	PCB	Visual	A106	Not Contained		
Transformer-Insulating oil-Electrical transformer - TF514503 / Essential Panel room / Fr. 37 - STB
