I-RL-3010.19-1320-970-TNA-001

TITLE: IHM Report – Part I

## Inventory of Hazardous Materials Manual Part I

Ship / Vessel name	PETROBRAS XIX
Flag	Panama
Distinctive No. / Letters	3FHI5
Port of Registry	PANAMA
Type of vessel	Floating storage unit
Gross Tonnage	22589
IMO Number	8753720
Name of Shipbuilder	
Name of Shipowner	BRASPETRO OIL SERVICES CO.
Date of delivery	31/12/1982
IHM Inventory Number	RJN0/2024/8753720/ssf
Revision Number	4.0

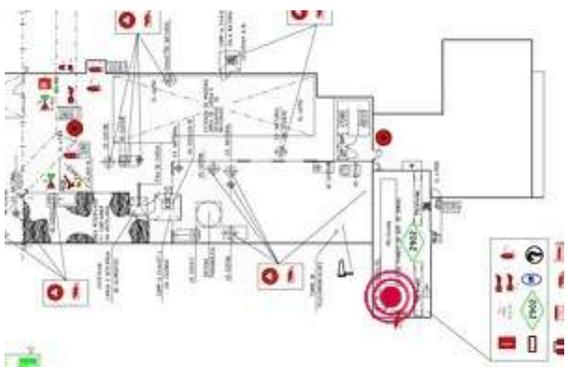
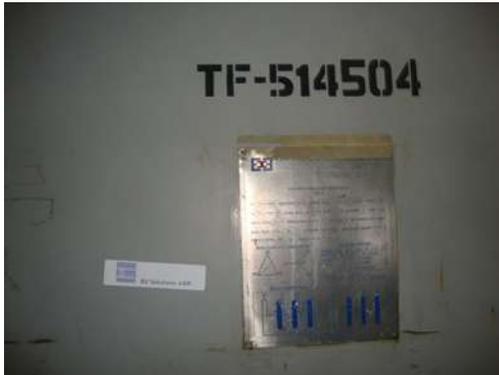
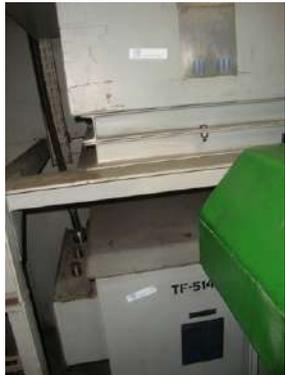
Upper Deck Superstructure	PCB	Visual	A105	Not Contained		
Transformer-Insulating oil-Electrical transformer - TF514504 / Essential Panel room / Fr. 37 - STB

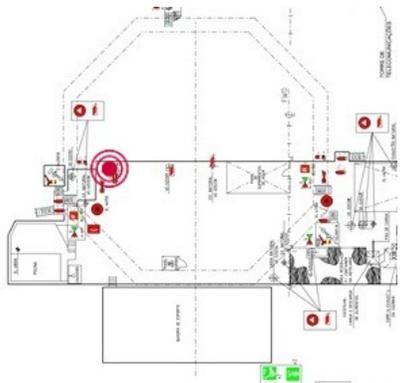
Location / Zone / Deck	Expected Hazardous Materials	Check procedure	Sample No.	Sample result	Quantity	Recommended Action
Helideck Miscellaneous	PFOS	Visual	A111	Contained	0.935 m3	No immediate action required
Fire protection/fighting system-Extinguishing agent-Foam tank (Tk 542401) / Fr.45 - PS

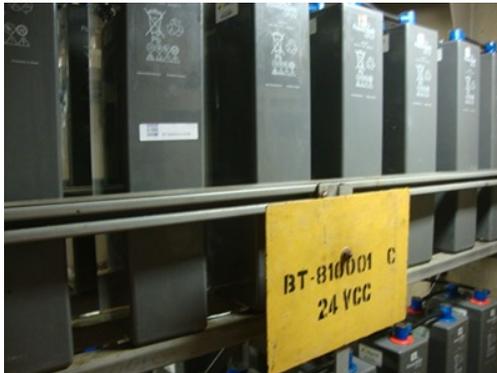
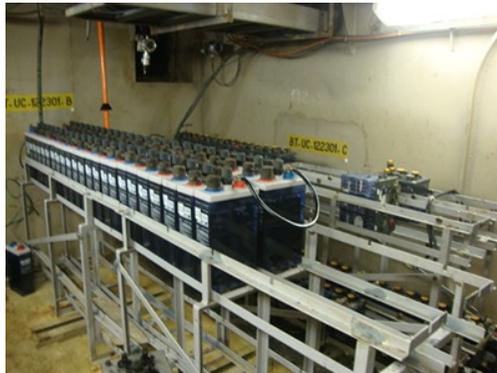
Location / Zone / Deck	Expected Hazardous Materials	Check procedure	Sample No.	Sample result	Quantity	Recommended Action
Lower Deck Cargo Area	Lead	Visual	A109	Contained	300 PCS	No immediate action required
Battery-Battery plates-Battery / Exportation pump room / Fr. 10 - PS

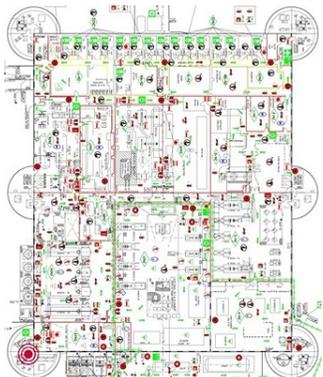
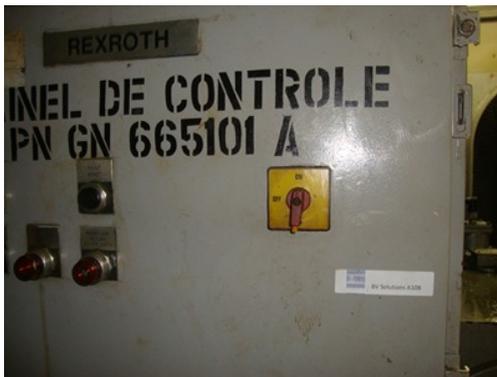
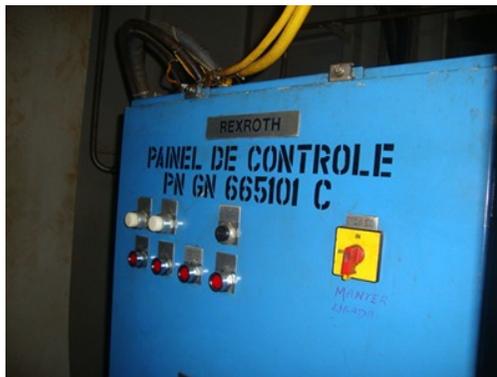
Lower Deck Miscellaneous	PFOS	Visual	A108	Contained	3.600 m3	No immediate action required
Mooring winches-Hydraulic oil-Anchorage winch UH GN665101A UH GN665101B UH GN665101C UH GN665101D / Columns FWD (P/S) AFT (P/S) / Fr. 6 - P/S Fr.45 - P/S

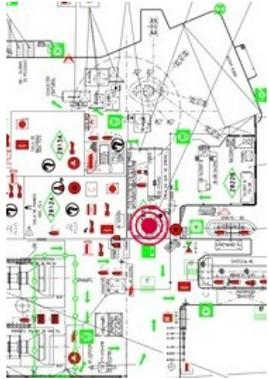
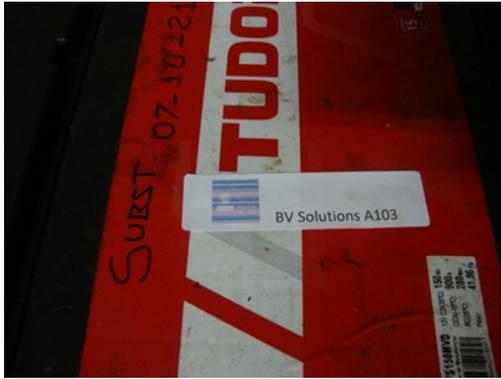
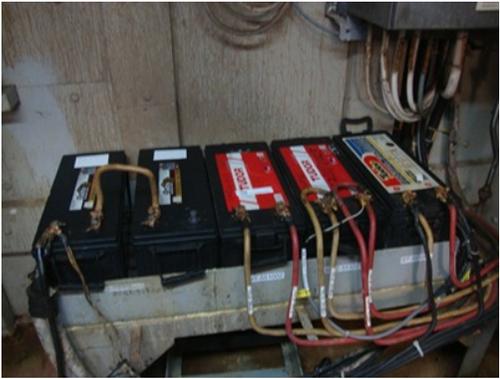
Location / Zone / Deck	Expected Hazardous Materials	Check procedure	Sample No.	Sample result	Quantity	Recommended Action
Main Deck Main Deck	Lead	Visual	A103	Contained	5 PCS	No immediate action required
Battery-Battery plates-Emergency generator room (DGE 514002) / Fr. 39 - STB

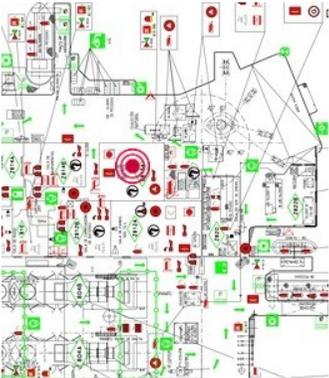
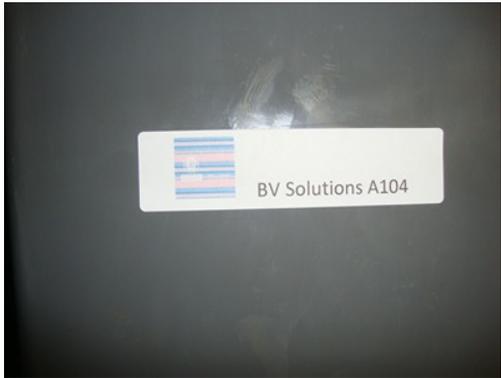
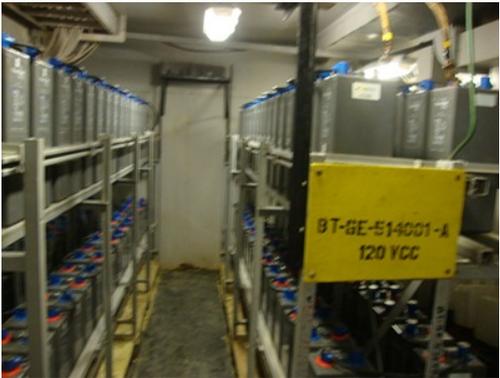
Main Deck Main Deck	Lead	Visual	A104	Contained	313 PCS	No immediate action required
Battery-Battery plates-Battery room / Fr. 44 - STB

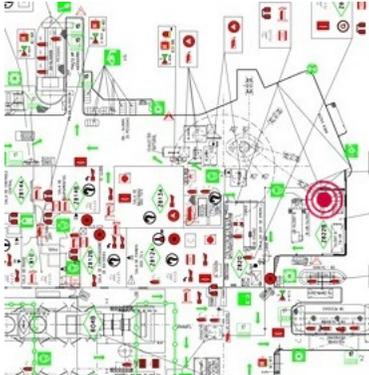
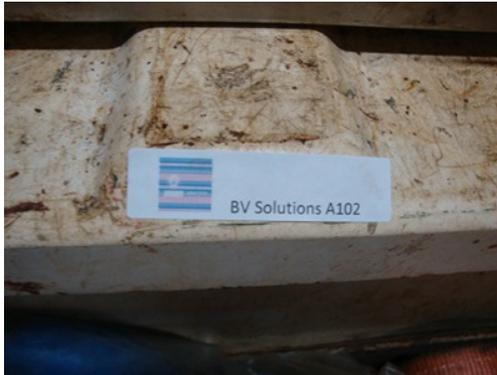
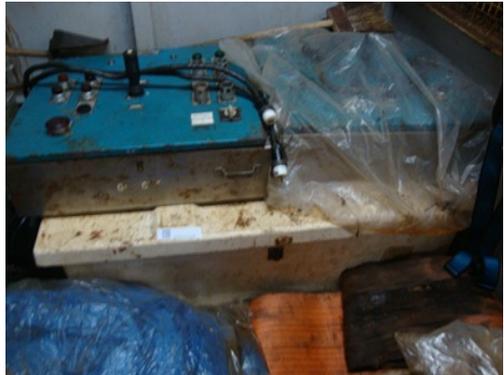
Location / Zone / Deck	Expected Hazardous Materials	Check procedure	Sample No.	Sample result	Quantity	Recommended Action
Main Deck Main Deck	Lead	Visual	A102	Contained	4 PCS	No immediate action required
Battery-Battery plates-Diesel Fire Pump MB-UB-542001B / Fr. 44 - STB

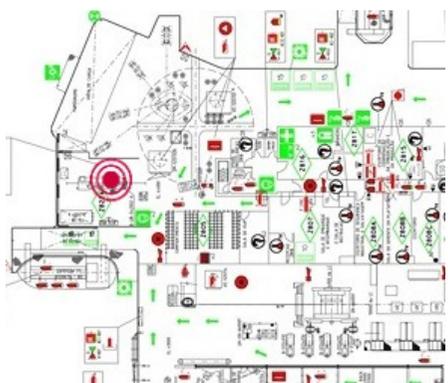
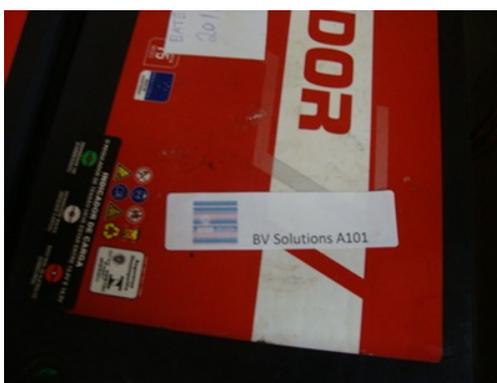
Main Deck Main Deck	Lead	Visual	A101	Contained	4 PCS	No immediate action required
Battery-Battery plates-Diesel Fire Pump MB-UB-542001A / Fr. 44 - PS

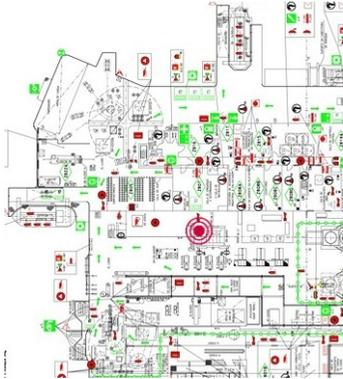
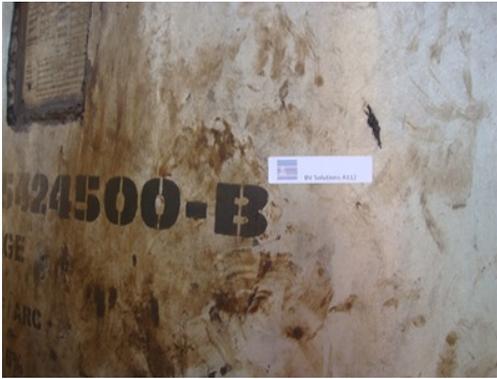
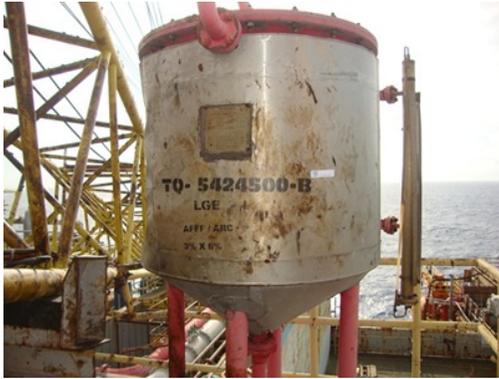
Location / Zone / Deck	Expected Hazardous Materials	Check procedure	Sample No.	Sample result	Quantity	Recommended Action
Upper Deck Cargo Area	PFOS	Visual	A112	Contained	0.75 m3	No immediate action required
Fire protection/fighting system-Extinguishing agent-Foam tank (Tk 5424500B) / Fr. 35 - PS

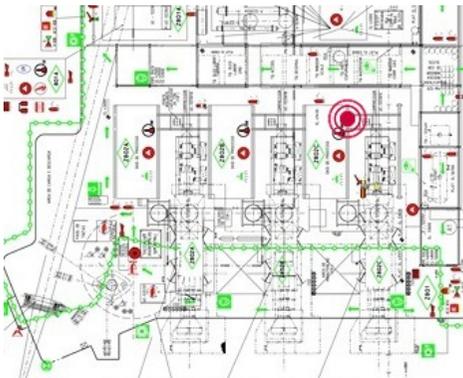
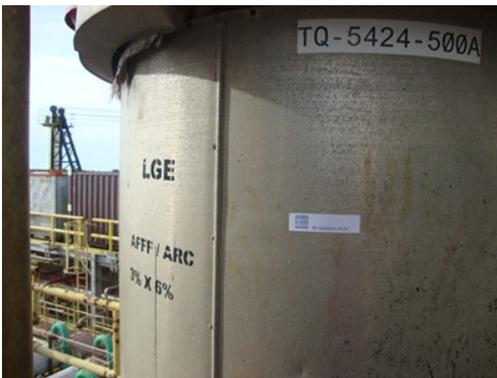
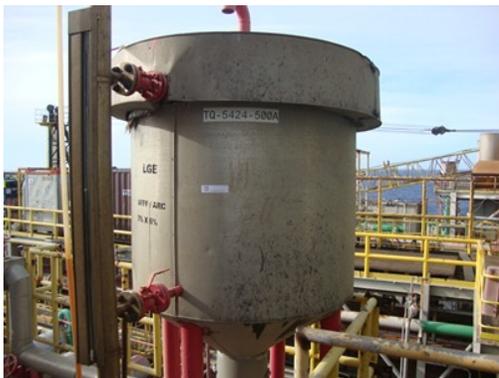
Upper Deck Cargo Area	PFOS	Visual	A113	Contained	0.75 m3	No immediate action required
Fire protection/fighting system-Extinguishing agent-Foam tank (Tk 542500A) / Fr. 18 - PS
